# KNKT.23.05.05.04

**Aircraft Accident Investigation Report**

PT Marta Buana Abadi (Dimonim Air) Cessna C208; PK-HVG Yabi Airstrip, Papua Republic of Indonesia 9 May 2023

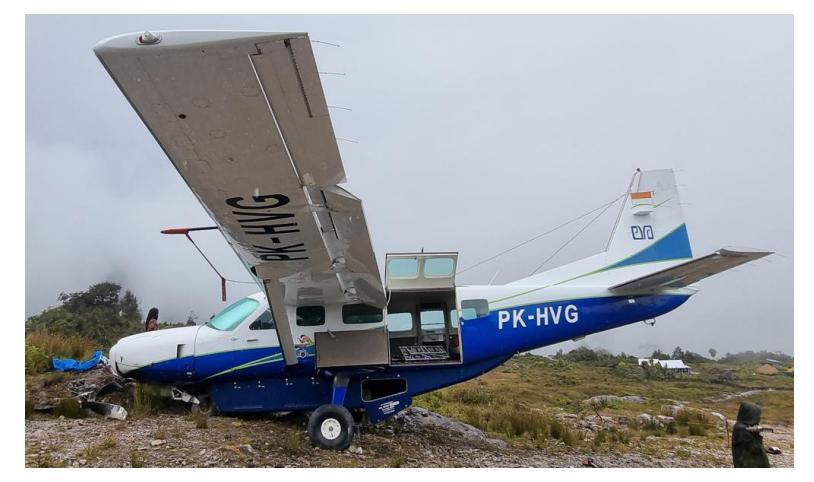
Figure 1: Damage to the aircraft

No one was injured in this occurrence. However, the sustained substantial damage, including bent propeller blades, a collapsed nose landing gear, and damage to the forward cargo door, engine cowling, and exhaust.

The aircraft was substantially damaged as shown by Figure 1 to Figure 5.

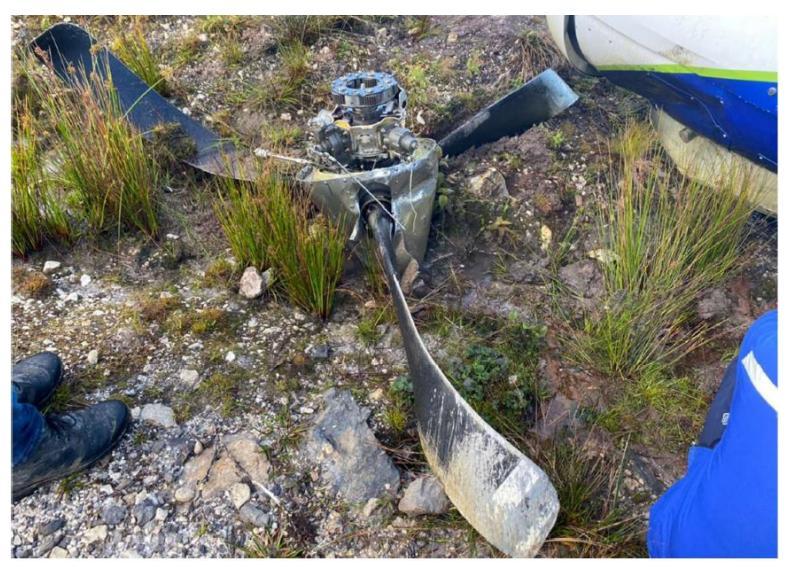
Figure 2: Damage to the propeller

As the aircraft kept going right, the pilot reduced the power and cut off the fuel by closing the fuel valve. The aircraft collided with a large rock led to the detachment of the propeller from the engine power drive and caused the aircraft to stop.

The propeller disassembled from the engine power drive and its blades were bent as shown by Figure 2.

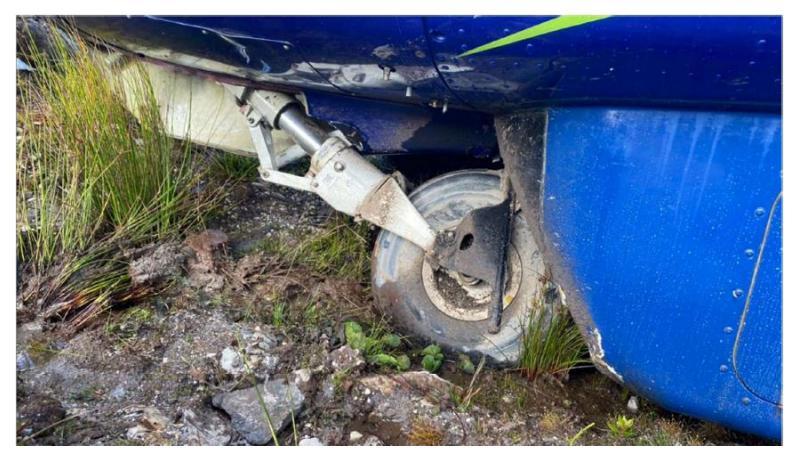
Figure 3: Damage to the forward cargo door

The nose landing gear collapsed and folded back causing damaged to the forward cargo door as shown by Figure 3.

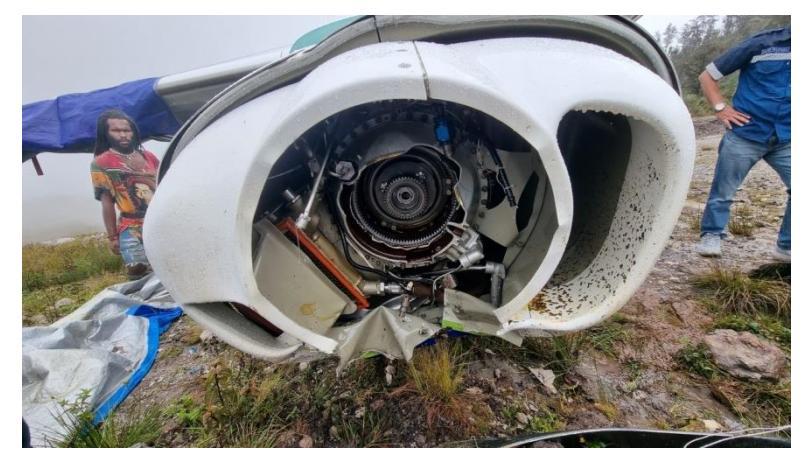
Figure 4: Damage to the engine and its cowling

The engine, its cowling, and the exhaust were wrinkled as shown by Figure 4 and Figure 5 respectively.

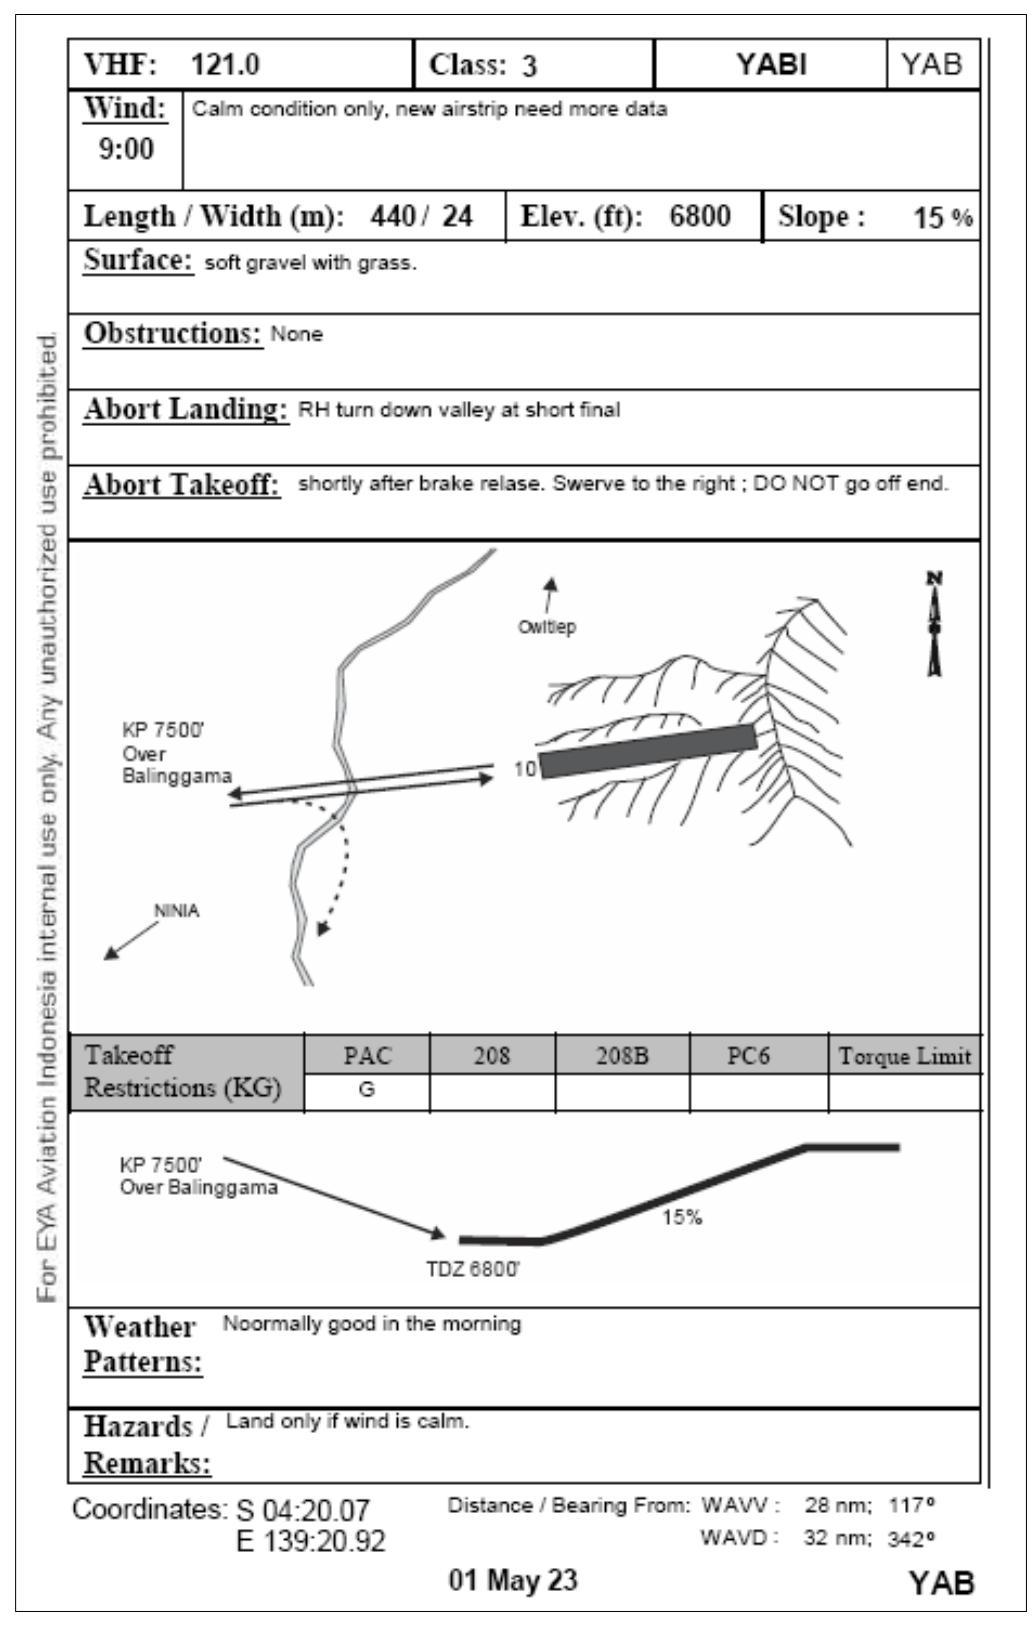
Figure 7: Yabi airstrip chart

According to Airport chart held by the pilot, Yabi airstrip was situated in a mountainous area at coordinates 04°20.07'S and 139°20.92'E, with an elevation of 6,800 feet. It was located approximately 28 nm from Wamena Airport (WAVV) at a bearing of 117°, and about 32 nm from Nop Goliat Dekai Airport (WAVD) at a bearing of 342°. The runway surface was soft gravel with grass, and it had a slope of 15%. The runway's dimension was 440 meters in length and 24 meters in width with designation number of 10/28 direction. The chart held by the pilot is illustrated by Figure 7.

During data collection, KNKT utilized other aircraft to reach the Yabi airstrip in the next day after the occurrence. Refer to the navigation instrument in the aircraft which utilized by KNKT, it was discovered that the runway azimuth was 08/26 direction with the elevation of the touchdown zone was about 7,300 feet.

Note: the Abort point showed by the dash line

The Dimonim Air developed Operation Manual Part C (OM-C) for internal use which provides area, route, and aerodrome information in Papua and Bali Area. The document includes airport, terrain, weather, route details and any other relevant information deemed useful for the flight operation in the local area. However, the latest revision of this document did not provide information related to Yabi. In the other hand, Yabi aerodrome chart in the possession of the pilot indicated a runway designation number of 10/28 and the touch down zone elevation was 6,800 feet. During the KNKT investigation, it was discovered that the correct runway heading was in 08/26 direction and the touch down zone was at 7,300 feet.

The absence of company document which provide correct information of the area, route and aerodrome poses a significant concern, as it hinders the assurance that pilots to have necessary information when conducting flight operations in specific areas.

Therefore, KNKT recommends the Dimonim Air ensures the provision of adequate and precise references to pilots, including all relevant information regarding Yabi airstrip and guidance for Dekai to Yabi operation to enhance flight safety and operational efficiency.

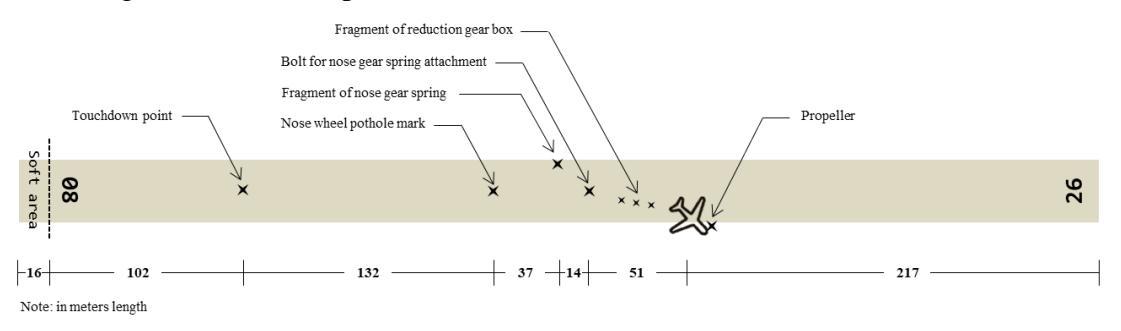
Figure 8: Impact sequence and wreckage trail

Figure 5 depicts landing sequence of the aircraft. Touch down mark was found 102 meters from the runway threshold, approximately 130 meters after that, the mark indicating the nose wheel pothole was identified.

A fragment of the nose landing gear spring was discovered about 270 meters from the runway threshold, and the bolt used for the nose gear spring attachment was found about 14 meters further along from that point. Scattered fragments of the reduction gear box were found along the trail as the aircraft made a right turn before stopped. The propeller detached from the engine power drive rested around 0.5 meters from on the left side of the aircraft nose.

- 7. Touch down mark was found 102 meters from the runway threshold, and the nose wheel pothole mark was identified at a distance of 234 meters. The aircraft came to a stop approximately 330 meters from the threshold, at the right side of the runway, after executing a right turn, colliding with a large rock which led to the disassembly of the propeller from the engine power drive.

- 10. The nose landing gear collapsed. A fragment of the nose landing gear spring was discovered 271 meters from the runway threshold, and the bolt used for the nose gear spring attachment was found 14 meters further along from that point. Scattered fragments of the reduction gear box were found along the trail as the aircraft made a right turn before stopped.
