KOMITE NASIONAL KESELAMATAN TRANSPORTASI REPUBLIC OF INDONESIA

PRELIMINARY KNKT.24.03.08.04

Aircraft Accident Investigation Report

PT Smart Cakrawala Aviation Pilatus PC-6/B2-H4; PK-SNE

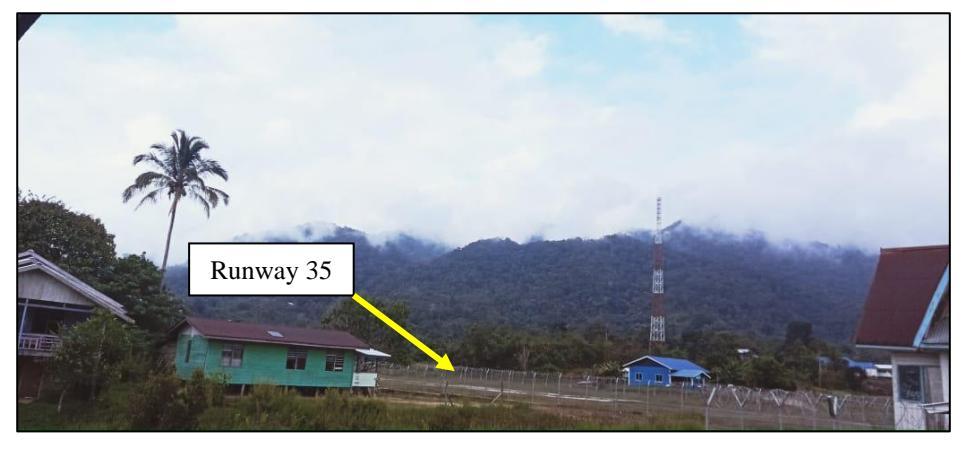
Figure 2: Weather condition on Binuang (view looking to the south)

Prior to departure, Binuang resident provided pictures that depicted the weather conditions over the airstrip to the Tarakan FOO and forwarded it to the PIC. The weather at the time of the occurrence was cloudy, as shown in the following figures.

- 7. During the flight preparation, the pilot received pictures that depicted the weather condition over the destination aerodrome. Those pictures were taken by Binuang resident and depicted that the weather was cloudy.

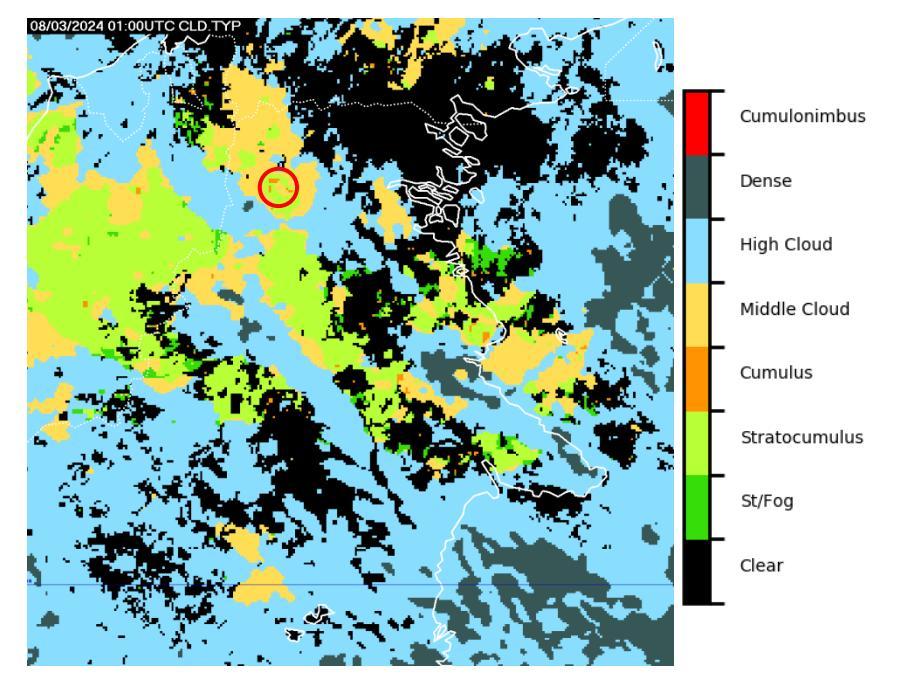
Figure 4: The satellite images to show the cloud type at 0100 UTC (0900 LT)

Based on the satellite images provided by BMKG as shown on the following figures, at 0900 LT and 0930 LT, it was shown that there were stratocumulus clouds, cumulus clouds, and middle clouds around the accident site (red-highlighted).

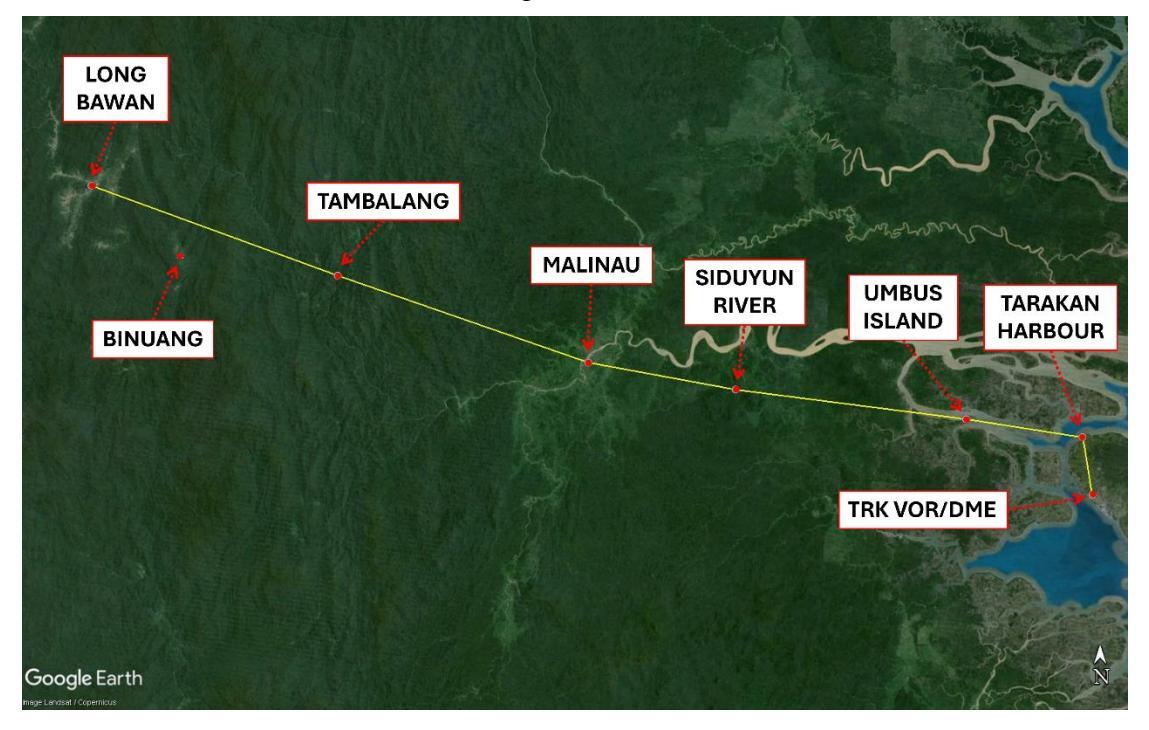
Figure 7: Illustration of the VFR route from Tarakan to Long Bawan

The AIP Volume I Subchapter ENR 6-1J provided VFR routes for North and East Kalimantan. The route for a flight from Tarakan to Binuang was not included. The

following figure is an illustration of the VFR route from Tarakan to Long Bawan based on the AIP with the location of Binuang.

Therefore, KNKT recommends Smart Aviation to develop and implement route guidance to conduct flights from Tarakan to Binuang.

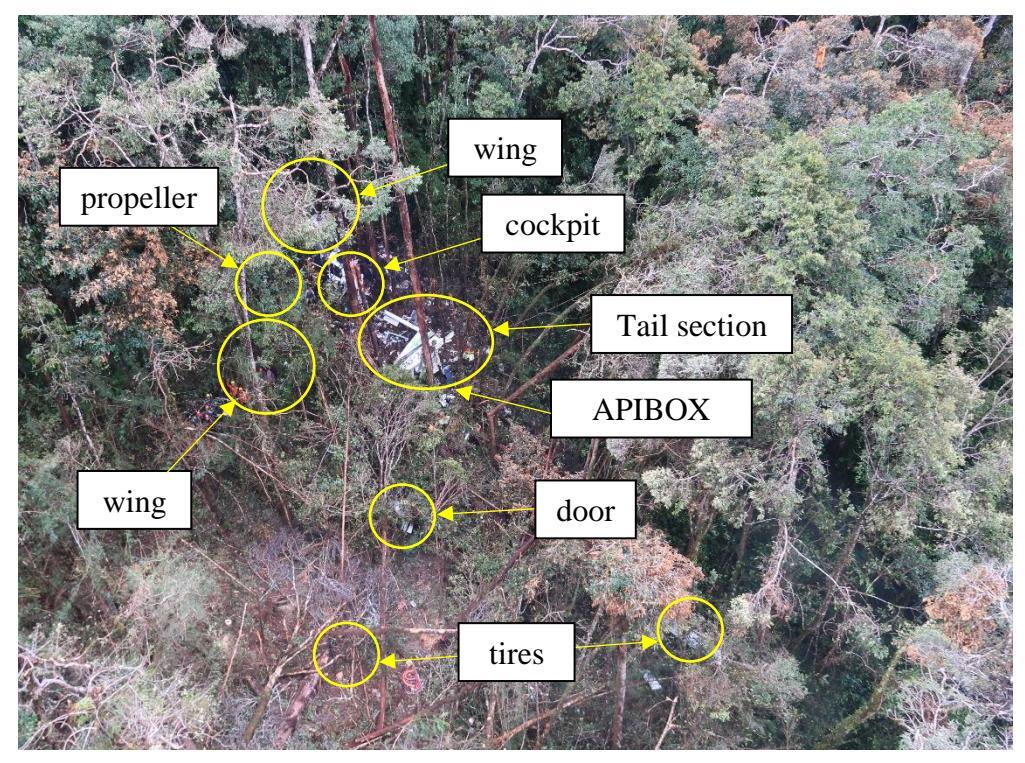
Figure 11: Wreckage Distribution

The aircraft wreckage was found at about 5.0 NM southeast of Binuang on a bearing of 305° with an elevation of about 4,500 feet at the ridge of a mountain with tropical rain forest.

The wreckage distribution of the accident was shown on below image.

- 16. The aircraft was found impacted into the ridge of the mountain with an elevation of about 4,500 feet on coordinates of 3° 43' 29.60" N and 115° 56' 24.04" E. The crash site location is about 5 NM southeast of Binuang on a bearing of 305°.
