FINAL
KNKT.15.12.10.03

Marine Safety Investigation Report
Collision between
Antigua and Barbuda Registered
General Cargo *THORCO CLOUD*
and Cayman Islands Registered
Tanker *STOLT COMMITMENT*
Singapore Strait 16 December 2015

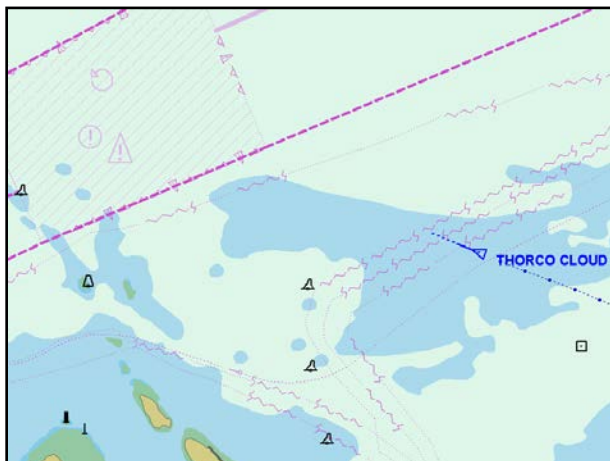
Figure 1: *Thorco Cloud* whilst approaching the TSS (source: Batam VTS)

At 17.45 LT, the Pilot boarded the *Thorco Cloud*. Around 25 minutes later, the ship departed the port and sailing towards the TSS of Singapore Strait. Her speed, course over ground (COG) and heading were around 11 knots, 292°T and 291°T, respectively.

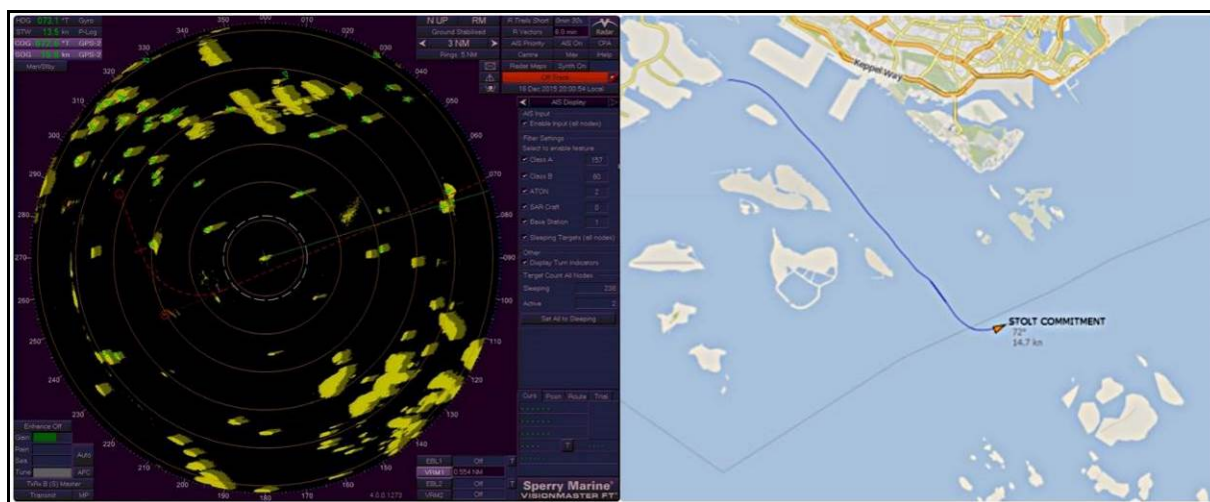
Figure 2: *Stolt Commitment* whilst sailing on the TSS (source: *Stolt Commitment's* VDR and Marine Traffic)

Meanwhile, a tanker vessel, *Stolt Commitment*, was sailing on the TSS heading easterly. She had departed from Singapore Port and was heading for the Port of Kaohsiung, Taiwan. The Second Mate and a couple of crew of *Stolt Commitment* were standing by to mitigate the

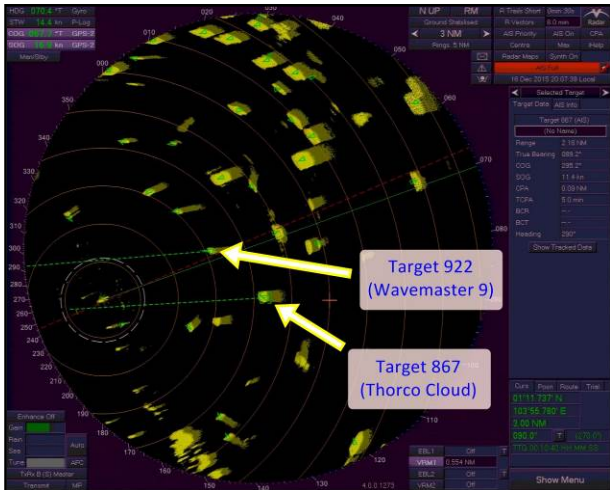
Figure 3: Wavemaster 9 & Thorco Cloud on Stolt Commitment's radar

On board the *Stolt Commitment*, the OOW checked the situation through radars regularly. Right before *Stolt Commitment* altered to left (from Singapore to join the TSS easterly), *BTS Elizabeth* was the first ship spotted on the radar target data. Soon after the *Stolt Commitment* completed left turning, *Wavemaster 9*, which was crossing *Stolt Commitment's* bow with the speed of 22 knots, was targeted as well. Later on, *Gulf Cobalt* was focused on the radar target. Finally, *Target 867* was clicked by the OOW on the radars. At this time, the *Thorco Cloud* was sailing approaching the *Stolt Commitment* and both of them did not reduce the speed.

At around 20.10 LT, the OOW was checking a target on the radar named Target 867 as shown in Figure 3. Initially, the radar system showed no name for the target 867. But thereafter, the radar system showed it as the *Thorco Cloud* when the range was 0.92 NM.

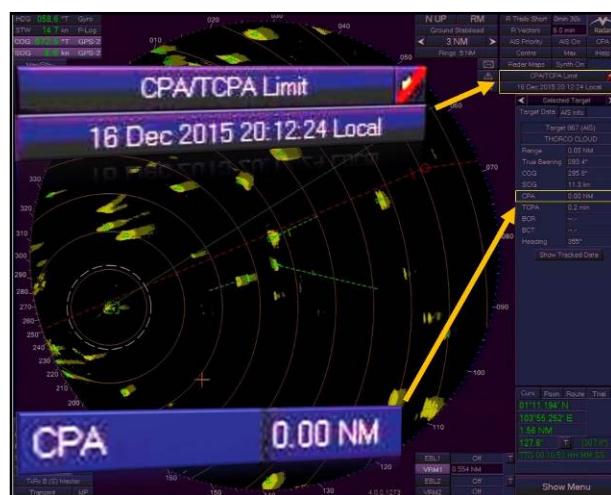
Figure 4: The CPA between Stolt Commitment and Thorco Cloud was zero

At around 20.12 LT, the Master of *Stolt Commitment* asked the OOW to check the CPA of *Thorco Cloud*. The OOW then informed the Master that the closest point approach (CPA) of *Thorco Cloud* was zero (0) nautical mile as shown in Figure 4. At that time, the distance between both

vessels was 0.8 NM. However, the Captain of *Stolt Commitment* did not order the crew to alter the course or reduce the speed.

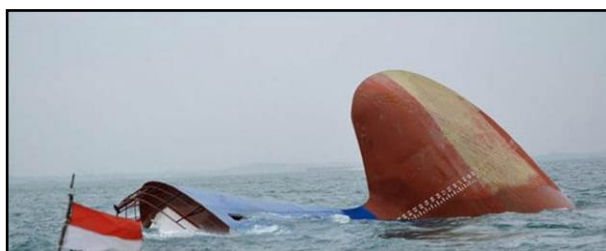
Figure 5: The bulbous bow of Thorco Cloud

At around 20.13 LT, the collision between *Thorco Cloud* and *Stolt Commitment* occurred at 1°12.2' N and 103°54.1' E or around 5 NM from Batam Port in Indonesian waters. The bulbous bow of *Stolt Commitment* collided the port side of *Thorco Cloud* between midship and accommodation room. As the result, the *Thorco Cloud* was broken into two parts, specifically fore and aft parts.

Around 9 minutes after the collision, the AIS signal from *Thorco Cloud* disappeared. The aft part sank first, while the fore part was floating in which the bulbous bow was facing upward.

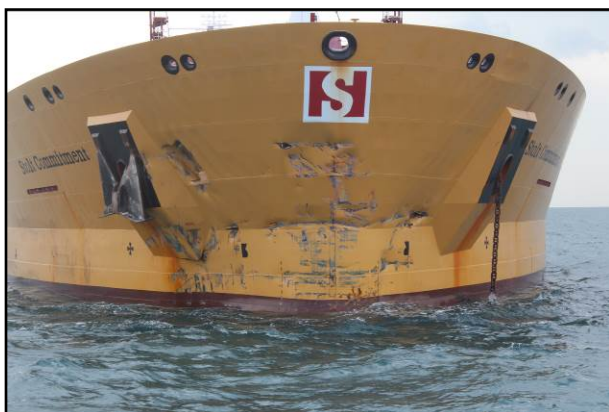
Figure 6: Minor damage on Stolt Commitment due to the collision

On the other hand, *Stolt Commitment* suffered minor damage on her bulbous bow and the haws pipe of starboard side as seen in Figure 6. She was in a stable condition because the damage did not allow water to ingress into the spaces forward of the collision bulkhead. After the joint investigation (the MPA Singapore and the NTSC Indonesia) had been done, the ship continued the voyage to Singapore to be checked by the marine surveyor.

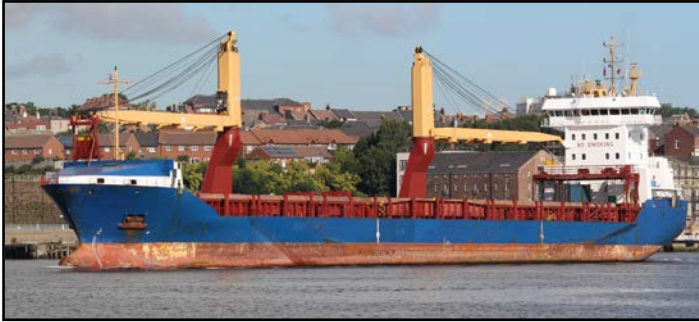
Figure 7: Thorco Cloud (source: Fleetmon)

She was built at Damen Shipyards in Galati, Romania in 2004 and classed into Det Norske Veritas (DNV) & Germanischer Lloyd (GL). Her length overall (LOA), breadth moulded (BM) and draught maximum height (H) were 145.63 m, 18.36 m and 7.8 m, respectively. Her deadweight was 10,385 tonnes.

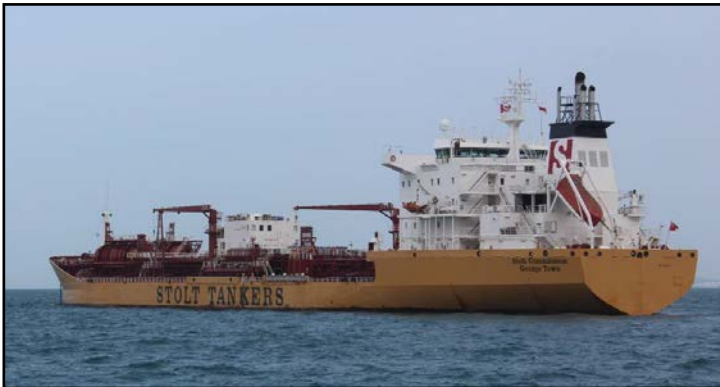
The Cayman Islands-flagged oil or chemical tanker *Stolt Commitment* (IMO number 9168647) was built at Stx Norway Floro AS in Norway in 2000. She is classed into Det Norske Veritas

Figure 8: Stolt Commitment

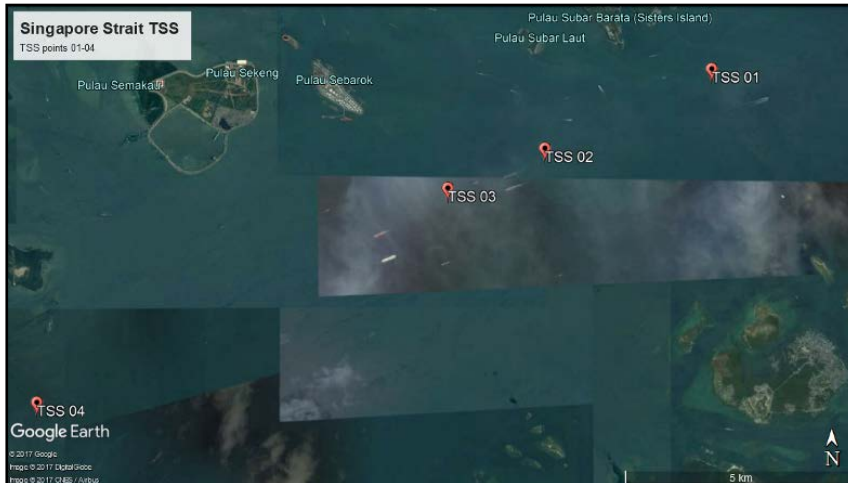
Figure 9: TSS checkpoints

The Traffic Separation Schemes (TSS) is applied to the Singapore Strait to enhance the marine safety in the area. The TSS divides the strait into two sections. Ships heading easterly will be sailing on the southern part of the TSS; westbound ships will be passing along the north part of the TSS as shown in Figure 9.

Refer to the Safety of Navigation in the Singapore Strait issued by the Maritime and Port Authority of Singapore in 2006, the checkpoints of the TSS are spread along the strait at 01°12.51'N/103°52.15'E, 01°11.59'N/103°50.21'E, 01°11.13'N/103°49.08'E and 01°08.65'N/103°44.30'E as depicted by Figure 9.

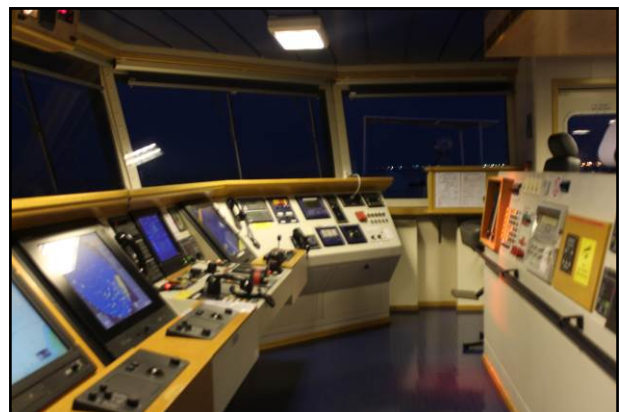
Figure 10: The situation on the bridge of *Stolt Commitment* towards the starboard side

There was no obstruction on visibility due to the weather, physical ability or window on the bridge of *Stolt Commitment*. All crew on her bridge could see any ships surrounding, particularly on their starboard side.

Both the Master and the OOW of *Stolt Commitment* acknowledged that their ship supposed to give way to the *Thorco Cloud*. However, as the *Stolt Commitment* was on the TSS, the Master of *Stolt Commitment* thought that the *Stolt Commitment* has the priority over the *Thorco Cloud* which was off the TSS. Furthermore, in reference to the interview, this point of view developed an

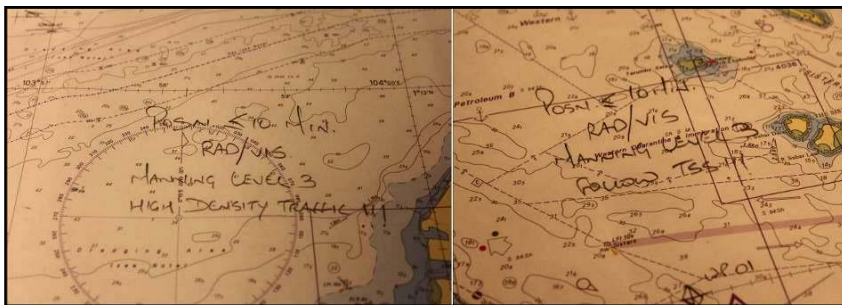
Figure 11: The note given on the chart of *Stolt Commitment*

Before the voyage, they planned to pass the Singapore Strait with the manning level set to level 3. There were a couple of notes regarding the high-density traffic in the Singapore Strait to anticipate any consequences derived by the considerable number of vessels crossing the channel as in Figure 11. However, the notes were not effective as she was sailing nearly at her top speed. With the speed as in an open sea, it is more difficult for the ship to take any action in avoiding the collision.

2. To ensure the seafarer's knowledge regarding the COLREGs related to TSS is updated.

1. To ensure the seafarer's knowledge regarding the COLREGs related to TSS is updated.

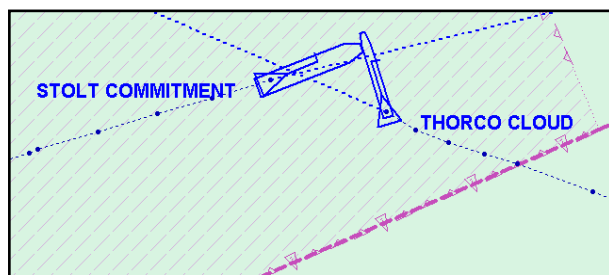
Figure 12: Both vessels whilst the collision (source: Batam VTS)

Compared to the *Stolt Commitment*, in accordance with the Rule 15 (crossing situation), the *Thorco Cloud* had the right to maintain her course to join the TSS. At this accident, the *Thorco Cloud* maintained her course very well until the last minute before the collision. In accordance to the Rule 17 (action by stand-on vessel), when the stand-on

vessel (*Thorco Cloud*) finds that the give way vessel (*Stolt Commitment*) cannot take an action alone, the stand on vessel should take an action to avoid collision in an adequate time by considering her speed and the distance to the surrounding situation. Despite the *Stolt Commitment* altering to the port side which was correct to reduce the collision impact, the action was taken in the latest time which gave both vessels no time to avoid the collision as depicted on Figure 12.
