Aircraft Serious Incident Investigation Report

Collision on the Ground

**PT. Manunggal Air Service And PT. Trigana Air Service
Antonov AN-26B Twin Otter
4L-IFE PK-YRU**

**Sentani Airport, Jayapura Papua
Republic of Indonesia
02 December 2010**

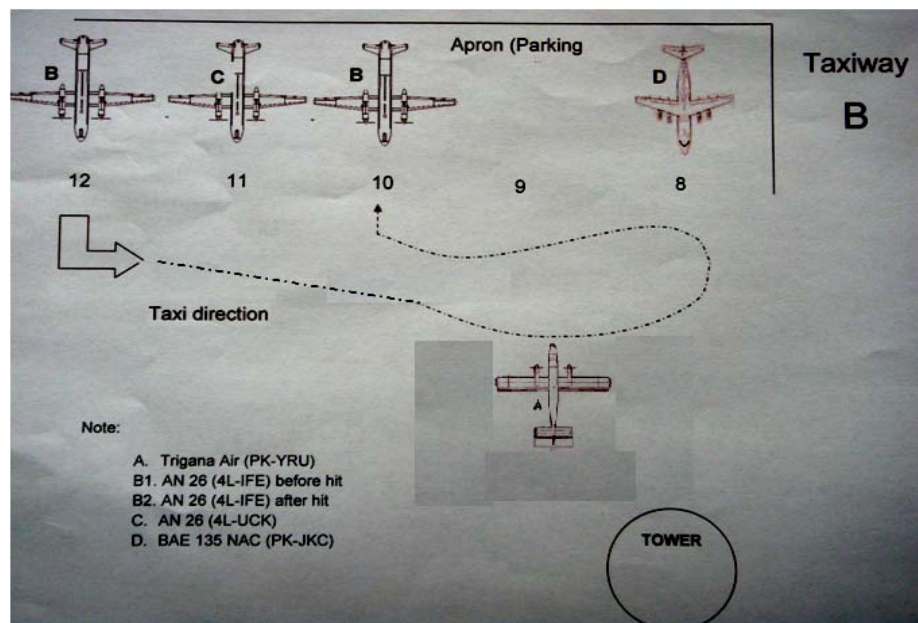
4L-IFE taxi out of parking bay number 12 to taxiway Bravo. Eyewitness informed that the aircraft was taxi faster than any other aircraft normal taxi speed. There were no marshaller to guide the Antonov aircraft taxing out and there were no taxi guide line on this area of the apron.

At abeam parking bay number 9, the right wing of the 4L-IFE collided with left engine and propeller of the PK-YRU.

Figure 1: Sketch of the parking area

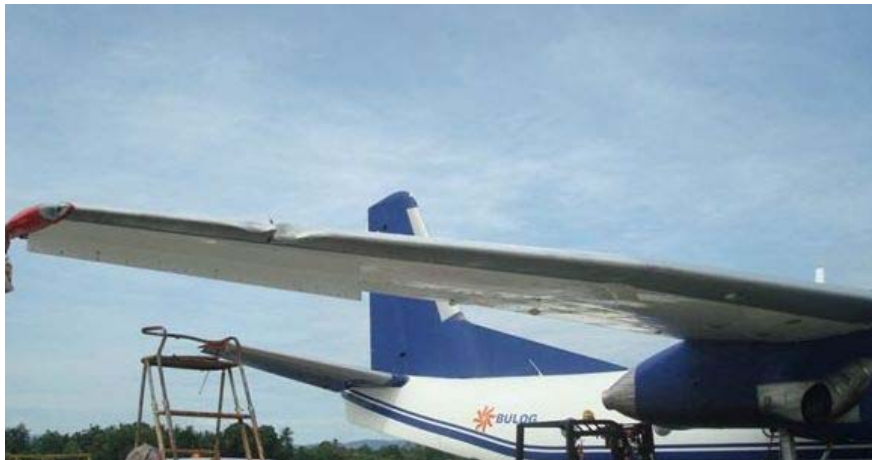
Right wing leading edge was dent at position about 2 meters from the wing tip.

Right Navigation light cover was broken.

Figure 2: Damage on the right wing leading edge

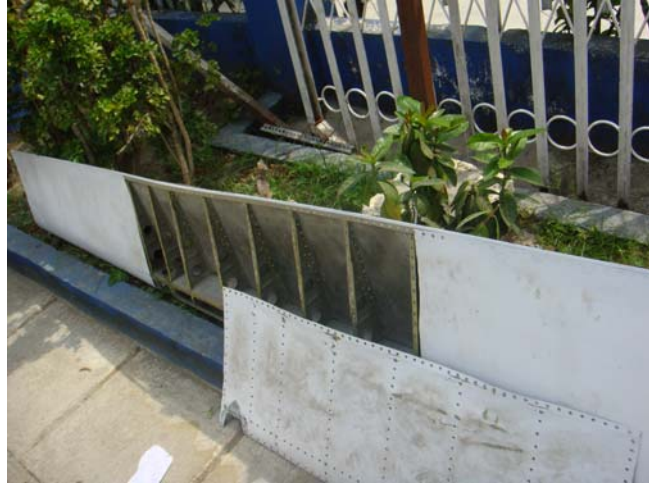
The right aileron was damage and removed for repair.

Figure 3: Lower skin of the right aileron scratched

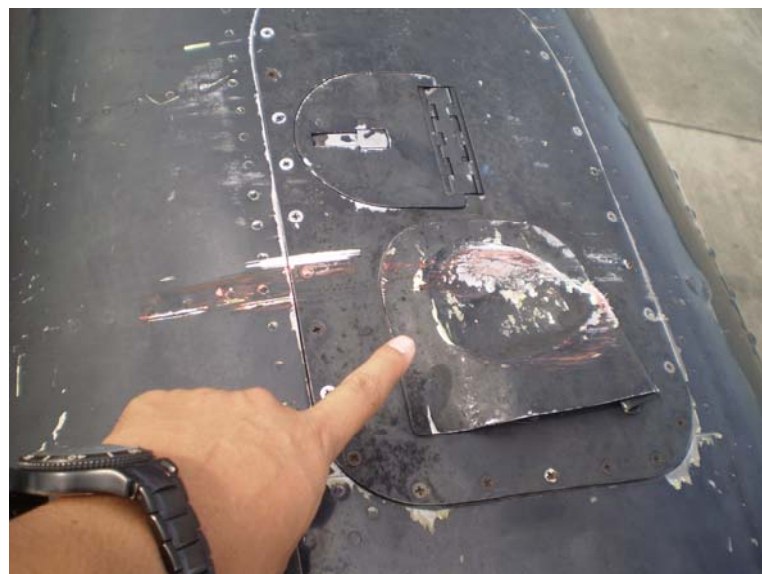
The left engine nacelles were damage, upper surface of the sta 125.55- 200.55 inches of datum scratched and the skin at Right hand upper of the engine cowling was wrinkled.

Both engine nacelles were bent down, and the skin of the right engine nacelle was wrinkle.

Figure 4: An upper surface left nacelle scratched

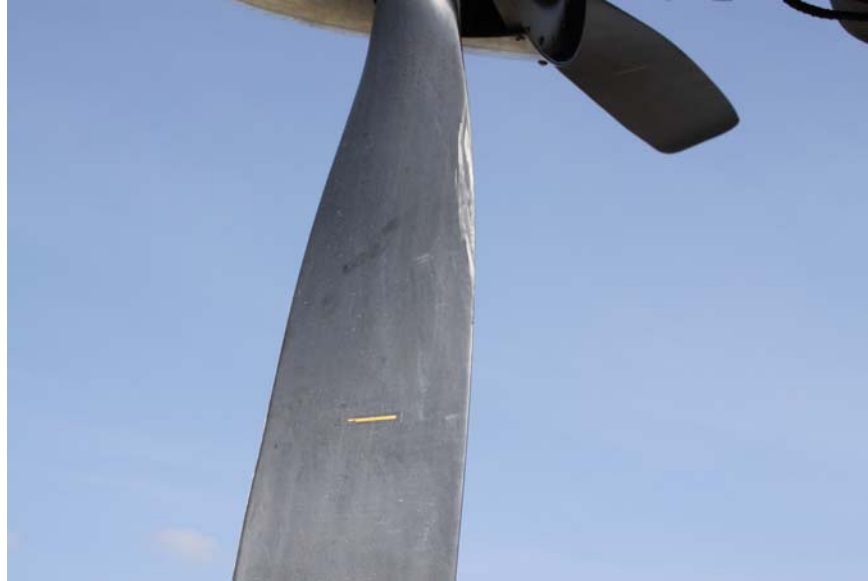
One of the propeller blades from left engine was scratch, and one of the right propeller blades were dent at the leading edge.

Figure 5: Left propeller blade scratched

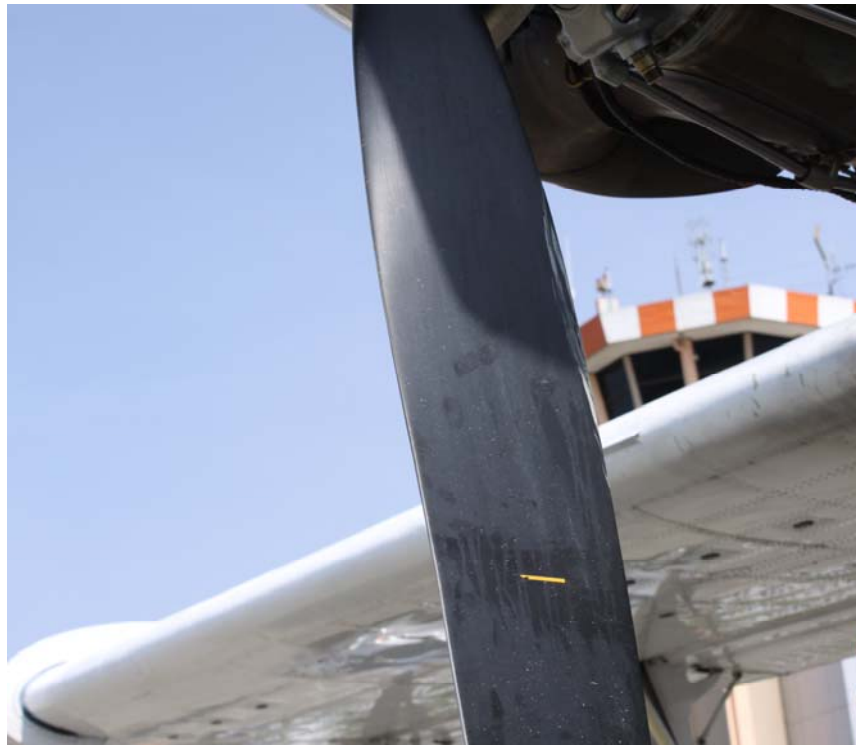
Figure 6: Right propeller blade leading edge dent
