SHORT SUMMARY REPORT

Aircraft Serious Incident Investigation Report

Cessna 172; PK-TGW

Budiarto Airport, Curug

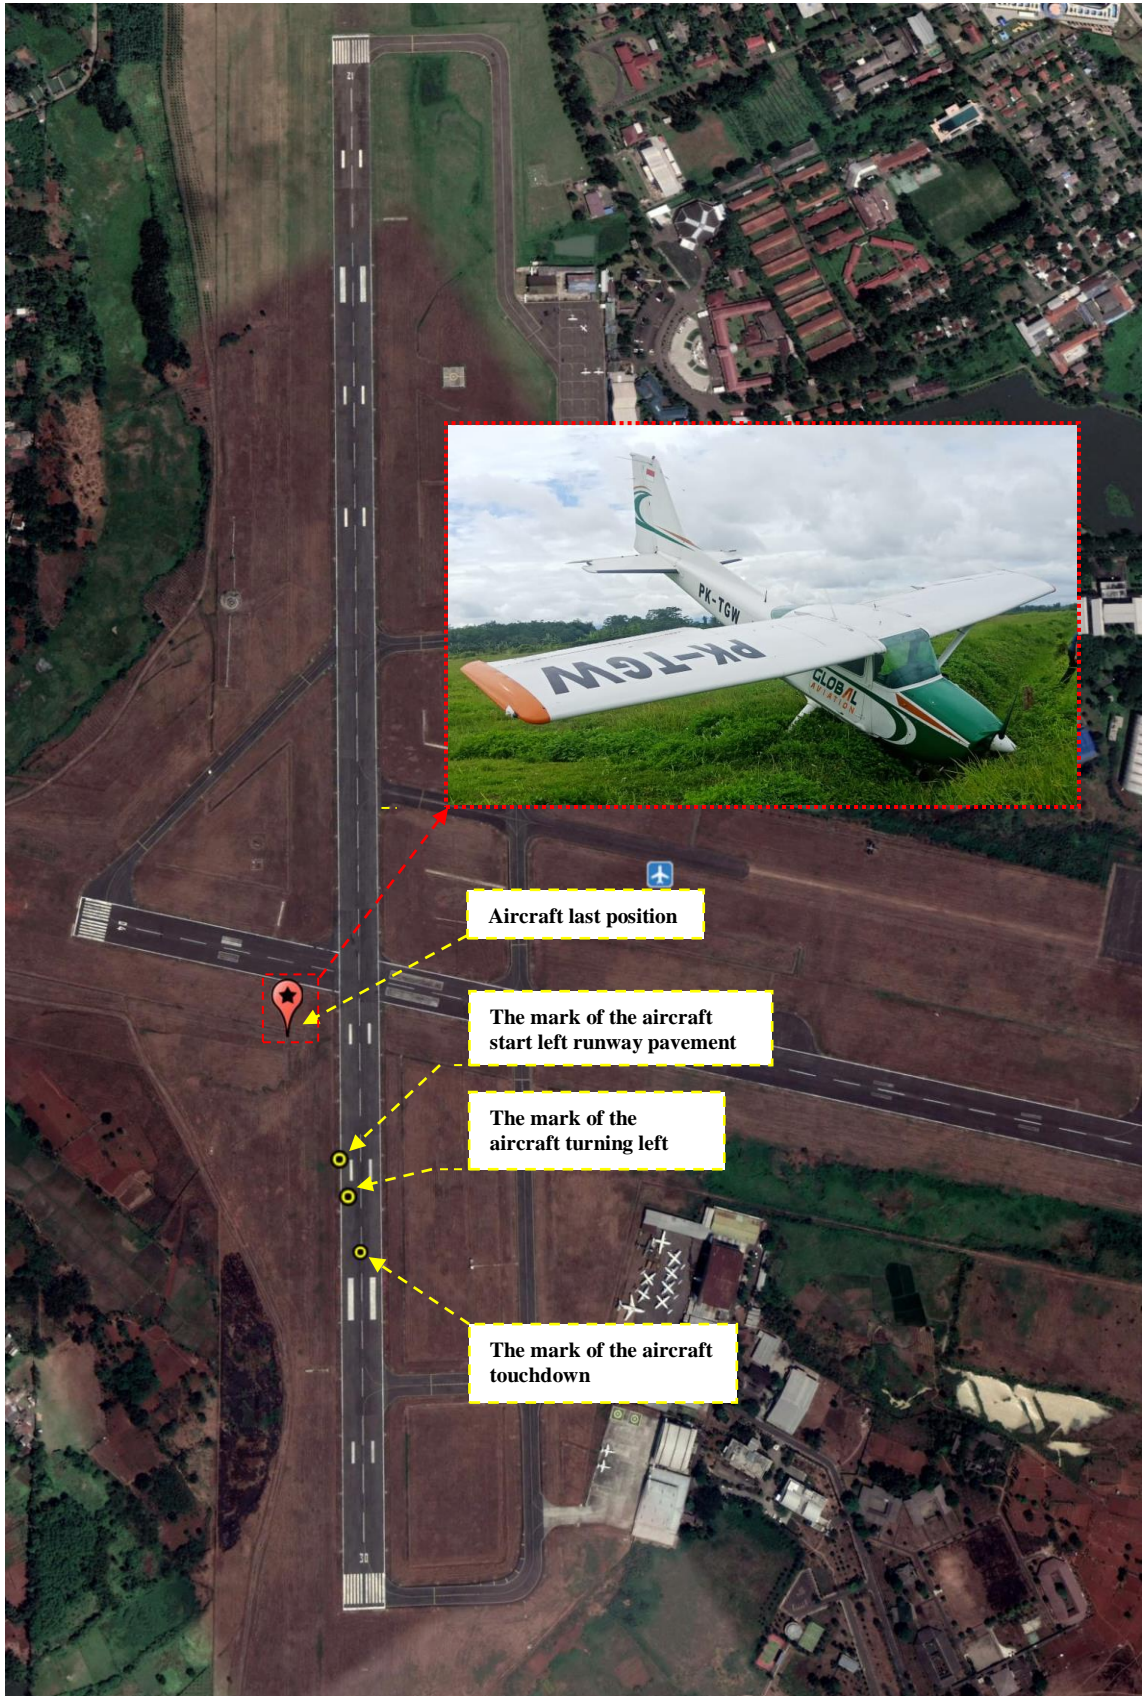
The student pilot felt that the approach was normal and uneventful. After touchdown the student pilot found that the aircraft tend to turn to the left and was hard to control to maintain the runway centerline. The aircraft continued move to the left and stopped on a ditch on the left of the runway 30, approximately 80 meters from runway centerline and 435 meters from beginning of runway.

Figure 1: The marks found on the runway indicated the aircraft movement

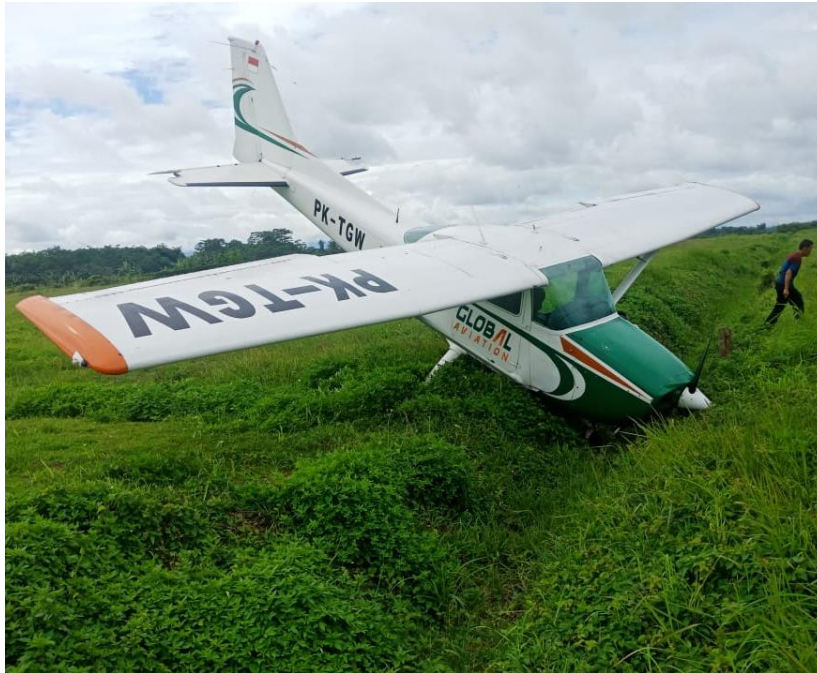
Figure 2: The aircraft last position

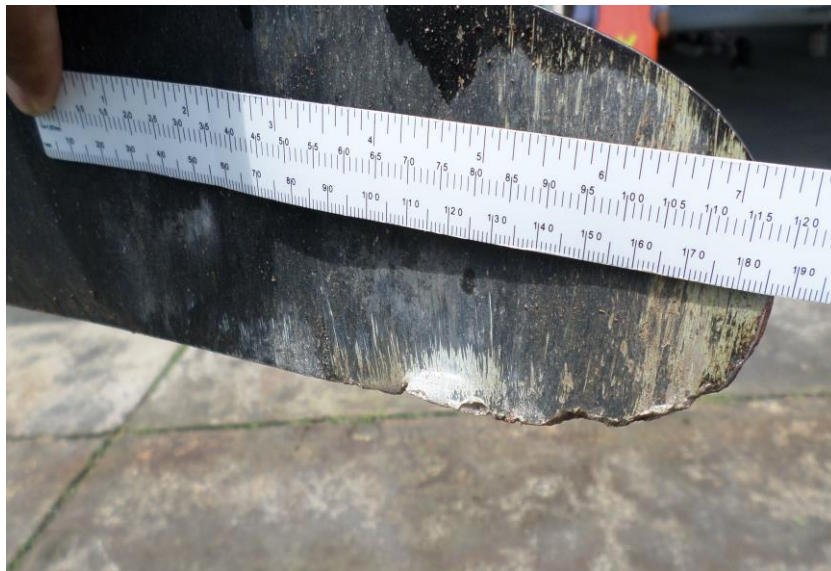
- a. The propeller tips scratched;
- b. Transponder antenna on the lower body broken.

Figure 3: Damage on propeller blade

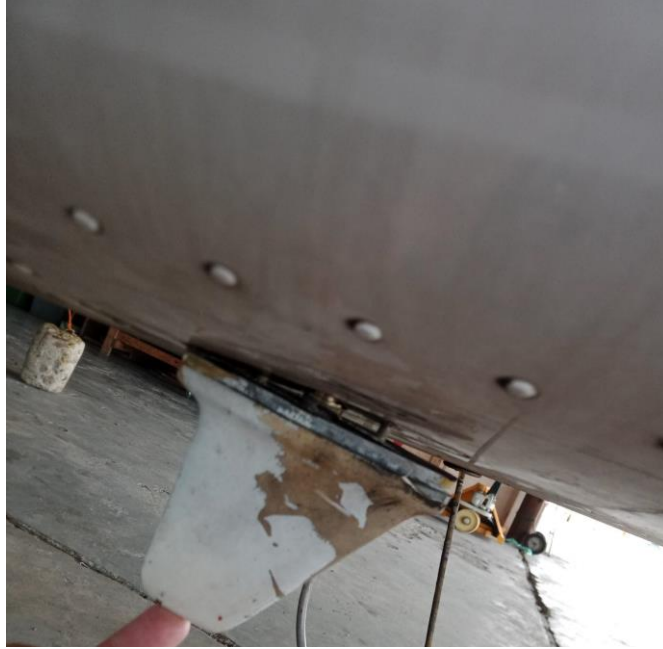
Figure 4: Damage on transponder antenna
