**NATIONAL TRANSPORTATION SAFETY COMMITTEE
REPUBLIC OF INDONESIA**

FINAL
KNKT.15.11.08.03

Marine Accident Investigation Report
Grounding of Indonesian Passenger Ferry *Sea Prince*
Nongsa Channel
Province of Riau Islands
Republic of Indonesia
29 November 2015

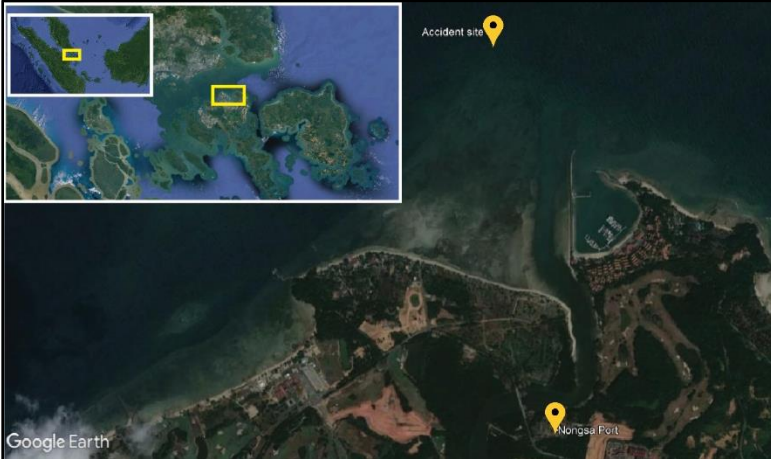
Figure 1: Location of accident site and Nongsa Ferry Terminal (image: Google Earth)

Suddenly, at a time recorded as 19.47 LT, Sea Prince was unable to control. She began altered to the left where the depth of water is shallower than in the middle. Shortly after, a shuddered voice was heard for a few seconds. The Master immediately pulled the engine telegraph to neutral to stop the engine and ordered the crew to investigate the abnormal voice.

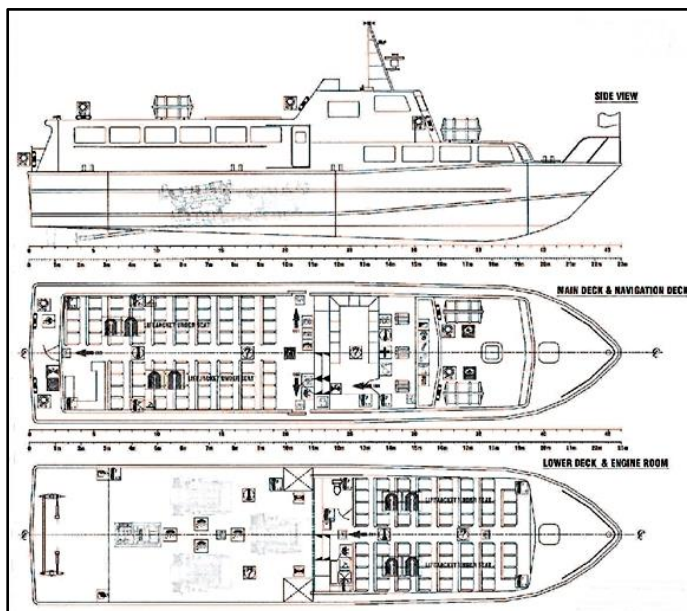
Figure 8: General Arrangement of Sea Prince

The dimension of her length, breadth and depth are 23.0, 5.4 and 2.5 m, respectively. One of the cabins is located below the main deck level (forward cabin) and the other at main deck level (aft cabin). The side view of the vessel can be seen on **Figure 8**, while the image of safety plan is attached on the appendix.

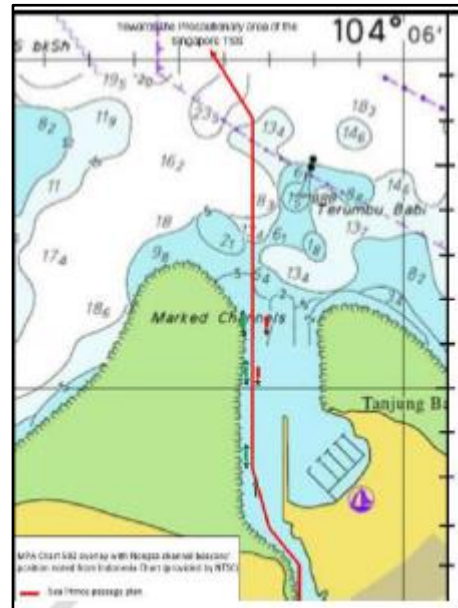
Figure 9: Passage plan

According to the approved passage plan, Sea Prince outbound passage through Nongsa demarcated channel would require the vessel to manoeuvre between spars extending to the last pair of lit beacons. Thereafter, passing the last pair of lit beacons, Sea Prince was supposed to head north for about 0.4 NM, passing an isolated danger mark (Terumbu Babi) on her starboard side.
