**KOMITE NASIONAL KESELAMATAN TRANSPORTASI  
REPUBLIC OF INDONESIA**

**Marine Safety Investigation Report**

**Fatality onboard Bahamian Registered Bulk Carrier GLOVIS MAPLE**

**4 April 2016**

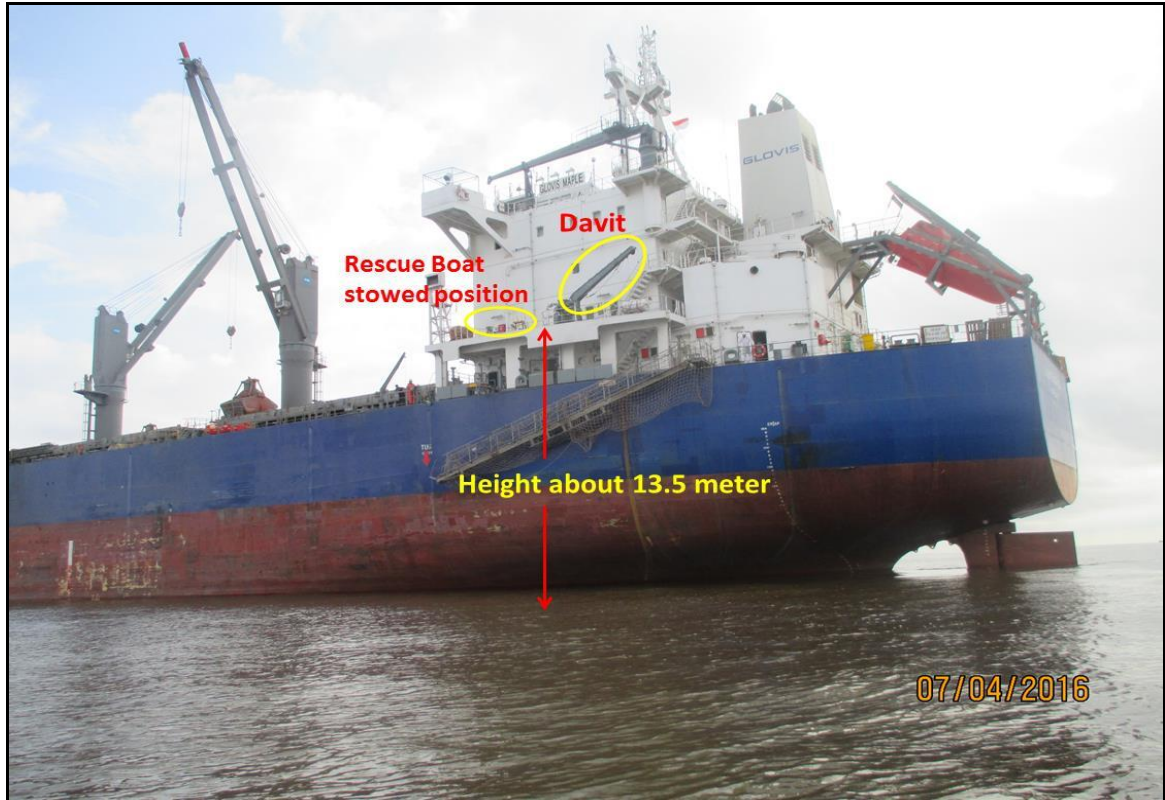
*Figure I-8: Rescue boat stowed location*

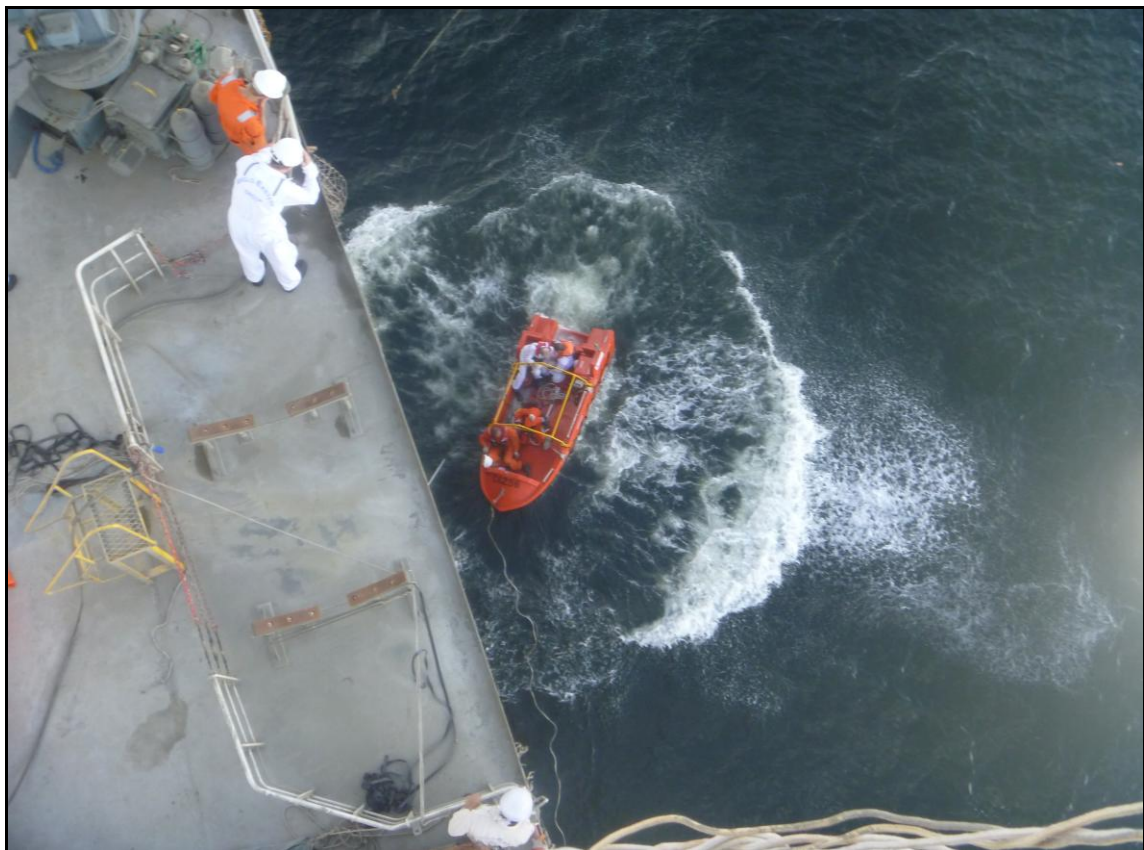
At 1630, while the rescue boat about to reach the deck 'A' level, the fall wire suddenly parted. The rescue boat fell down into the water from an estimated height of 13.5 metres; it slammed hard the water surface evenly. The rescue boat remained afloat and in upright position with four injured crew inside. Due to the hard impact the outboard engine was detached from its assembly place and sank.

*Figure I-9: Rescue boat remained afloat after it fell down (picture taken by the ship's crew)*

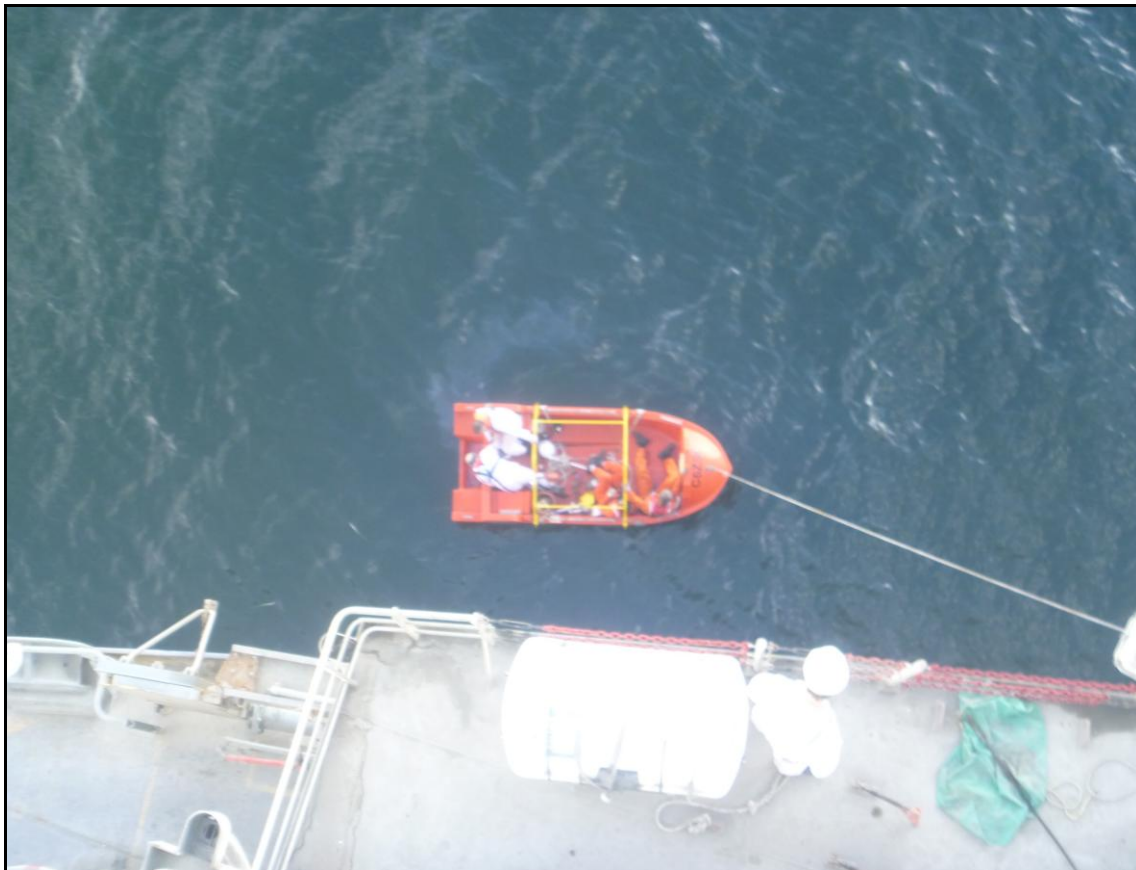
*Figure I-10: Rescue boat pulled to the port side (picture taken by the ship's crew)*

The rescue boat crew were unable to move due to injured. Only the third engineer could respond to verbal communication from deck. They could not get back to the ship without assistance. The rest of the ship's crewmembers were pulling the forward painter and brought the rescue boat alongside on the port side between cargo hold 4 and 5, where it reachable by cargo crane no. 4. Afterward the aluminium draft ladder was rigged up for the ship's crew access to the rescue boat.

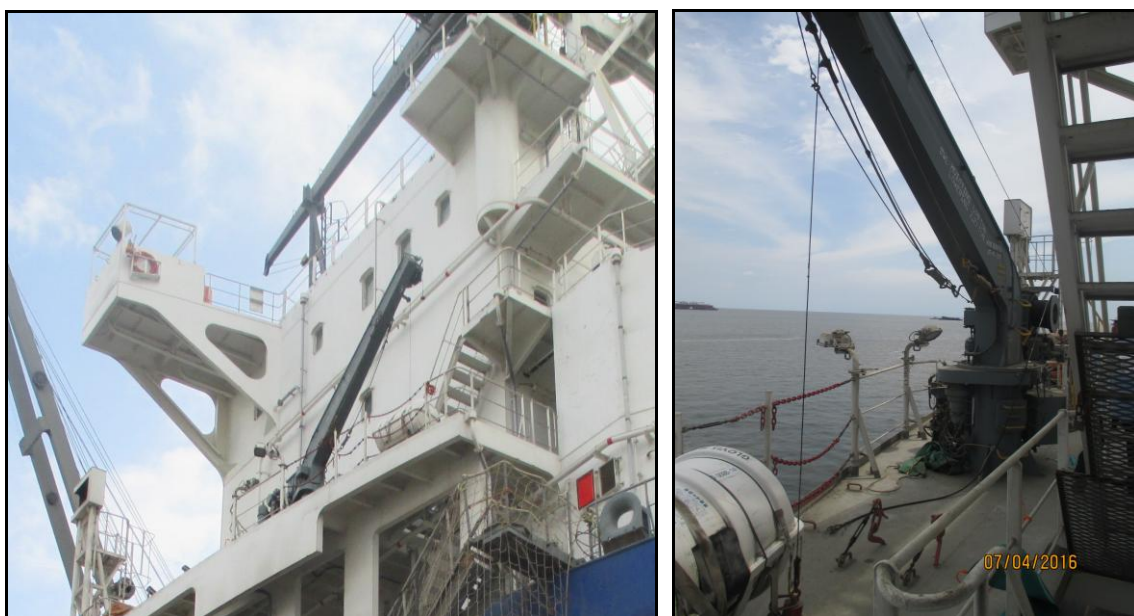
**Figure I-13: Davit system**

When KNKT arrived aboard the *Glovis Maple*, the davit system situated on the deck 'A' port side of the superstructure was found swung-in position and the rescue boat was placed on the port side upper deck. The parted fall wire which was connected to the load block was laid nearby. There was no damage found on the steel structure of the davit system or base.

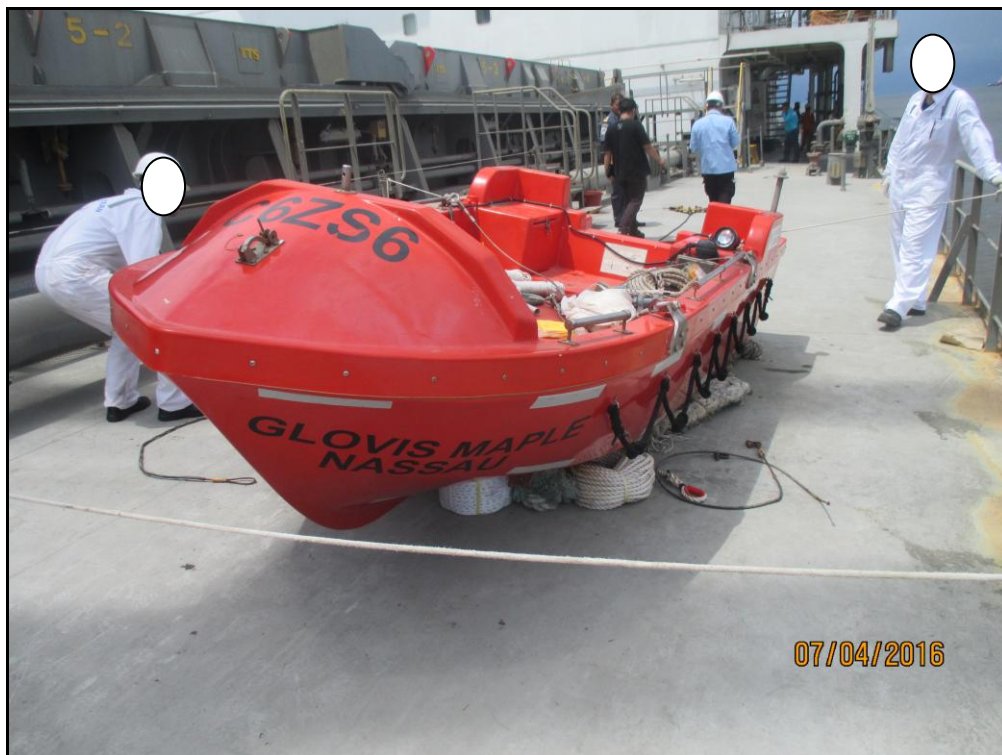
Figure I-19: Rescue boat view from forward

The rescue boat was laid up on the upper deck port side. It seems that there was no major damage due to impact on the rescue boat hull. There was line of cracks sighted on the boat starboard stern, however it was unsure whether the cracks due to impact or it already there beforehand.

The outboard motor was detached from its place and it sank. The bracket of four point bridle suspension system and fittings such as connecting shackles, bridle wires and master link were still in place.
