KOMITE NASIONAL KESELAMATAN TRANSPORTASI
REPUBLIC of INDONESIA

FINAL
KNKT-17-12-34-03

Marine casualty investigation report

Fatality on board Singapore registered coal barge

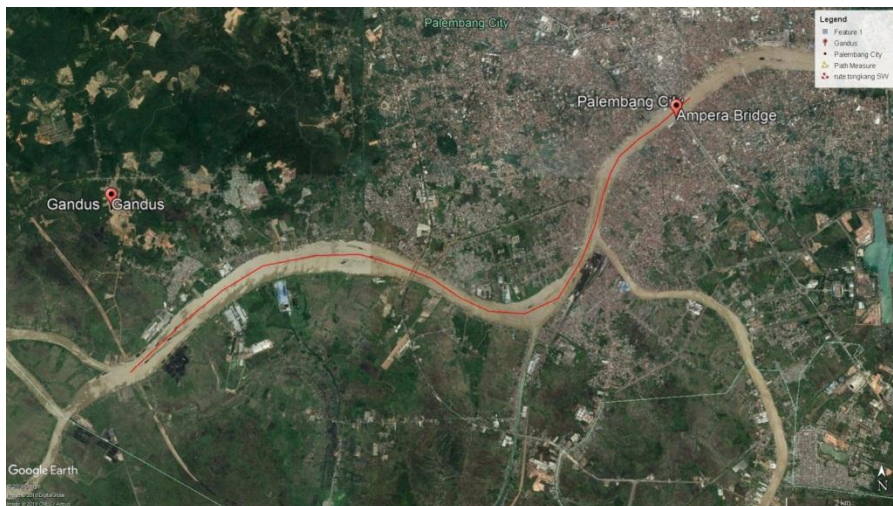
Figure 1: Red line indicates the towing route crossing musu river from Gandus to Ampera Bridge. The line was about 6.9 nm long.
