**NATIONAL TRANSPORTATION SAFETY COMMITTEE
REPUBLIC OF INDONESIA**

FINAL
KNKT.18.03.09.03

Marine Accident Investigation Report

**Pipeline Damage and Crude Oil Pollution in Balikpapan Bay
Balikpapan, East Kalimantan
Republic of Indonesia
30 March 2018**

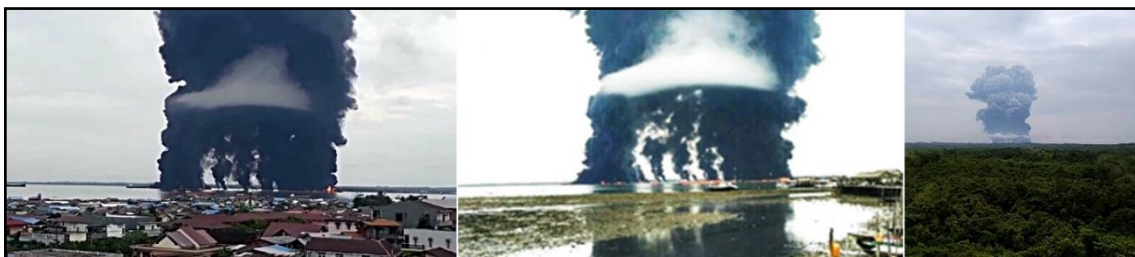
At about 11.05 LT, a huge fire blaze with thick black smoke began to spread out. It was started from in front of the *Ever Judger* (approximately 1.5 km from the Pertamina's jetties) and then spread towards north and south. The fire was spreading on the water towards the front and the aft of the *Ever Judger*. One crew who was on the aft deck was burnt on some parts of his body. He then jumped to the water to escape and was rescued by a boat, later on. The other crew who were in the accommodation building closed all windows and doors. In the surrounding *Ever Judger* was black and hot.

Figure I-6: Fire and smoke in the initial of the fire blast occurrence could be seen from a distant

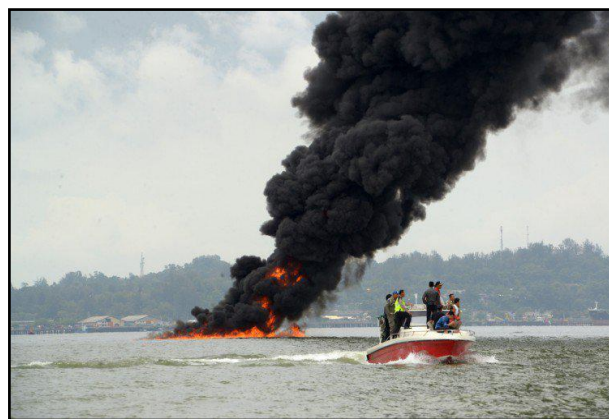
Figure I-12: The thick smoke from oil fire in Balikpapan Bay

The air pollution was created by two elements. First, the oil odour in the early morning on 31 March 2018 which made a great number of people felt a headache. Second, the burnt oil on the same day. However, there was no detailed record regarding both matters on the MoEF report.

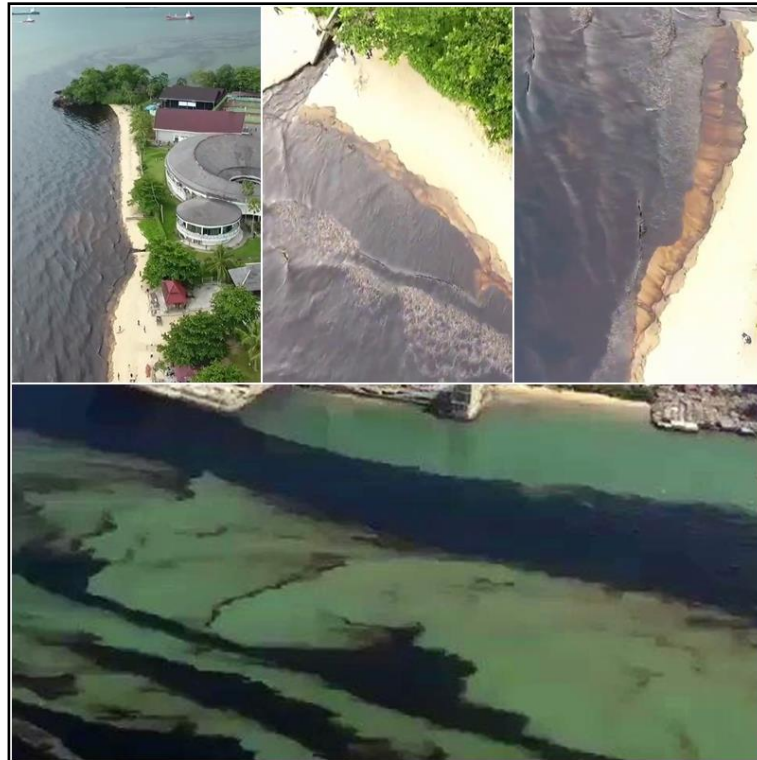
The consequences of the oil pollution on marine animals and plants were the main concern by the MoEF. Regarding the MoEF's report, there were more than 7,000-kilo litres of crude

oil spread onto more than 13,000 hectares of the bay. The worst conditions were along the coastline of Balikpapan and North Penajam Paser District, East Kalimantan.

Figure I-14: Aerial captures of the oil spill in Balikpapan Bay

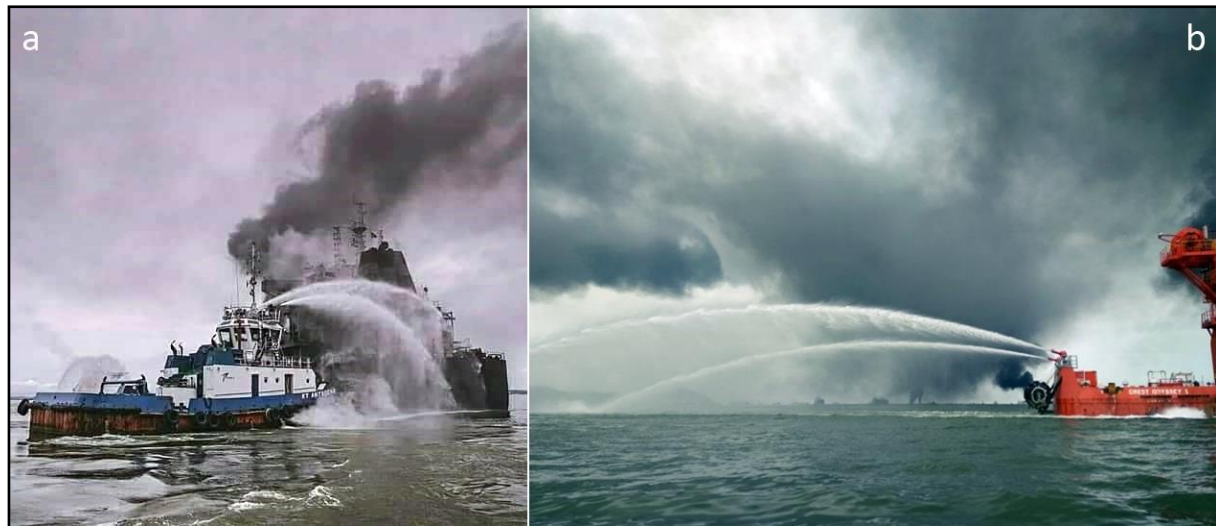
The Balikpapan Harbour Master had a fireboat to extinguish a fire on the sea. However, the boat had not been equipped by the foam which is needed in fighting the fire due to oil or its derivatives. The inadequacy of oil fire extinguisher made the fire take longer to be controlled.

Figure I-25: Fire extinguishing by sea water which was done by a) Antasena; and b) Crest Odyssey 1

The water should not be involved solely without foam in suppressing an oil fire. As the water is easier to vapour than the oil when heated by the fire, gas of water would cause the flaming oil to spread everywhere or even create a fireball which is larger than the original size. Also, the water pressure could break the oil inundation into many smaller parts. Further, this would trigger a bigger issue if the helper vessel caught by the fire. The problem of the proper fire extinguisher was not solved by the coming up of other fireboats. The other fireboats and Harbour Master's boat were focusing on cooling down *Ever Judger* by using the same fire extinguisher. Luckily, the situation did not turn to worse, such as an additional burnt ship.

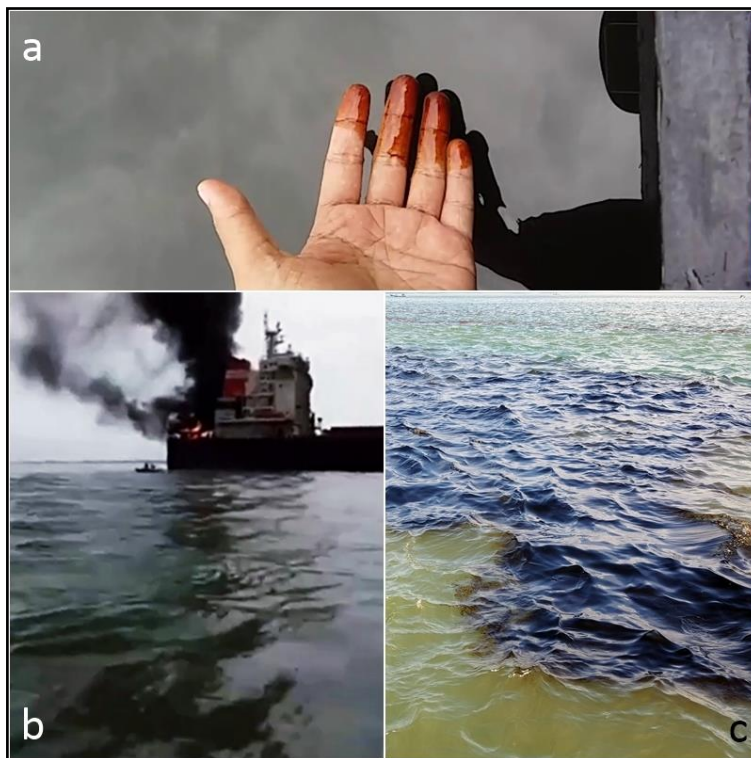
Figure I-26: a) A video uploaded by one of the deceased on 31 March 2018; b) Oil film on 31 March 2018; c) Oil film on 2 April 2018

Despite localisation of the oil by oil booms had been done, it was far from effective. The extensive area of the Balikpapan Bay made the effort impossible to be taken as there was no available long boom to block the channel bank to bank. This elevated the issue in letting the oil to be spread out towards Makassar Strait. The only available boom was the short one which usually used at the Semayang Port, the domestic passenger ferry port. Although the Article 10 of the regulation states that the port should have a boom with the minimum length of 1.5 times of the biggest ship operate in the area, the local port still had no required boom. Considering the *Ever Judger* as the longest ship, the minimum length of the boom should be 345 m.

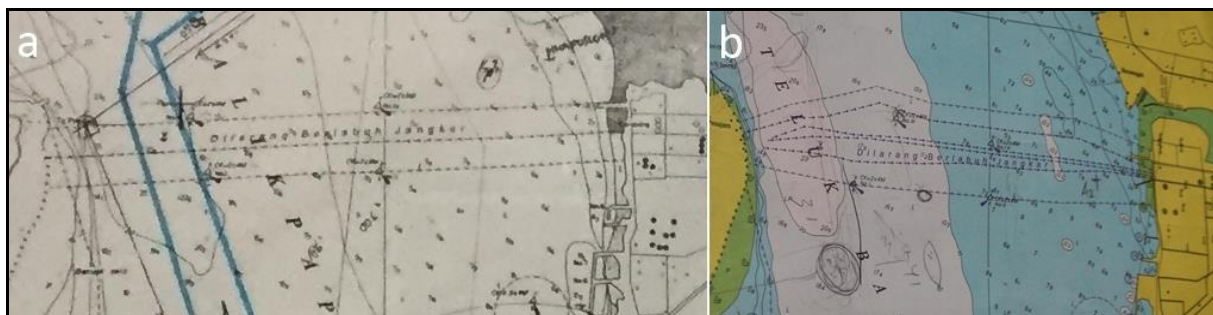
Figure I-28: Subsea pipes in Balikpapan Bay on the old (a) and new (b) marine chart

The updated Indonesian nautical chart showed incorrect information about the number of pipes. The chart displayed four pipes on the channel, despite there were actually five pipes. Based on the post-leak survey by the Hydrographic & Oceanography Office of the Indonesian Navy (Pushidros TNI AL), it was confirmed that there were five pipes underneath the restricted area. Amongst them, only one was buried as seen in Figure I-29 (black line) and Figure I-30. This condition was found after the oil disaster sparked off.

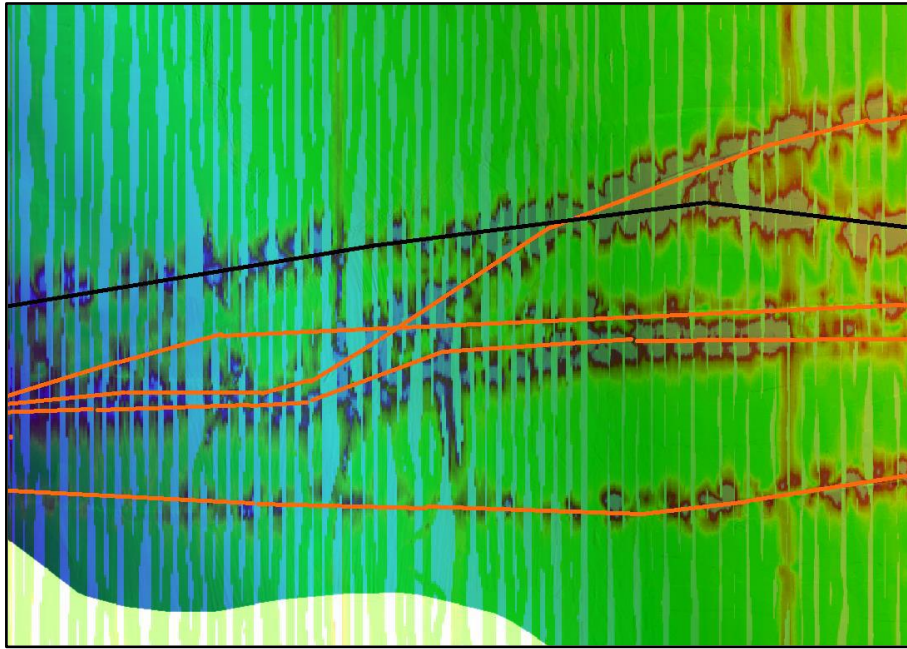
Figure I-29: Pipes image read by Magnetometer (source: TNI AL)

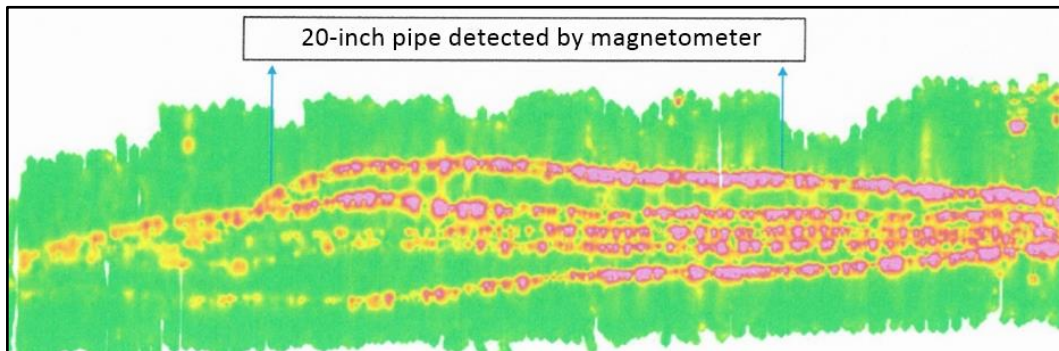
Figure I-30: The image of the 20-inch pipe (source: Pertamina RU V)

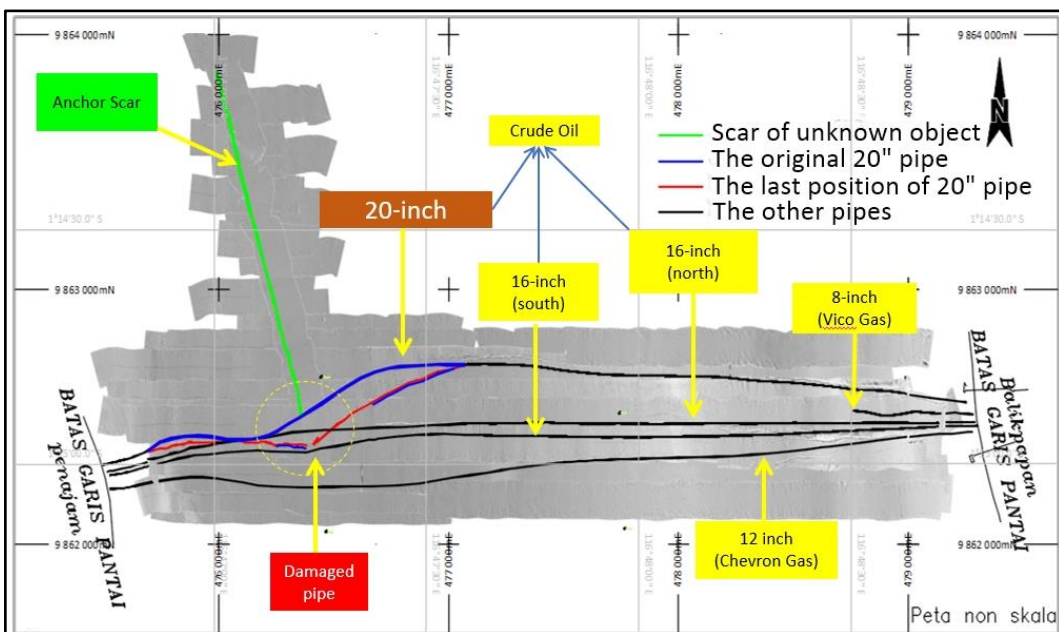
There was the various size of underwater pipes. The biggest one was the damaged one with the diameter of 20-inch. The two 16-inch pipes, belonged to Pertamina EP Asset 5 Tanjung, were occasionally used to transfer crude oil. The other small pipes were used to transfer gas with the diameter of 8 and 12-inch which owned by Vico and Chevron, respectively. The smallest pipe was buried and inactive for a long time.

Figure I-31: The underwater pipes in Balikpapan Bay (source: Pertamina RU V)

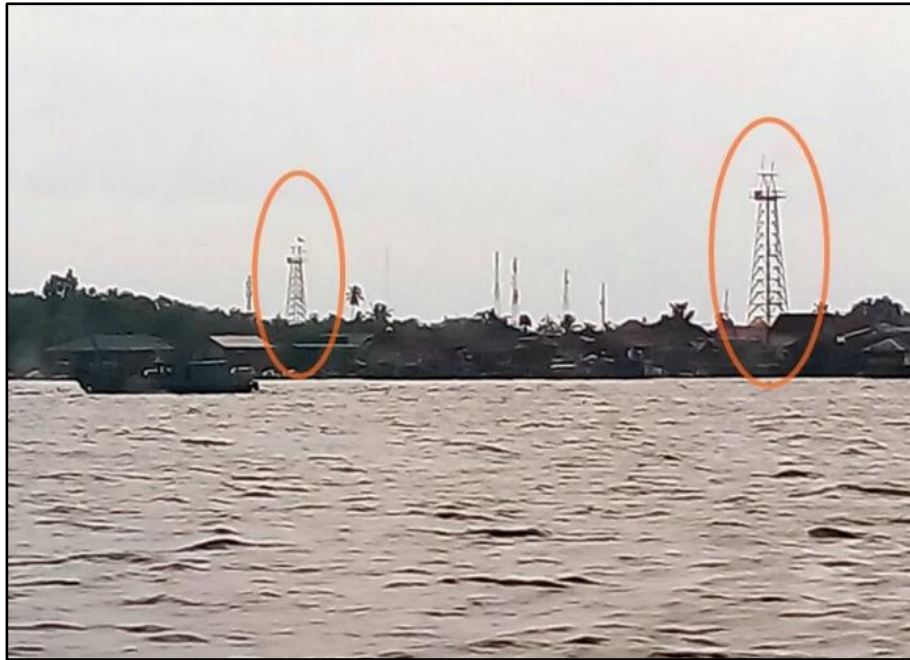
Not only on the map, pipe markings were also made on the waters and the shore. There were four buoys located on the channel to inform the border of Prohibited Area and were in good condition. There were also four towers equipped with lights with the same function as buoys. Two towers located at Balikpapan side and the others at Panajam side.

Figure I-32: Towers as subsea pipe markings

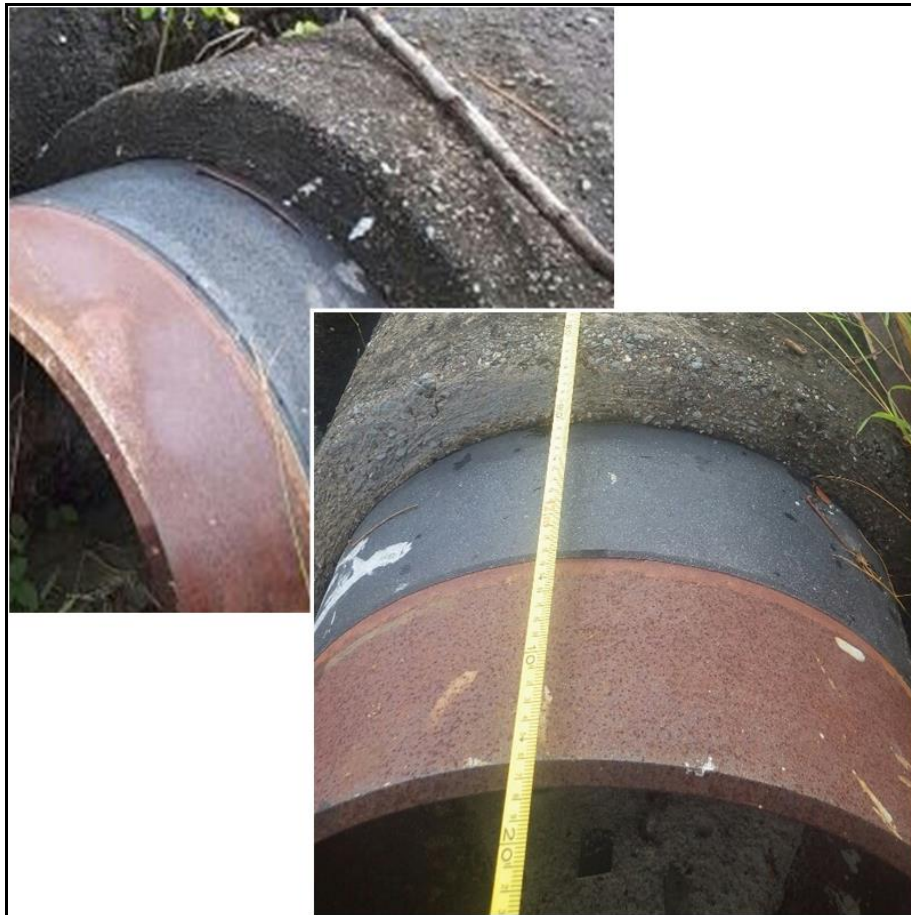
The 20-inch pipe was already protected by two materials. The inner layer was coaltar enamel as thick as 5 mm, while the outer cover was concrete coating with the thickness of 3.09". The concrete was used to insulate the main pipe from rust and marine creatures. Also, the concrete provided more weight to stable the pipe on its position.

Figure I-33: Protection layers of an underwater pipe

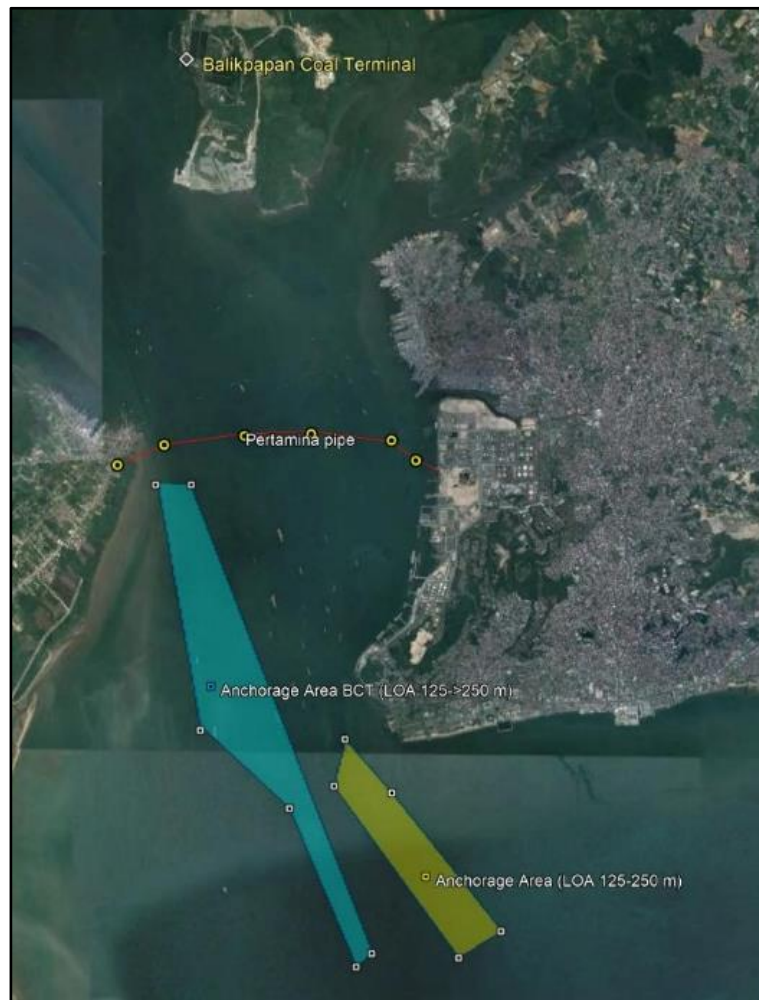
Even though the anchorage areas could not be found on the map, they are known by Pilots and Harbour Master Officers as stipulated in the Local Harbour Master's regulation No. UM.003/21/5/KSOP.Bpn-2013. The picture or map which depicts the location of both anchorage sectors could not be found.

Figure I-34: Anchorage area in Balikpapan (the chart was recreated using Google Earth based on Balikpapan Harbour Master Regulations)

Nonetheless, the Minister of Transportation Regulations No. 129 Year of 2016 on Sea Shipping Channel and Offshore Buildings and/or Installations at Article 46, verse 5 stipulates that the ship anchorage areas should be charted on the nautical chart. Balikpapan Channel had a limited area compared to the number of ships anchoring there. The more ships coming in, there will be the need to optimally need the anchorage territory to wait for berthing or departing. Further, the more ships berthing in the anchorage area would force them to lay their anchor approaching the restricted zone. The hazard of anchoring near the restricted zone would be bigger when the strong current came up combined with a failure on a ship's anchor. For these reasons, the anchorage border should be reviewed to consider additional protection for more ships.

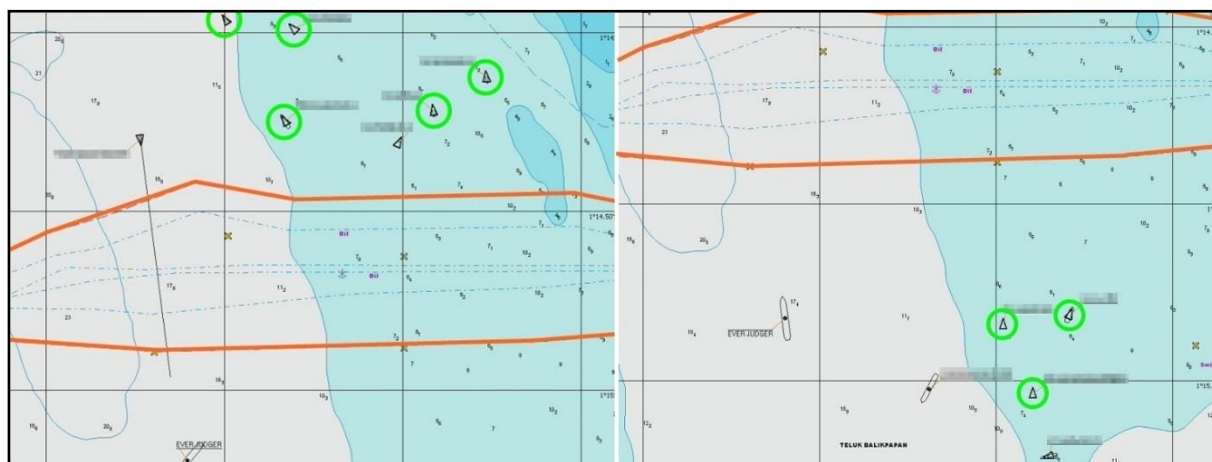
Figure I-35: Ships whilst anchoring (green circles) in the south (right) and north (left) of the restricted zone
