**NATIONAL TRANSPORTATION SAFETY COMMITTEE
REPUBLIC OF INDONESIA**

Marine Accident Investigation Report

The Grounding of *Sea Flyte*

11 October 2018

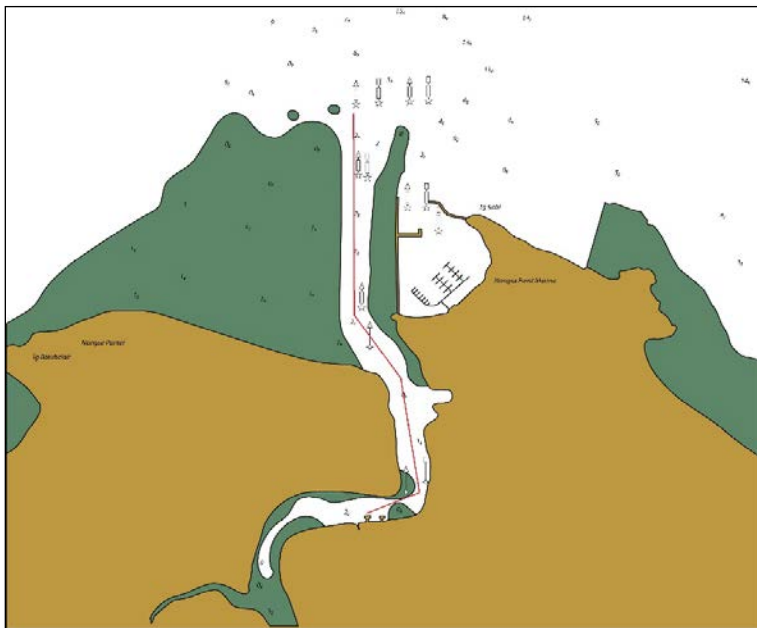
Figure 5: Nongsa Channel

Based on the CCTV footage record, the accident time was raining. At the beginning of the embarkation, there was a light shower. However, right after she passed Buoy No. 9, torrential rain started with strong winds.
