FINAL
KNKT.19.01.03.03

Marine Safety Investigation Report

Collision between *ANTEA* and *STAR CENTURION*

13 January 2019

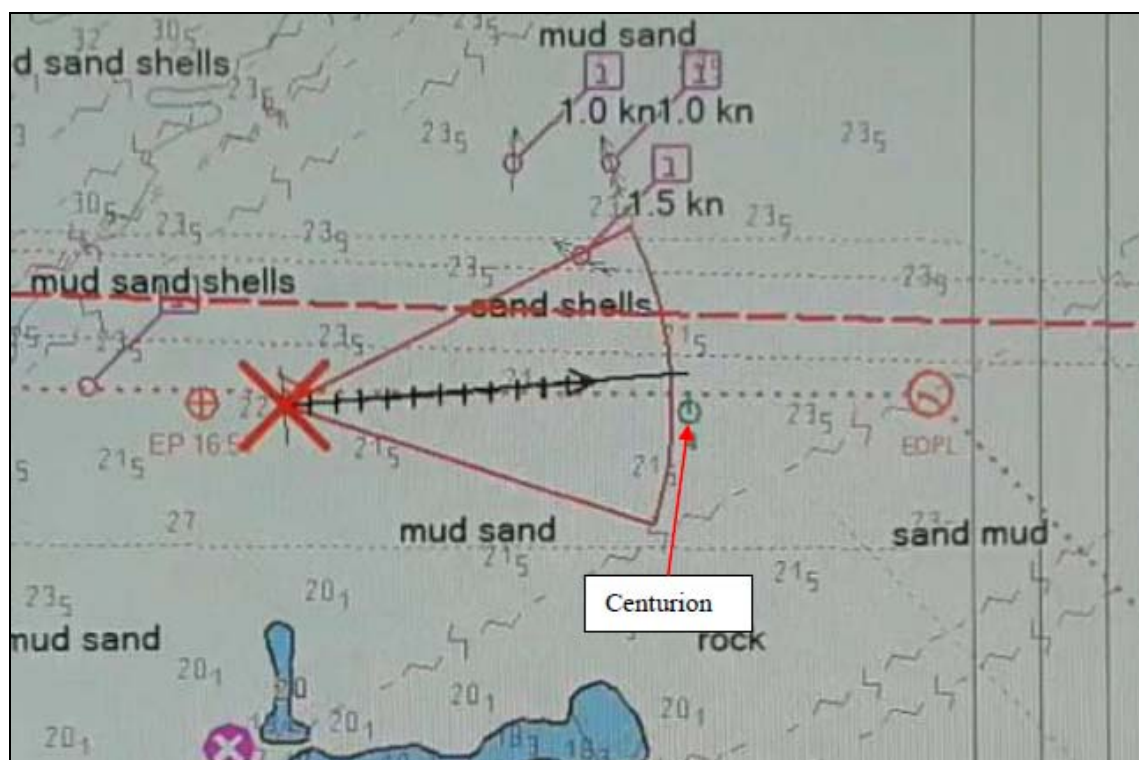
At about 0607 hours, the third officer taking over the watch. He could see the accommodation and deck lights of a vessel fine on starboard, which he later found out it was *Star Centurion*. In the meantime, *Antea* maintained its course of 085° (T) and speed made good over ground of 11.1 knots. Following the handover, the second officer left the bridge for take a rest.

Figure I-7: ECDIS playback at 0605 hours. Star Centurion about 2 nm from Antea

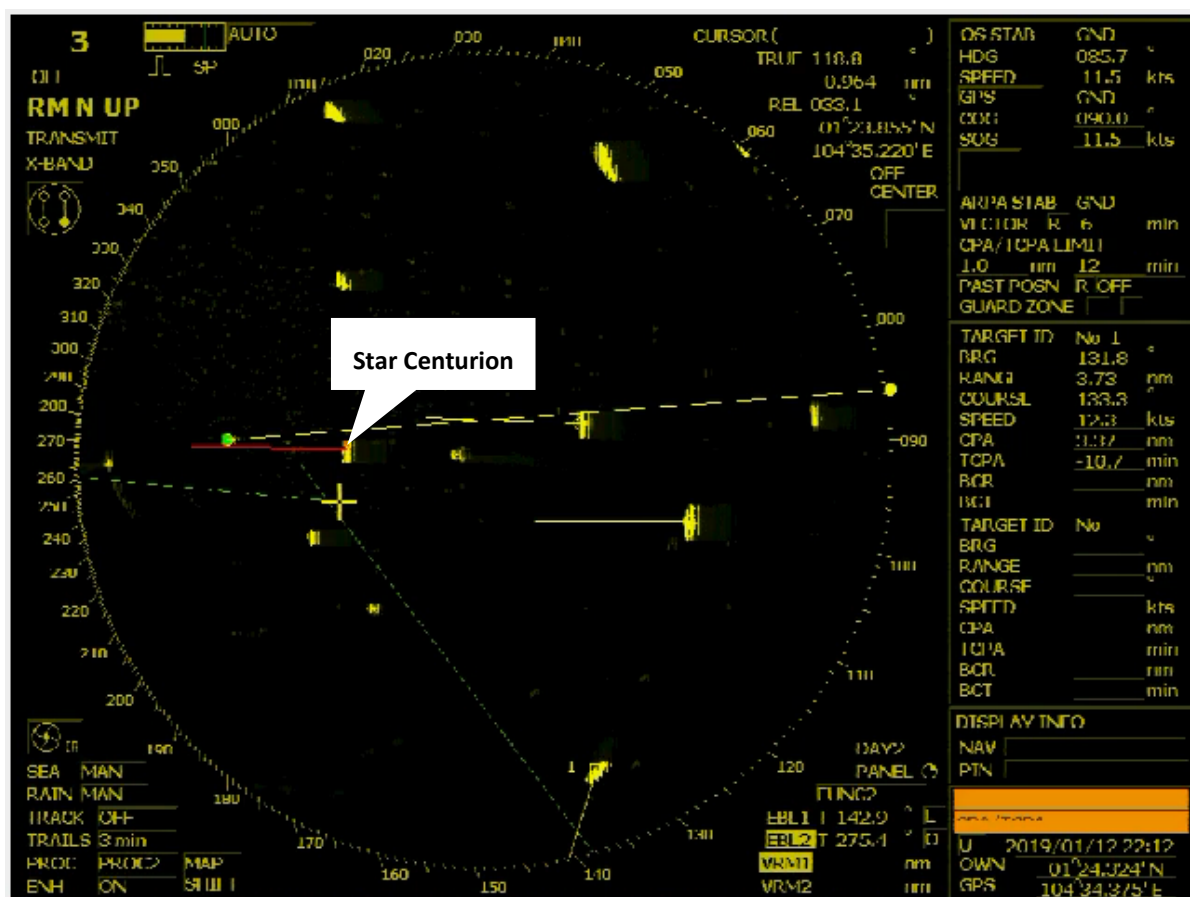
Shortly after, the helmsman applied the steering wheel to starboard 15 to 20 degrees. The officer on watch intention was to pass through in between the two anchored vessels, and leave *Star Centurion* on the port side.

The helmsman noticed that the ship's heading had go to starboard about five degrees over the next minute, however the heading change was smaller and slower response compared to previous occasions when he assigned for steering the vessel.

Figure I-9: Extract from X-band radar on Antea at 06:12:10 hours. Instruction to manual steering

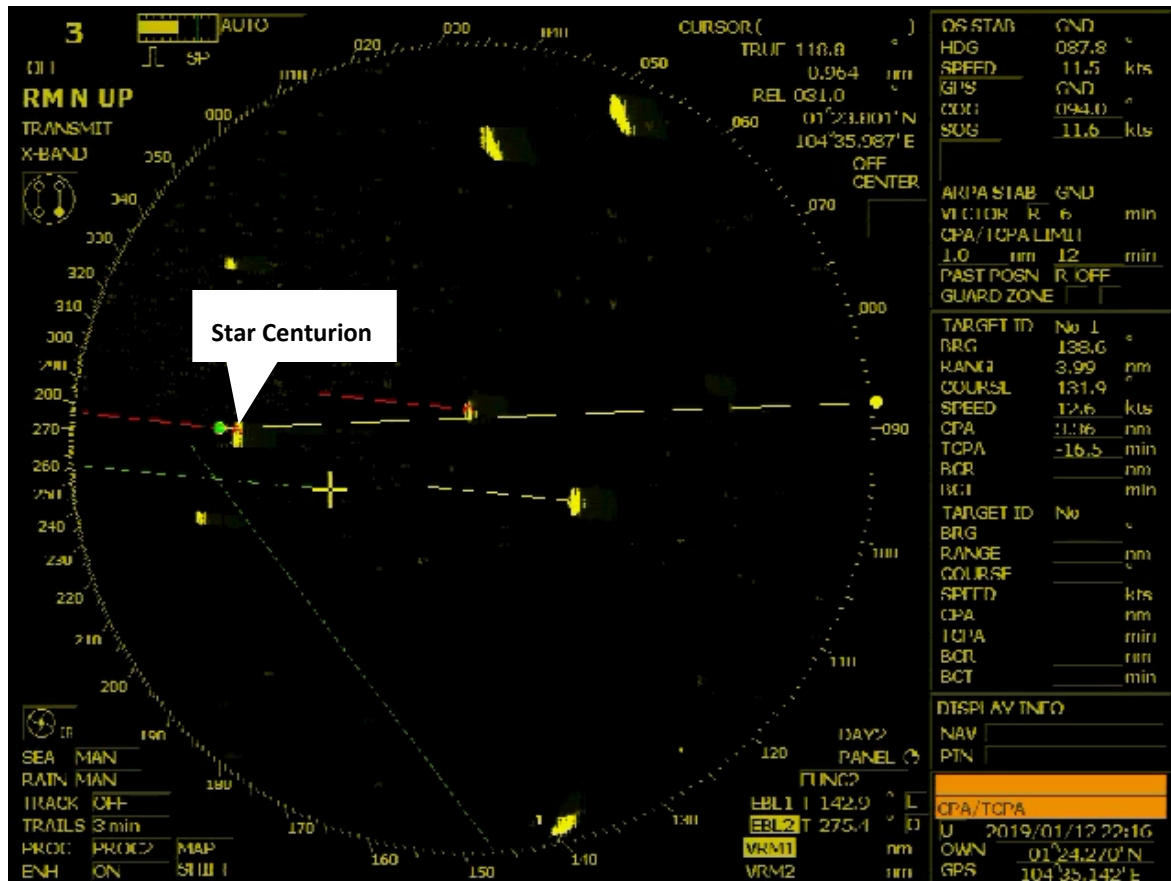
At 0616:10 hours, the bow of *Antea's* at a speed of 11.5 knots make contact with *Star Centurion's* almost amidships on the latter's port side.

Figure I-13: Extract from X-band radar on Antea at 06:16:10 hours. Impact (noise heard on recorder)

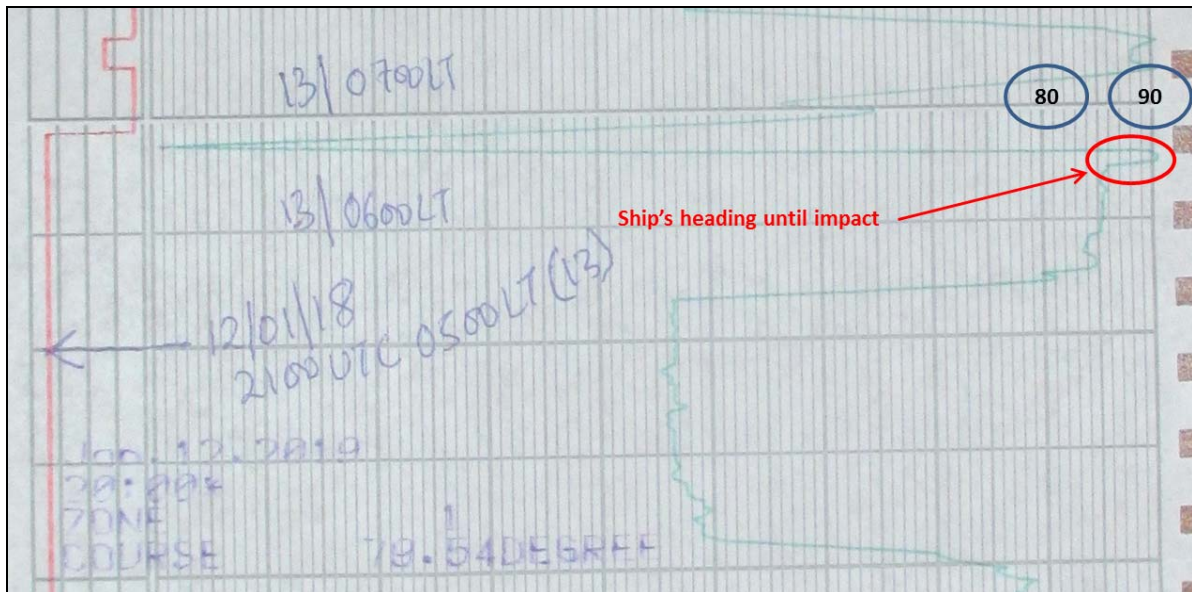
Figure I-14: Antea's heading changes to impact based on information from course recorder

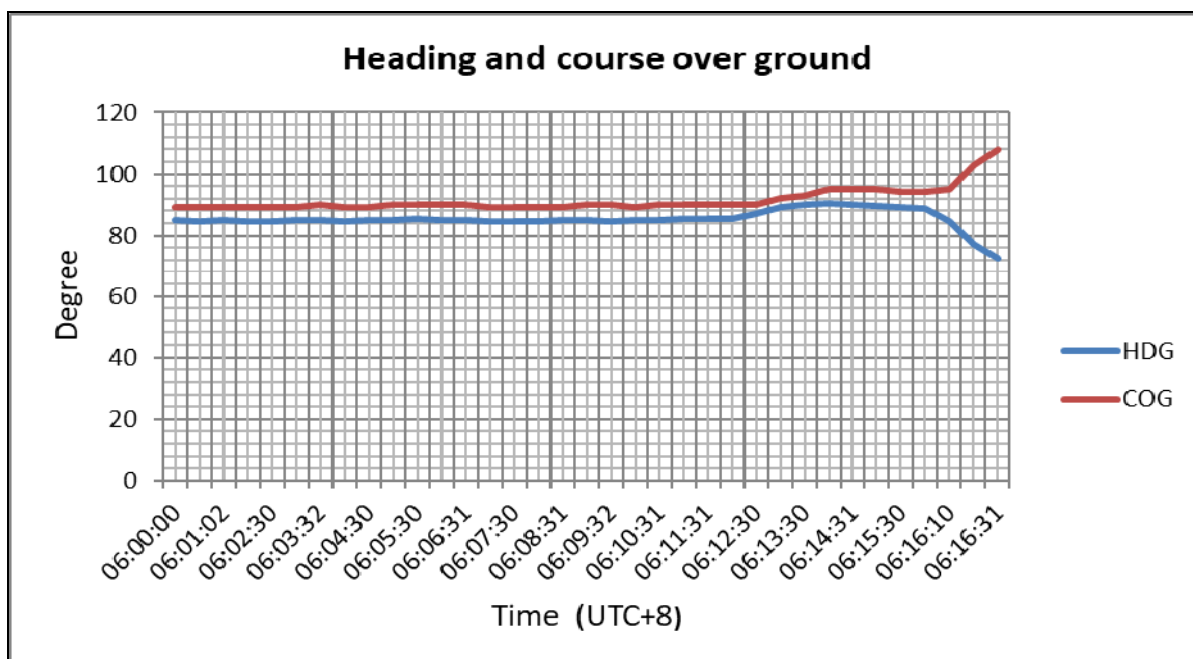
Figure I-16: Diagram showing *Antea*'s heading and course over ground in the last few minutes until impact. The diagram based on information from VDR.

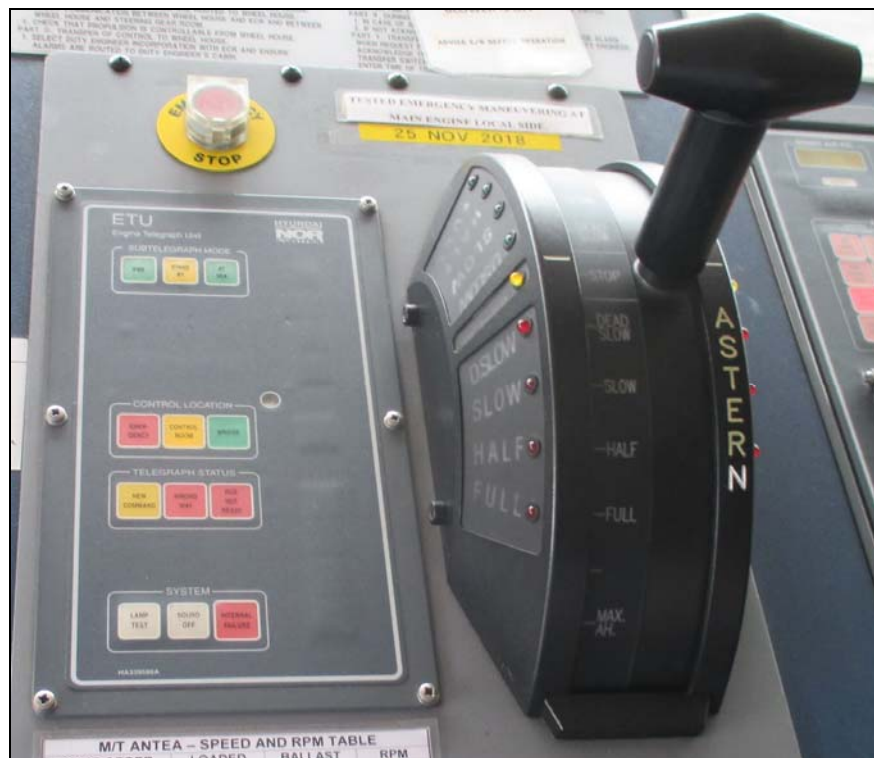
Figure I-25: The bridge engine telegraph unit

At the time of collision, the engine control location is place to engine control room and there is no engineer on duty. The engine room is manned by an oiler who is working in the lower engine flat and he did not hear the telegraph alarm. If the engineer is not in the engine control room, moving the bridge telegraph will not stop the engine. It will merely ring the telegraph alarm in the engine control room. The alarm will continue ringing until the telegraph in the engine control room is place in the same command.
