**NATIONAL TRANSPORTATION SAFETY COMMITTEE
REPUBLIC OF INDONESIA**

FINAL
KNKT.19.07.16.03

Marine Accident Investigation Report

*Allision of **Soul Of Luck** with Container Gantry Crane*

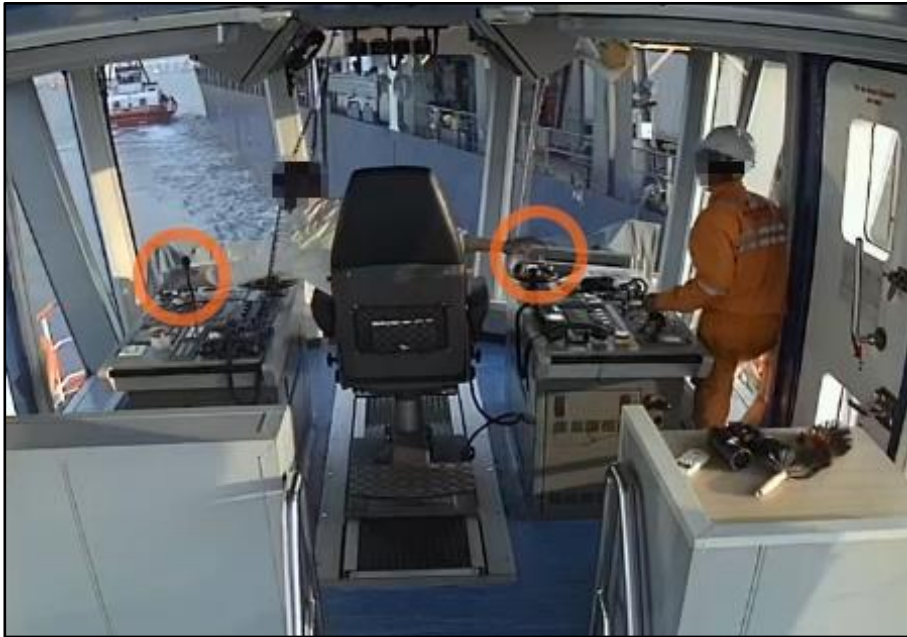
Figure I-8: The Master of *Jayanegara201* was taking a mobile and took off the ship's console whilst having a conversation with a tug crew (source: CCTV footage of *Jayanegara 201*)

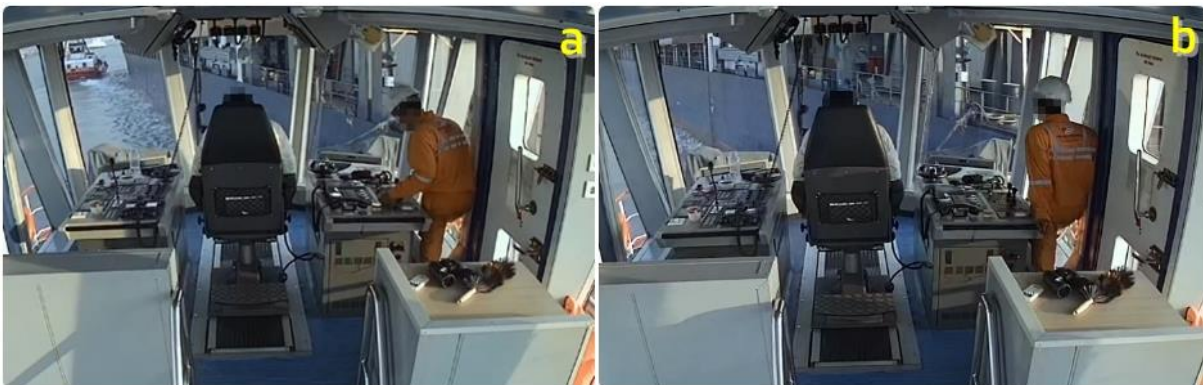
Afterwards, the Master of *Jayanegara 201* did something on the mobile phone by using his both hands. After about 40 seconds of being on the phone, the Master of *Jayanegara 201* checked the situation. The contact angle between the *Jayanegara 201* and the *Soul Of Luck* was slightly changing. Afterwards, the Master of *Jayanegara 201* adjusted the heading of *Jayanegara 201*. Right after it, the Master came back to the mobile and conversed with a crew member of the *Jayanegara 201* who was standing nearby. By the time, the *Jayanegara 304* was still approaching the *Soul Of Luck*.

Figure I-9: (a) The Master of *Jayanegara 201* began to do something on the mobile phone; (b) the situation about 40 seconds later (images: CCTV footage of *Jayanegara 201*)

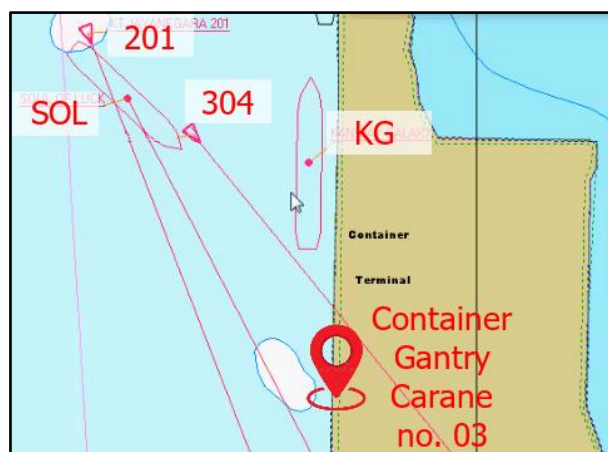
Knowing the conversation with a high intonation amongst the Master and the ship crew, the Pilot understood that there was an issue with the engine of the *Soul Of Luck*. The Pilot immediately ordered the *Jayanegara 201* to pull the *Soul Of Luck*. Following the pull order, the Master of *Jayanegara 201* put down the mobile phone and began to pull the *Soul Of Luck*. The Pilot repeated the order several times. The *Jayanegara 201* then acknowledged the order.

Figure I-10: The *Jayanegara 201* (201) was pulling and the *Jayanegara 304* (304) was pushing whilst the *Soul Of Luck* was approaching the *Kanway Galaxy* (KG) (image: Semarang VTS)

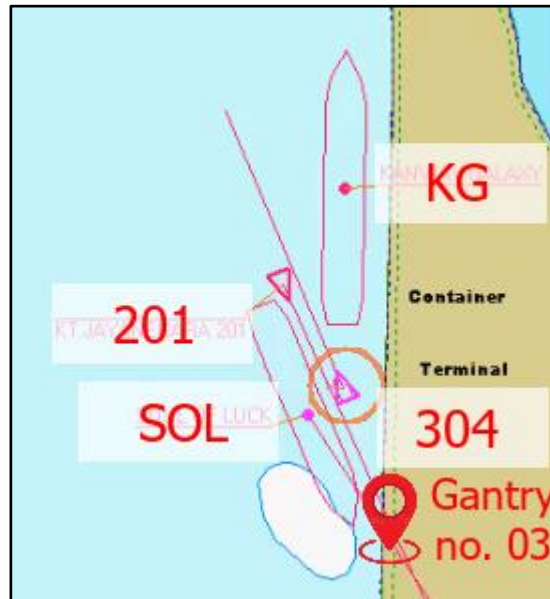
Figure I-11: The Jayanegara 304 (304 with orange circle) whilst fleeing away from the Soul Of Luck (SOL)

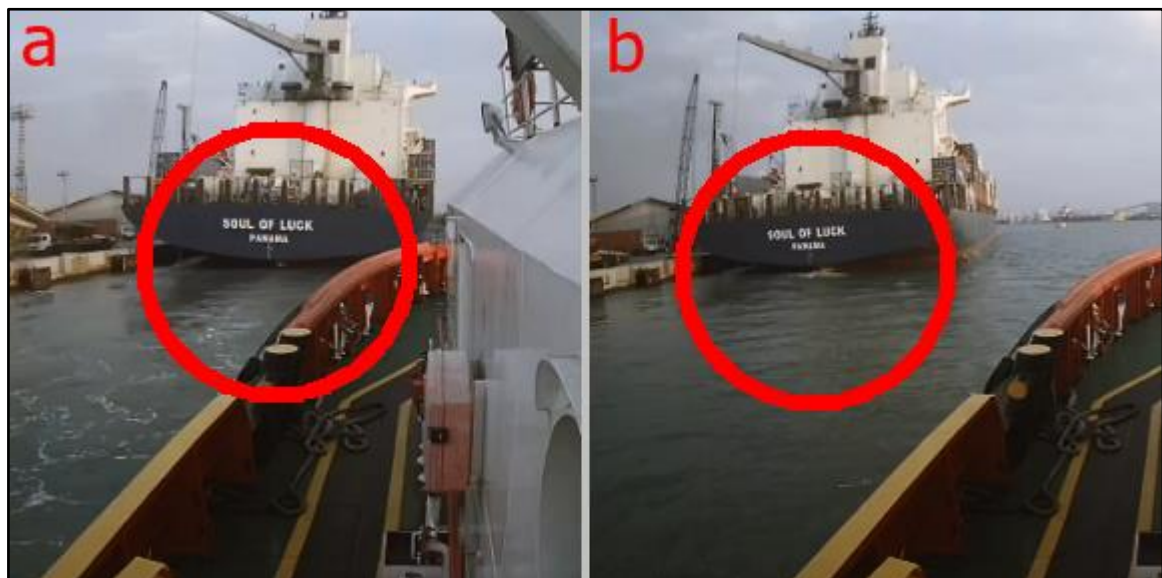
After the allision, the *Soul Of Luck* was keep moving towards another container ship in front of her, named *Ceria 8*. Knowing the propeller of the *Soul Of Luck* was kicking towards ahead, the Master of *Jayanegara 304* informed the situation to the Pilot and reminded that the *Soul Of Luck* was keep moving forwards.

Figure I-13: Sample of no wakes (a) and wakes (b) behind the Soul Of Luck

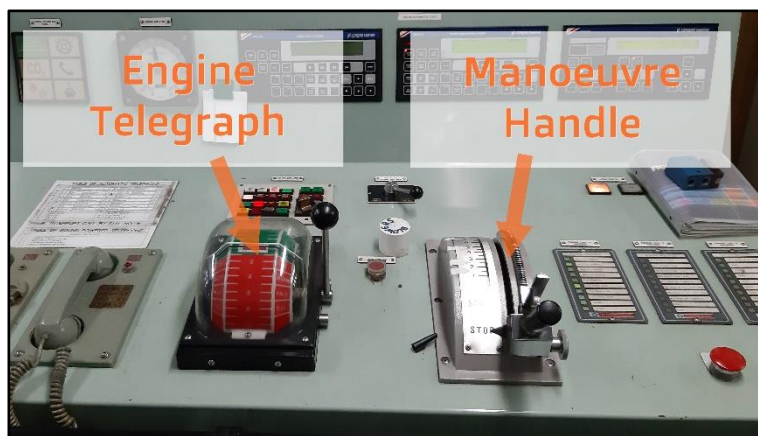
Figure I-19: Engine console of Soul Of Luck

At the accident of *Soul Of Luck*, when the handle of manoeuvring system was positioned to astern, the control system did not work. The engine crew found that the pilot valve of manoeuvring system for astern had a leakage. Therefore, the air was wasted out of the system. The leakage made the system had insufficient power to switch the engine to the astern position.

After the accident, the engine crew switched the engine control from ECR side to the engine side. The testing used the replacement of pneumatic valve was successfully done.

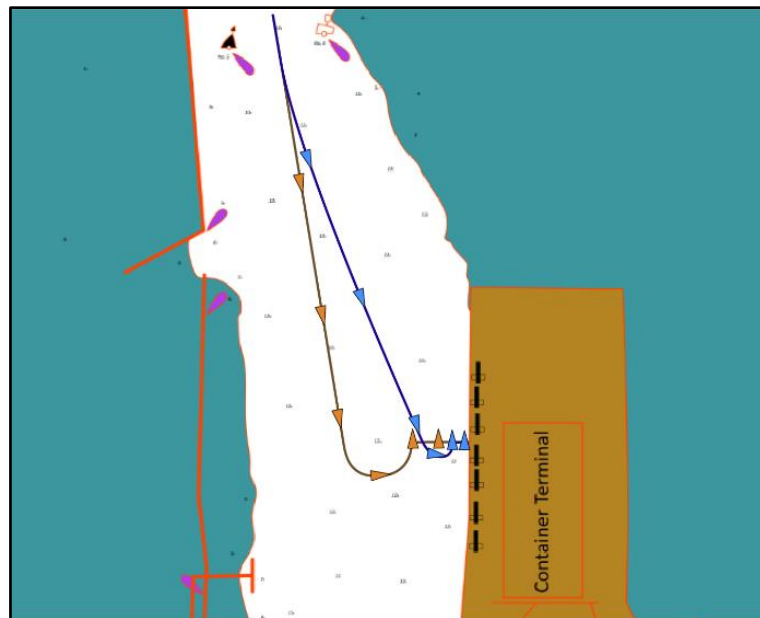
Figure I-21: The direct (blue) and indirect (brown) methods

Based on the explanation from the Pilot, generally, there were two types of berthing practised by Pilots in Tanjung Emas area, namely direct and indirect as shown in the Figure I-21. The direct method meant turning the assisted ship in turning to port near the targeted port. This option was commonly practised because it allowed the Pilots to finish the berthing works in a shorter time than in another way. The Investigation Team found that most of the witness who worked in the Container Port territory admitted that most Pilots applied this method.

Otherwise, the indirect method was by turning the assisted ship to port in the middle of the basin of the Container Port. This method was less favoured by the Pilots as it took longer time to be completed. Based on the Pilots' experience, the indirect method was only applied for cruise ships which their sizes are larger than *Soul Of Luck*. When this method was applied, most ships surrounding the basin should be cleared to enable a cruise ship manoeuvre safely.

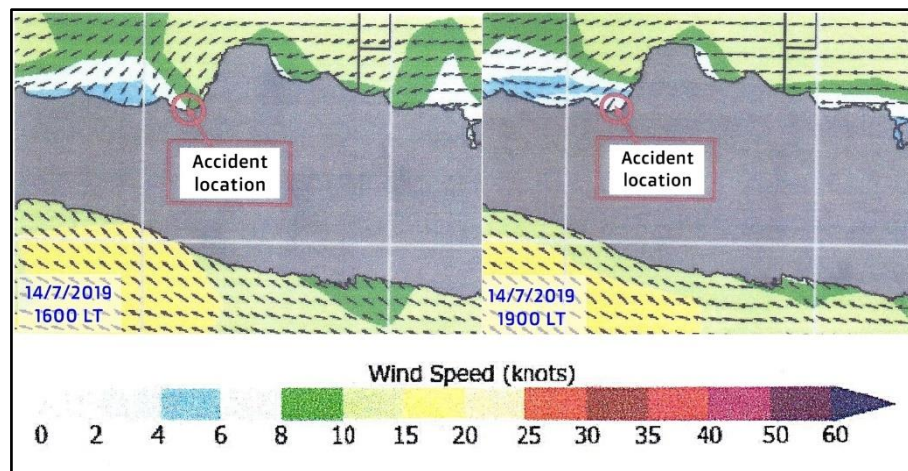
Figure I-22: The wind direction on 14 July 2019

From the weather information, it was known that the wind blew towards the Tanjung Emas Port with the strength of between 4-12 knots within period of 16.00–19.00 LT of the incident day. The wind direction was north-east, whereas the motion of the *Soul Of Luck* right before the collision was towards the east.

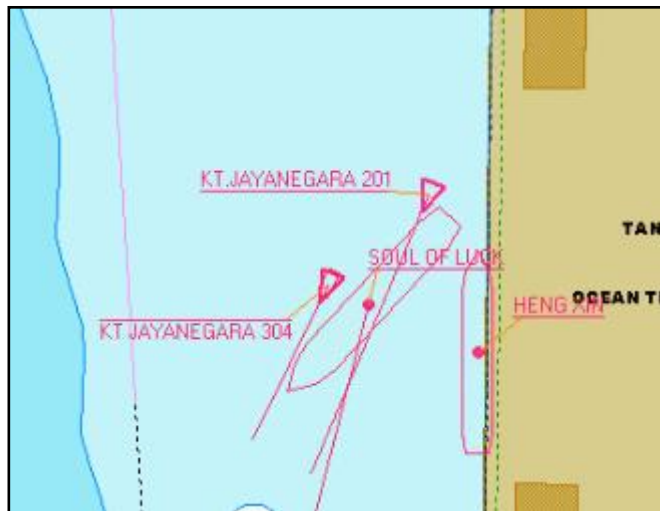
Figure II-4: The position of Jayanegara 201 and Jayanegara 304 on the starboard side of Soul Of Luck after the allision and collision

Having look back to the speed of *Soul Of Luck*, the speed less than one knot was reached after she was held by *Ceria 8* and *Heng Xin*. Nonetheless, dropping anchor at that speed was fruitless because the *Soul Of Luck* was heading away from Tanjung Emas Port. In addition, the tug boats have moved to the starboard side of *Soul Of Luck* after the allision and collision. Therefore, dropping starboard anchor was extremely dangerous for those tugs. Should *Soul Of Luck* dropped off her starboard anchor, this would also create another obstacle for the *Jayanegara 201* to re-fasten the tug line.

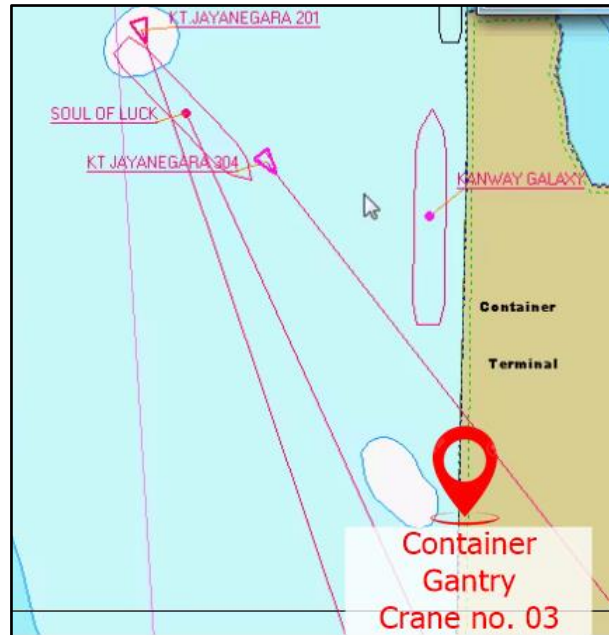
Figure II-5: The situation when the engine control malfunction was known in the first place

In the *Soul Of Luck* accident, the space and time did not allow the anchor to be used. Refer to the time gap between the engine control failure firstly known and the allision which was only around four minutes and the distance to the wharf was too close. Similarly, the speed of vessel, also did not allow the anchor to work effectively.

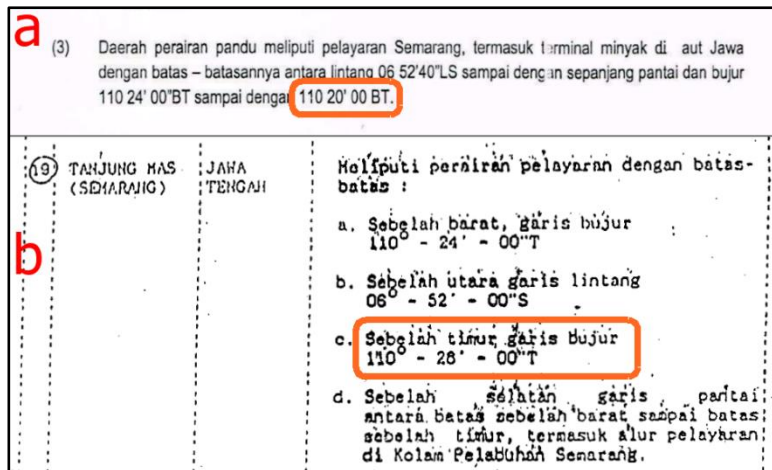
Figure II-7: Points of Pilotage Waters in the Official Regulation by the Harbour Master of Tanjung Emas KP.105 (a) and the Ministerial Decree by the Minister of Transportation 22 (b)

Another typo was also found in the Official Regulation by the Harbour Master of Tanjung Emas No KP.105/06/07/KSOP.Tg.Emas-16 on Procedures of Pilotage. One reference coordinate of Pilotage Waters was different than the superior rule, specifically the Ministerial Decree by the Minister of Transportation No 22 Year 1990 on Decision of Level of Pilotage Waters. It was

written 110° 20', while the correct coordinate was 110° 26'. This error might from the unclear characters as the regulation was issued in 1990 when the quality of typing machine was very limited.

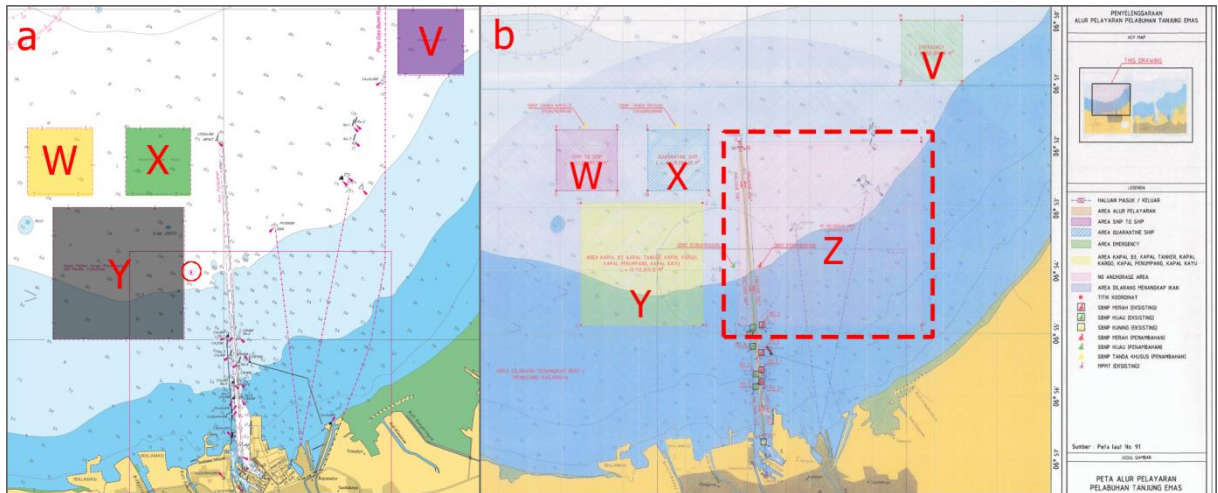
Figure II-9: The no anchorage area(Z mark) in the Nautical Chart No 91 (a) and in the Ministerial Decree by the Minister of Transportation KP 475 (b)

Nonetheless, there was no anchorage area in the Nautical Chart No 91. As the area already enacted in the Ministerial Decree by the Minister of Transportation KP 475, it should appear in the Nautical Chart No 91 as well. Thus, the chart needs to be revised to match the national regulations.
