**NATIONAL TRANSPORT SAFETY COMMITTEE  
REPUBLIC OF INDONESIA**

**KNKT.20.11.11.03**

**Marine Casualty Investigation Report**

*Cape Kallia (IMO 9447160)*

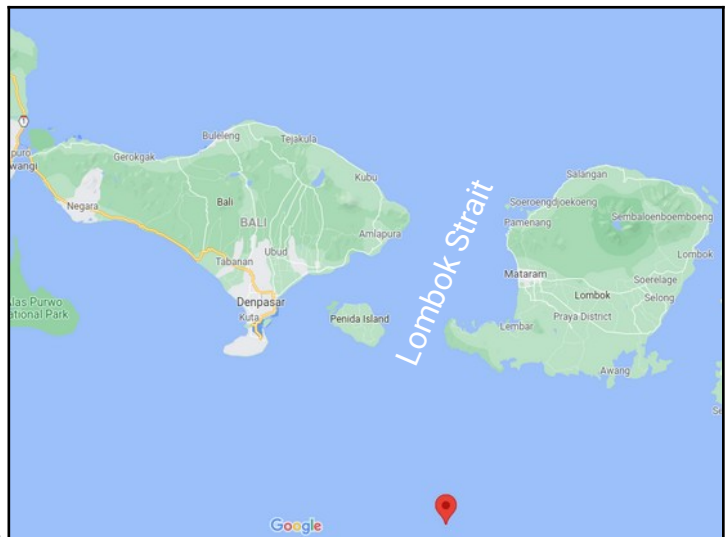
At around 03.00 local time<sup>2</sup> (LT), she had just finished passing the Lombok Strait (around the waypoint #33). Both 2/O and ABD spotted an unknown object on the RADAR as a little dot. No information was appeared regarding the object RADAR. To ensure the object, they checked the object visually by using binoculars and found a light in the port bow of *Cape Kallia* in the approximate distance of 6 nautical miles (NM). Based on the interview, they thought it might be a fishing vessel as their previous experience. At the time, the bulk carrier was sailing with approximate course overground (COG) 167° in the speed of around 10.3 knots. Also, because all fishing vessel they ever met always give way to the merchant ship, they decided to keep *Cape Kallia* on her course.

Figure 1: The position of CP at around 03.00 LT

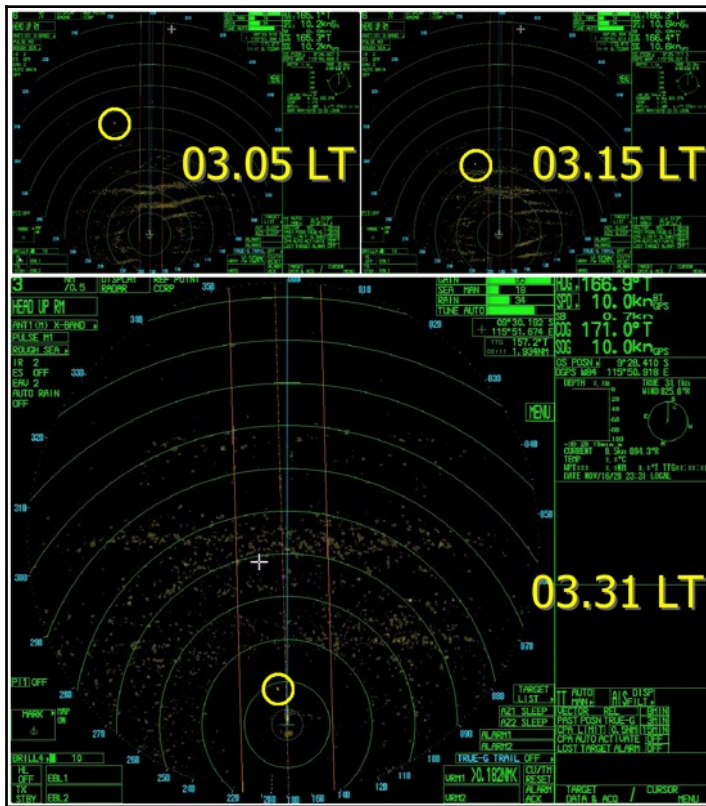
Figure 2: The positions of *Kerinci Indah 02* (yellow circle)

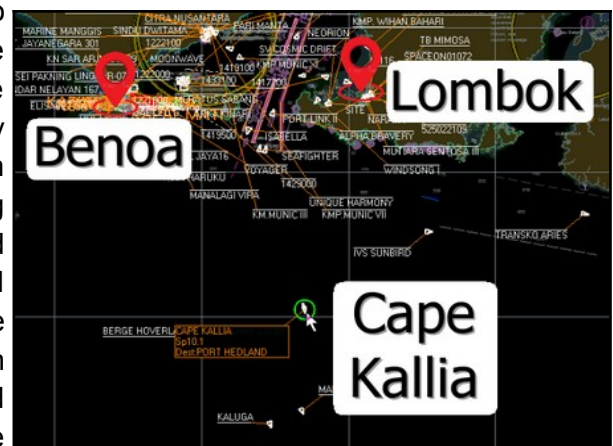
Figure 3: The position of *Cape Kallia* (green circle) at 03.32 LT (image: Bena VTS, annotated by KNKT)

Due to the distance between both vessels was decreasing, the Skipper took the decision to push the steer hard to port side. By the time, position of *Kerinci Indah 02* had just passed the bow of *Cape Kallia*.

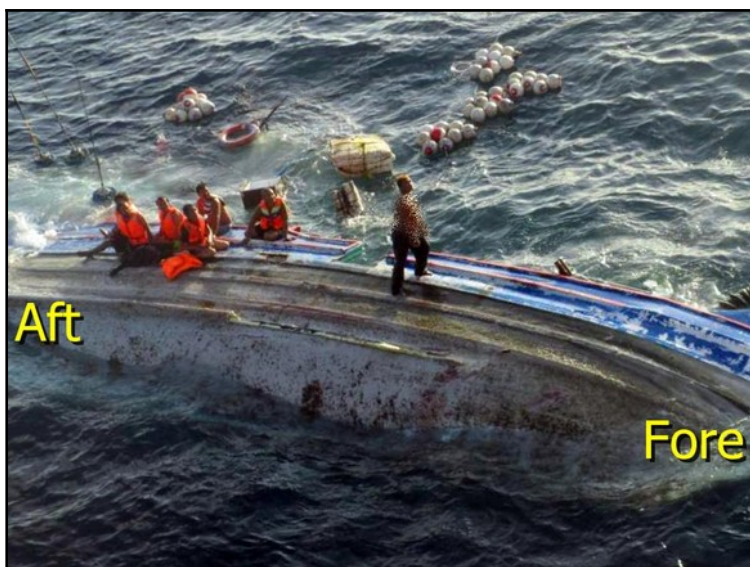
Figure 5: Some survivors of *Kerinci Indah 02* were found (image: crew of *Cape Kallia*)

At 04.55 LT, the Benoa VTS informed the Master of *Cape Kallia* that the local Coast Guard had been contacted by Benoa VTS. The Master explained that the a boat was finally found in capsized condition and some people were on the floating starboard side. *Cape Kallia* intended to evacuate them.

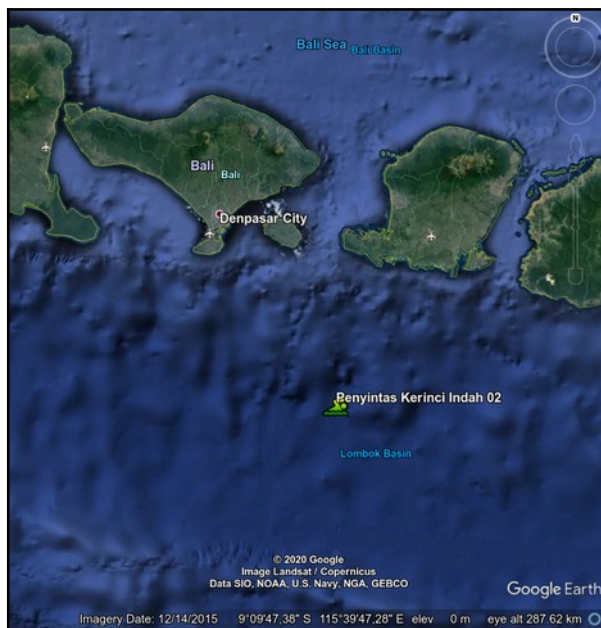
Figure 6: The location where survivors (*penyintas*) were found (image: Google, annotated by KNKT)

After seven days in searching the missing people from *Kerinci Indah 02*, the BASARNAS declared that four people were still missing. The fishing vessel of *Kerinci Indah 02* was also not found by the MRCC team. Therefore, only seven people were saved.
