FINAL
KNKT.08.04.10.04

Aircraft Accident Investigation Report

**PT. Derazona Air Service
Bell 206 B Jet Ranger ; PK-DAT
Labih Ricefield, Labih Village, Gianyar, Bali
Republic of Indonesia**

23 April 2008

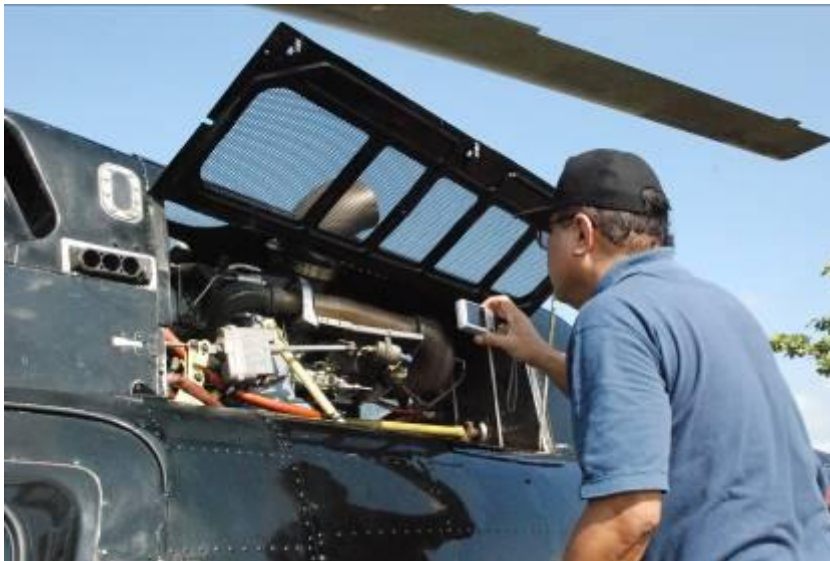
Figure 12: The engine Allison 250-C20

Investigation found that the plumbing connection (B Nut) detached. If the B nut still attached mark by torque paint

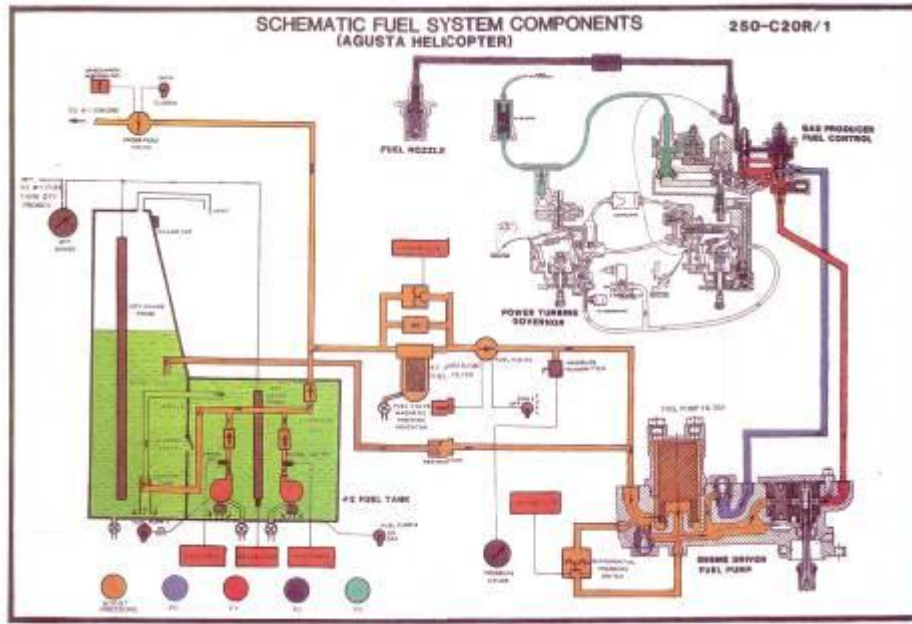
Figure 16: The fuel system engine Allison 250-C20 schematic and Pc port position

The investigation found the Pc port of B-nut FCU was detached, indicated there was no slippage marks (torque paint).

The helicopter engine has no power, caused no pressure from compressor. There was effect from the Pc port of B-nut FCU detached.

The National Transportation Safety Committee recommends that the Directorate General Civil Aviation to ensure the operators which operation engine Allison Model 250 series should follow the EASA Airworthiness Directive 2004-0009 R2.
