KNKT.08.07.16.04

Aircraft Accident Investigation Report

**PT. Garuda Indonesia
PK – GZN
Boeing Company 737-400
Syamsudin Noor Airport, Banjarmasin,
Kalimantan
Republic of Indonesia**

23 July 2008

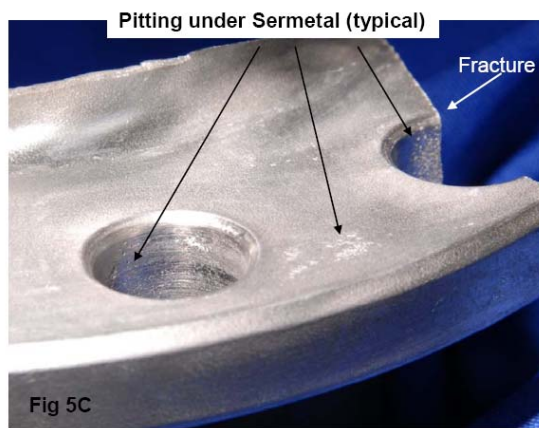
6) Stripping of the Sermetel coating on the flange and bolt holes in the area of the fracture revealed the presence of underlying corrosion pitting in the base metal (figure 5A – 5C). The fracture initiated from one of the areas of heavy pitting (figure 5B).

Figure 5A: Bore surface at fracture origin (arrow) with Sermetal coating in place.

Figure 5B: Bore surface at fracture origin (arrow) with Sermetal removed which exposed underlying corrosion pitting in base metal.

Figure 5C: Flange and bore surface adjacent to fracture with Sermetal removed to expose underlying base metal pitting.
