**FINAL**  
KNKT.08.03.06.04

# NATIONAL TRANSPORTATION SAFETY COMMITTEE

Aircraft Accident Investigation Report

**Federasi Aero Sport Indonesia (FASI)**  
**Pelikan; PK-SKI**  
**Pamulang Village, Tangerang**  
**Republic of Indonesia**  
**16 March 2008**

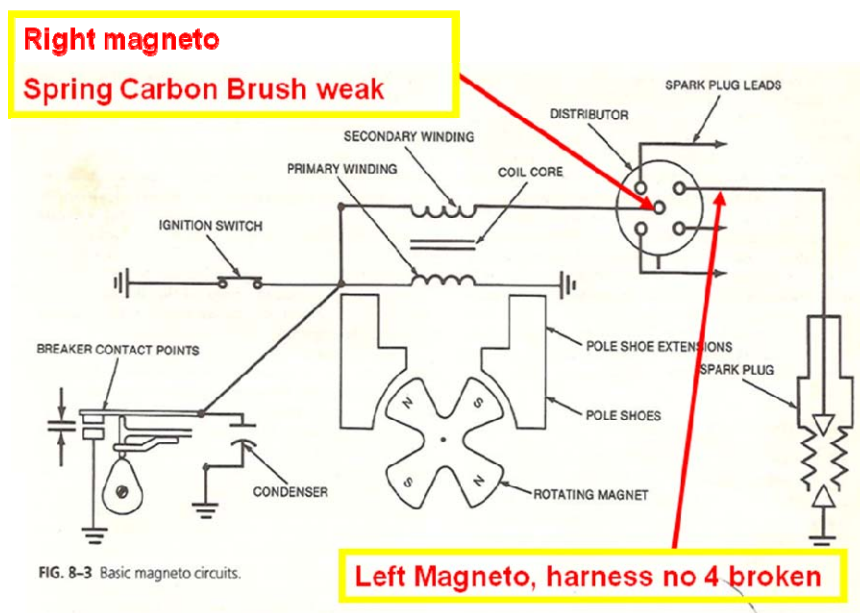
Figure 5: Basic magneto circuit

The number 4 left magneto ignition harness has been broken and the carbon brush spring on right magneto weak or did not press properly the distributor to the carbon most likely produced and unstable ignition.

The number 4 cylinder did not produce power, so that the engine was not produce sufficient power for operating the aircraft.
