KNKT/08.26/09.02.39

Aircraft Accident Investigation Report

DORNIER 328-100

PK-TXL; EXPRESS AIR

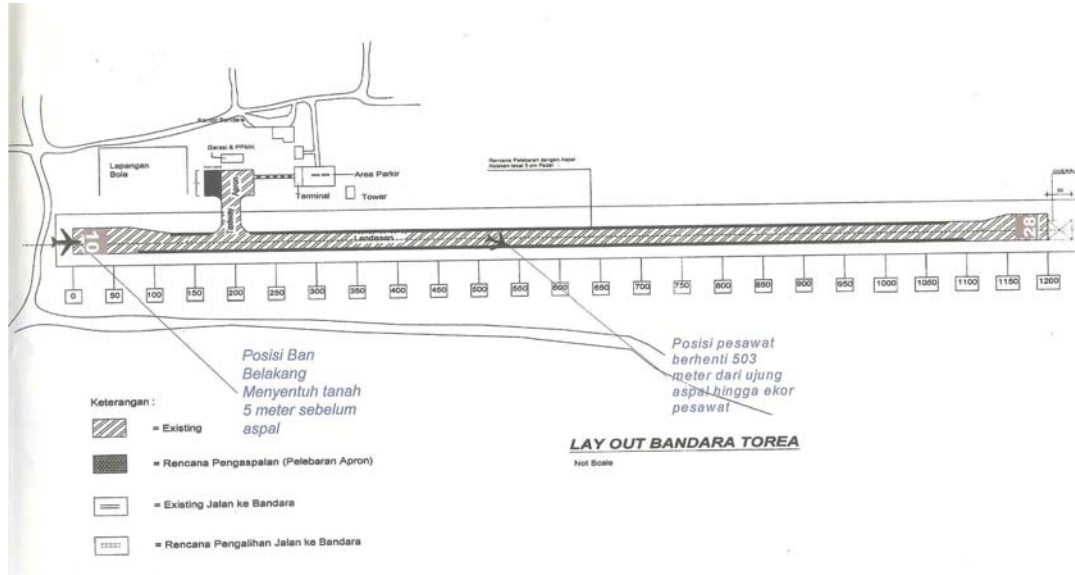
Figure 5: Torea runway diagram

There were tire marks on the stones 5 meters before the end of the runway, and wheel and fuselage scrape marks on the runway.
