KNKT.08.03.06.04

Aircraft Accident Investigation Report

Transall C-160

PK-VTQ

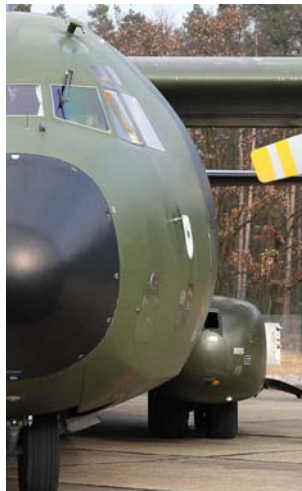
The Flight Engineer was the first occupant to disembark. He left the aircraft through the forward left air-stair door, and saw smoke coming from the area of the left main landing gear bay.

Figure 12: View of a Transall C-160 main landing gear. Note the wheels covered by the landing gear bay

The pilots reported that they left the aircraft after completing the engine shutdown checklist. They looked under the wheel bay and saw what they believed may have been a burning substance dripping from the wheels and flames coming from the left wheel-bay area. The pilots were unable to describe the dripping substance.
