KNKT 09.12.04.01

Aircraft Accident Investigation Report

PT. Aviastar Mandiri

British Aerospace BAe 146-300

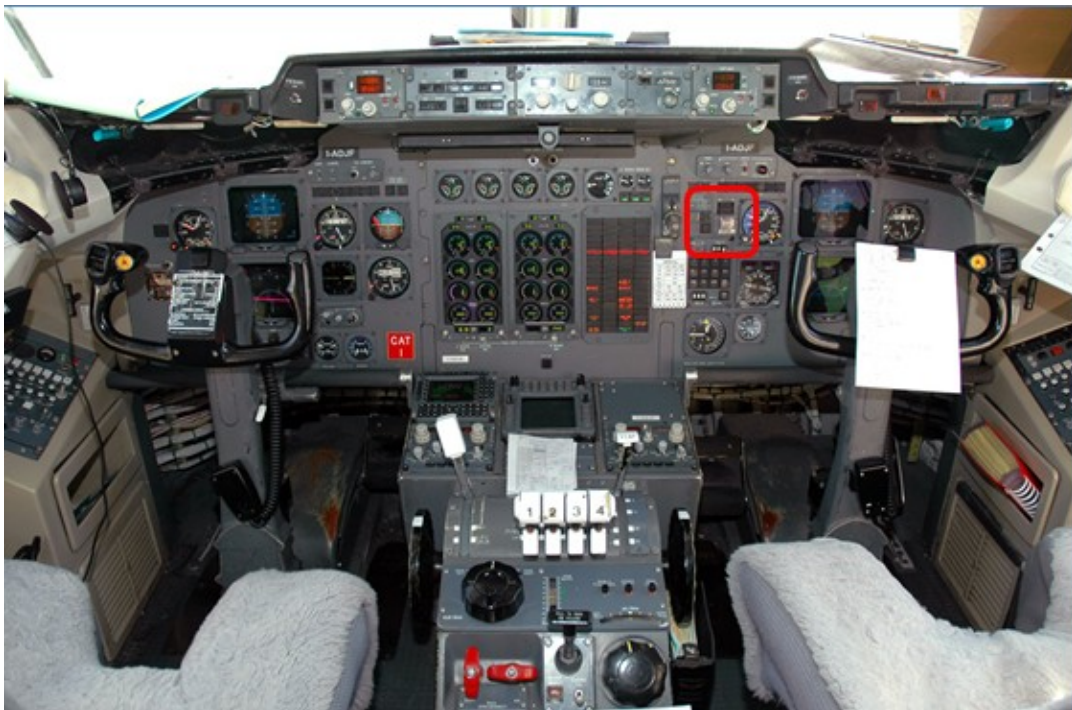
Appendix D : BAe 146 Instrument Panel

Red square on co-pilot panel denotes location of TERR SYST switch as detailed in the diagram taken from Appendix C.
