FINAL
KNKT.09.12.21.04

Aircraft Accident Investigation Report

**PT. Sinar Mas Super Air
Fletcher FU24-950 ; PK-PNX
Ketapang, West Kalimantan
Republic of Indonesia**

31 December 2009

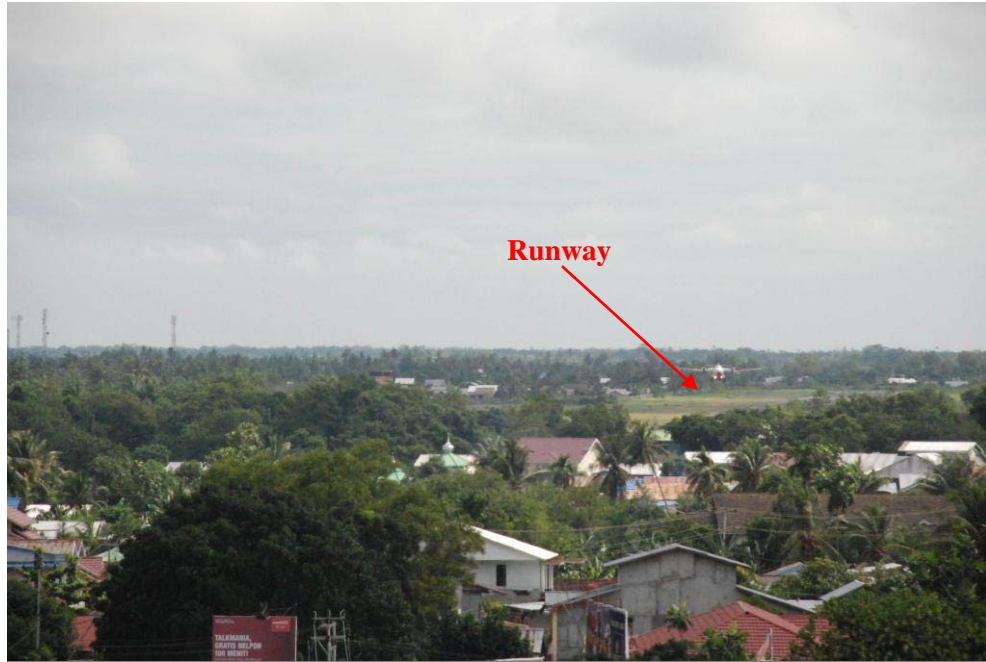
The investigation found the population and building for about 500 meters from the end of runway, a head of the take-off flight path.

Figure 4: The aerodrome area
