**KOMITE NASIONAL KESELAMATAN TRANSPORTASI  
REPUBLIC OF INDONESIA**

**Aircraft Accident Investigation Report**

**PT. Lion Mentari Airlines (Lion Air)**

**Boeing B737-400 ; PK-LIQ**

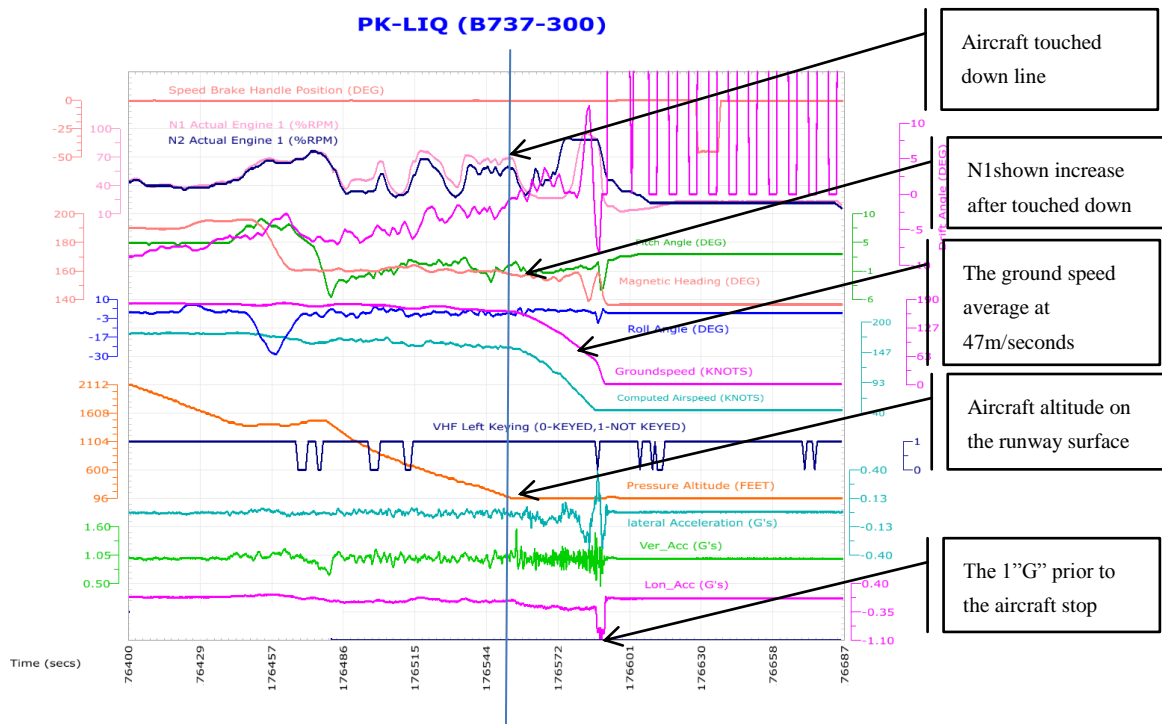
Figure 5: Parameters selected from the FDR

Selected and related data down loaded from the FDR, the detail data is shown in the table on the figure below.
