FINAL
KNKT.10.09.14.04

NATIONAL TRANSPORTATION SAFETY COMMITTEE

Aircraft Accident Investigation Report

**Bali International Flight Academy
Cessna 172 Skyhawk; PK-ROG
2.4 km SW Blimbingsari Aerodrome
Banyuwangi, East Java
Republic of Indonesia
1 September 2010**

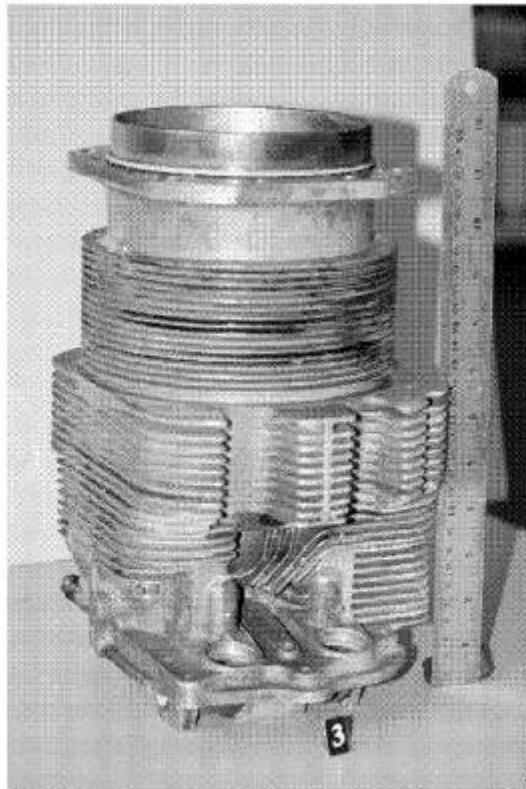
Fig.1. Cylinder assembly: Cylinder head is at lower position of the picture

The examinations were performed on the damaged cylinder, i.e. the number 2 cylinder. Fig.1 shows cylinder number 3 which is identical to the number 2. The number 2 cylinder was cut into halves to show the damages (Fig.2).
