**NATIONAL
TRANSPORTATION
SAFETY
COMMITTEE**

Aircraft Accident Investigation Report

**PT. Trigana Air Service
PK – YRP
Avions de Transport Regional ATR 42-320
Samboja Area, Km 41 Balikpapan
East Kalimantan
Republic of Indonesia**

11 February 2010

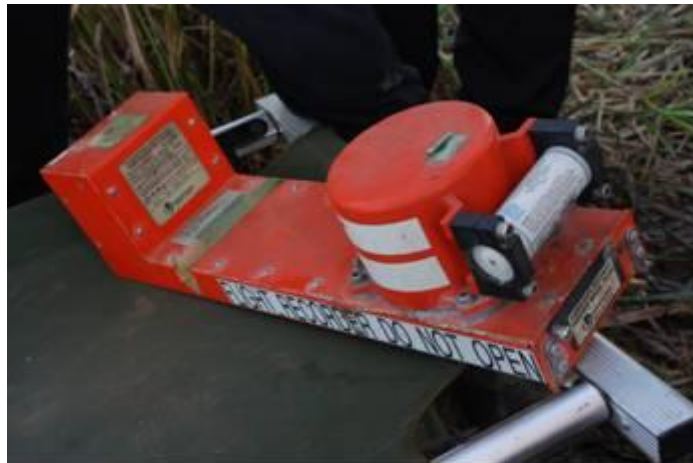
Figure 1: Flight Data Recorder

The aircraft was equipped with a Fairchild/ L3 communications FA2100 flight data recorder. The FDR was a solid state recorder designed to record at least 25 hours of flight data in an ARINC 747 format. The FDR was sent to ATSB (Australia Transport safety Board) on 22 February 2010.

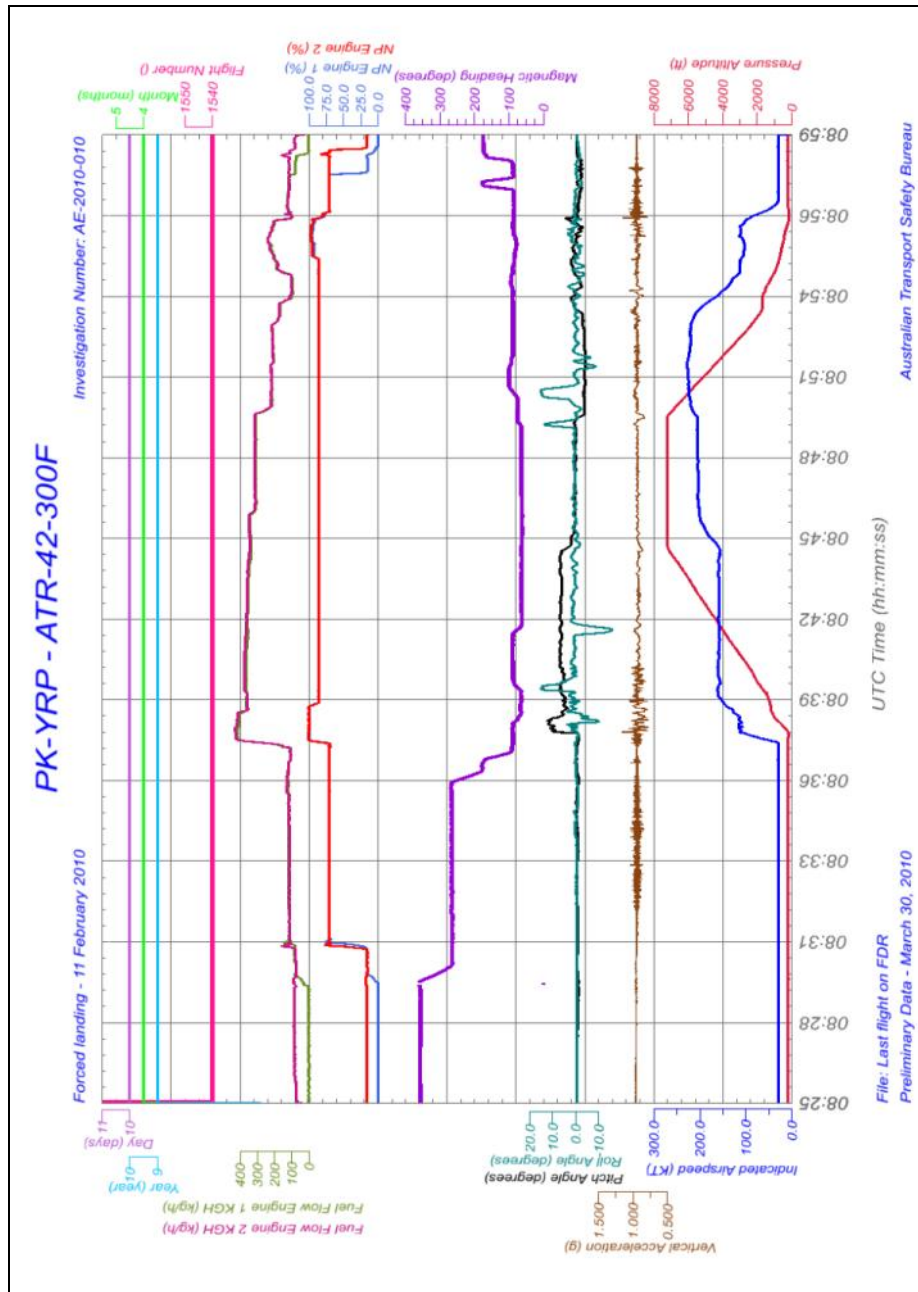
The FDR contained about 184 hours of good quality data covering 208 flights. The FDR data was examined and a sequence of events was developed for the last flight recorded (Figure 6 and Table 2). This flight was not the accident flight.

Figure 7: Graphical representation of last flight recorded on the FDR

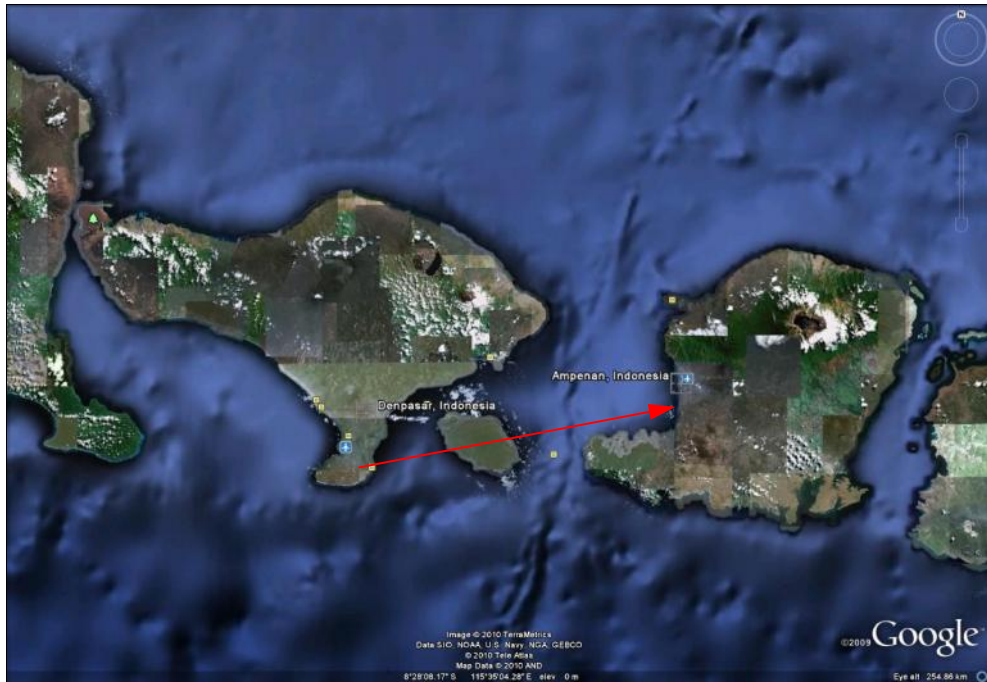
Figure 8: The last flight recorded in FDR , Denpasar to Ampenan, Indonesia

The aircraft performed a normal takeoff and landing. No indications of engine shutdown were found during this flight. The last flight recorded on the FDR was uneventful and therefore it was concluded that it was not the accident flight. It should be identified during C of A renewal by inspector, where the FDR down load is a mandatory to be supplied as the requirement.

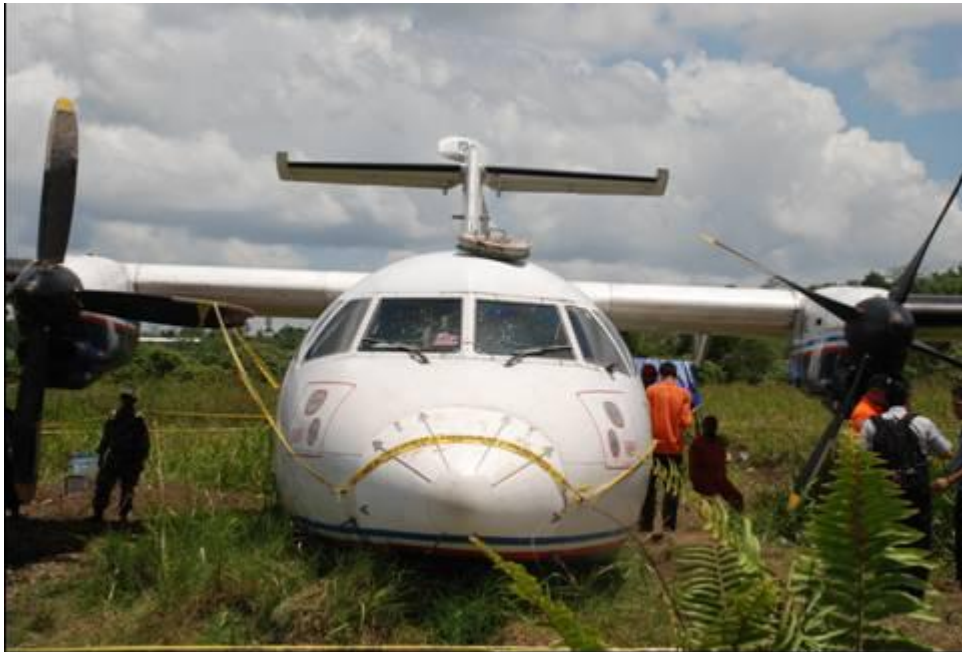
Figure 11: The aircraft at final position

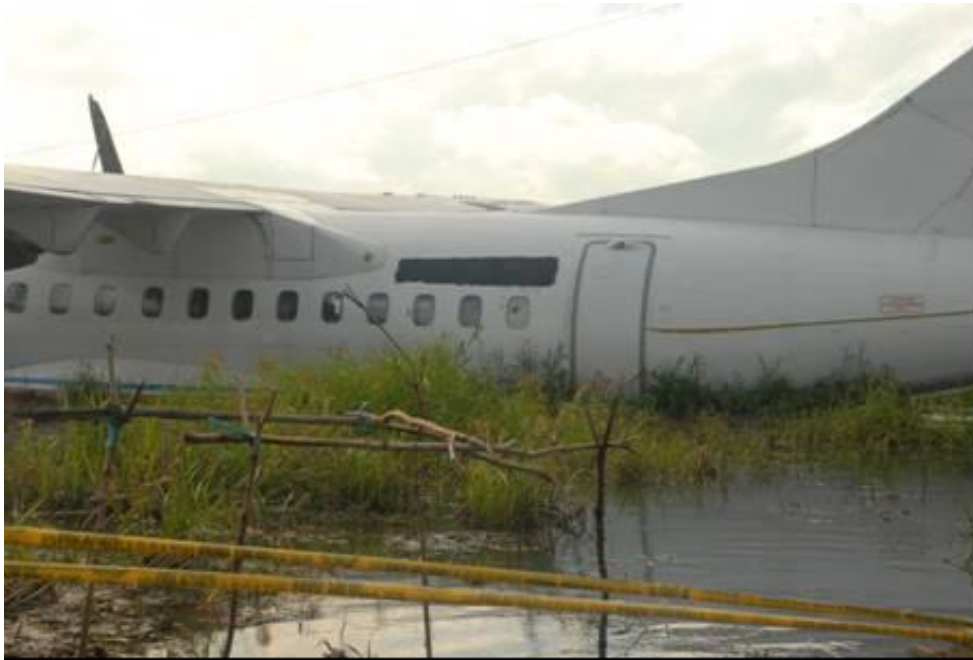
Figure 14: After view days of accident the area was flooded

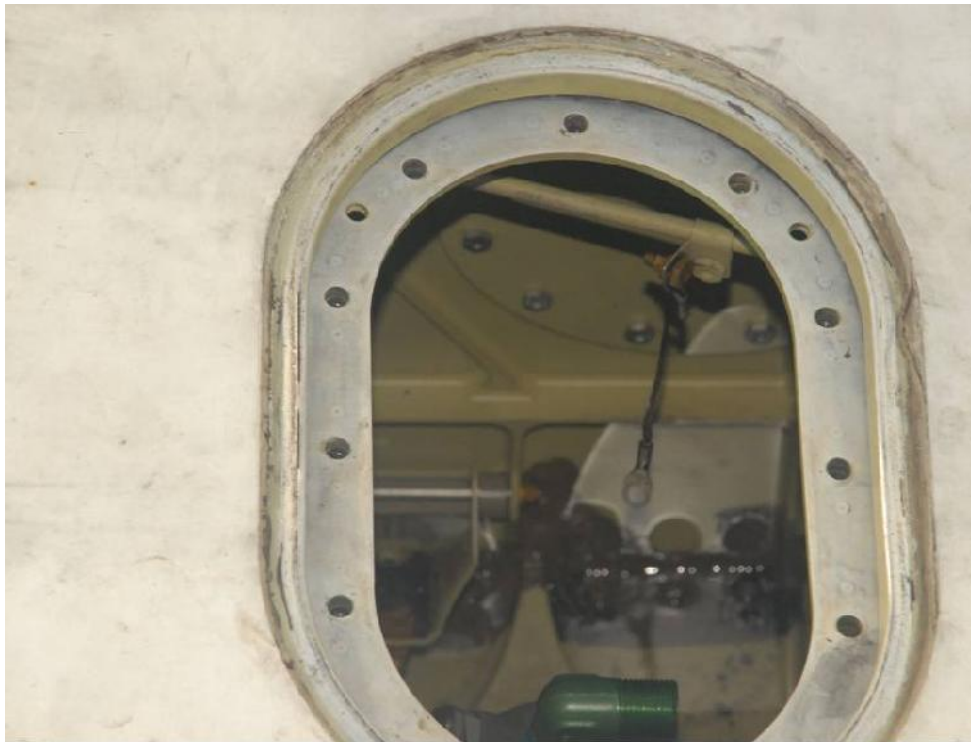
Figure 15: The aircraft wing tank

At the accident area has been observed that no indication of fuel leak from the aircraft, so the fuel remaining in the both wing tanks showed at the condition of the accident.
