**KOMITE NASIONAL KESELAMATAN TRANSPORTASI
REPUBLIC OF INDONESIA**

Aircraft Serious Incident Investigation Report

PT. Wings Abadi Airlines

ATR 72-212A; PK-WFG

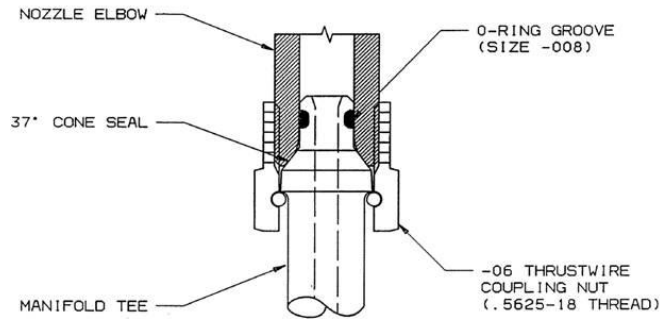
Figure 7: The sealing feature of SB 21705

The primary sealing is metal to metal surface sealing between manifold fitting (see the MANIFOLD TEE refer to the figure 7 above) and the fuel adapter (see the NOZZLE ELBOW refer to the figure 7 above).

The secondary sealing is done by the installation of preformed packing (see the O-RING GROOVE (SIZE -008) refer to the figure 7 above) on the fuel nozzle manifold fitting. The preformed packing is designed as secondary backup sealing for added protection.

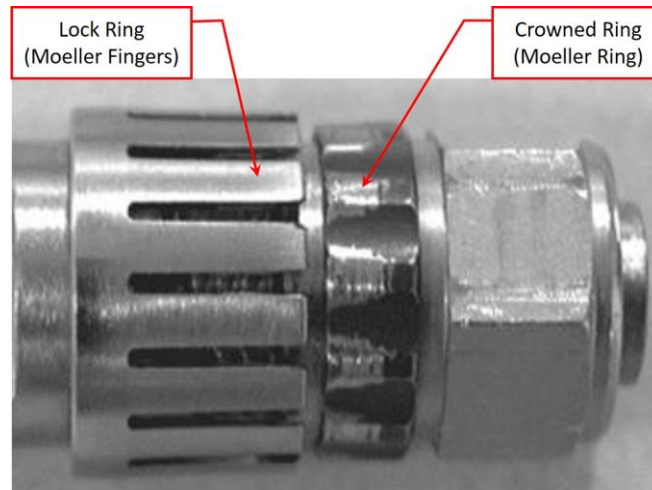
Figure 8: Moeller Fingers and Moeller Ring

While locking features seals can ensure efficient sealing, but improper installation of Moller Fingers on the Moeller Ring will result in premature wear of the preformed packing secondary sealing.

The PWC recommends the removal and installation of the fuel nozzle assembly should use the proper tooling of PWC tool kit part number PWC56616. The investigation revealed that on 15 April 2011, during the installation of the fuel nozzle, the engineer did not utilize the proper tool kit. Without utilizing the proper tool while the engine was still installed on the nacelle, the engineer could have difficulties in aligning and correct applying torque to the fuel nozzle position number 1 and 14. The other positions of the fuel nozzle may be able to be installed easier.

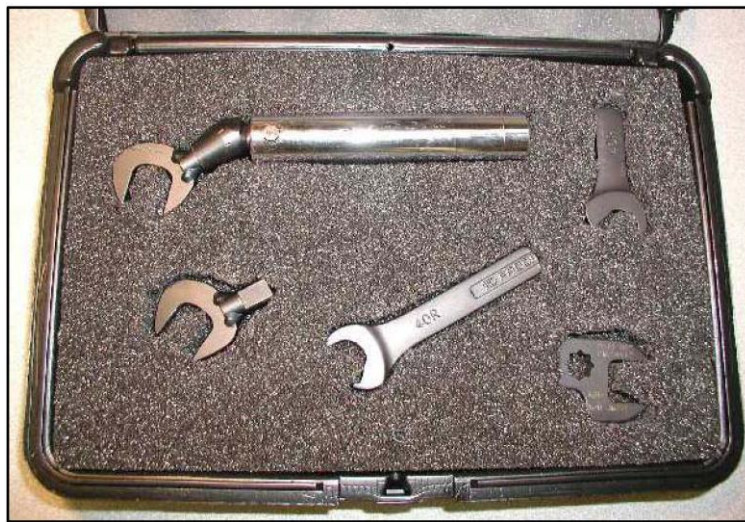
Figure 20: The PWC tool kit part number PWC56616

This tool kit is to ensure that the removal and installation to the fuel nozzles and manifold in the difficult location (such as fuel nozzle and manifold position 1 and 14 in the PW100 engine) can be managed properly.

The Service Experience recommend the operator to utilize the tool kit part number PWC56616 for fuel nozzle flexible manifold removal and installation.

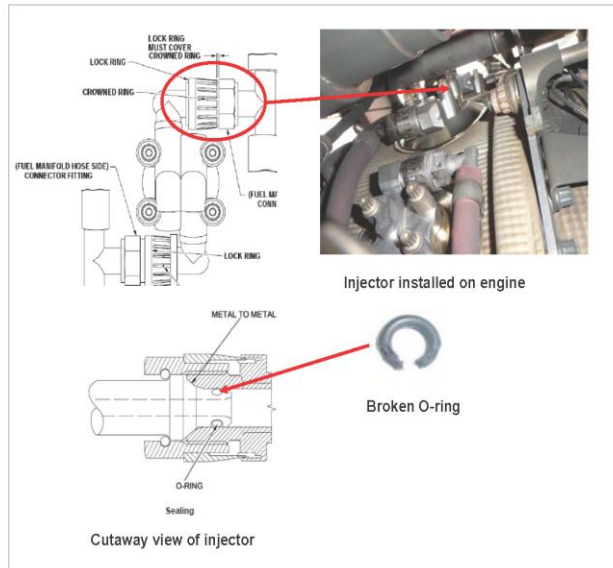
Sealing between the injector and the manifold is ensured by tightening, metal against metal, to a torque level defined by the manufacturer. The two O-rings create an additional safety when this tightening is not correct. Any damage to them can lead to a leak.

The maintenance manual specifies changing the injector nozzle manifold every 1,000 flying hours. Once the operation is finished, sealing of the injectors is checked by a leakage check (wet ventilation), then by a ground run at 80% performed for 10 minutes. The presence of the O-rings can mask incorrect tightening during this leakage check.
