**FINAL**  
KNKT.11.12.31.04

**Runway Excursion Investigation Report**

**PT. Sriwijaya Air  
Boeing 737-200; PK-CJD  
Sultan Mahmud Badarudin II Airport,  
Palembang, Sumatera Selatan,  
Republic of Indonesia  
24 December 2011**

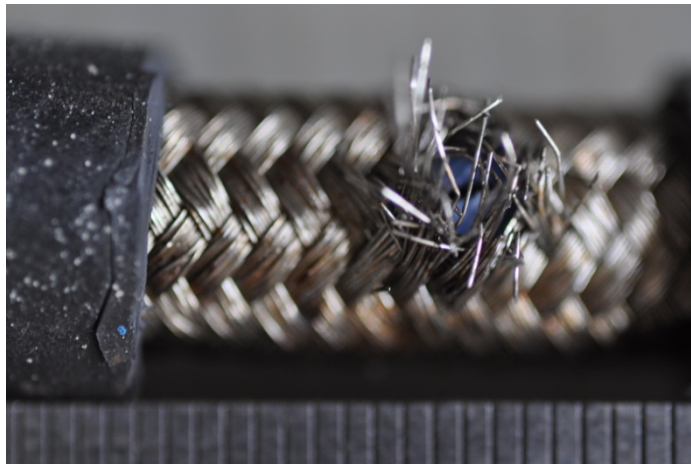
- a. The external cover is hydrocarbon rubber (nitrile butyl rubber) that used for ester phosphate (skydrol).
- b. The internal part as per label wrapped at the hose is teflon hose covered by wire mesh.

Figure 8: The external rubber was peeled to expose the wire mesh and internal hose
