NATIONAL TRANSPORTATION SAFETY COMMITTEE

Aircraft Accident Investigation Report

PT. Sriwijaya Air

Boeing 737-300

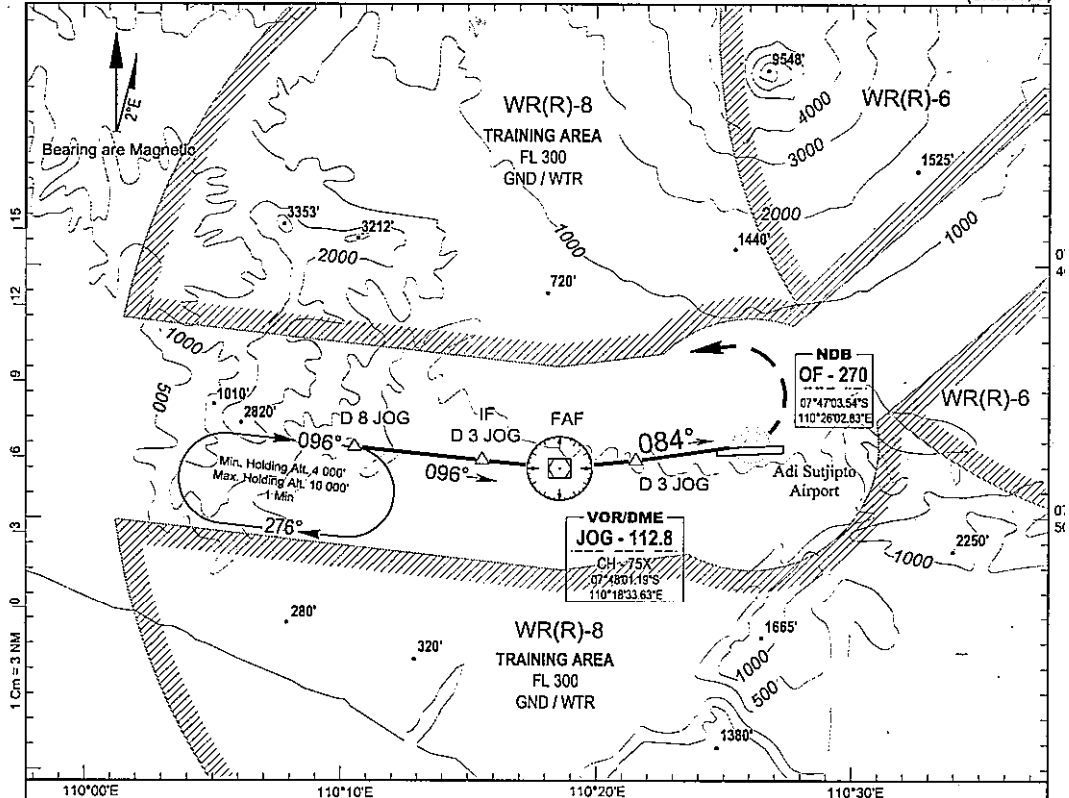
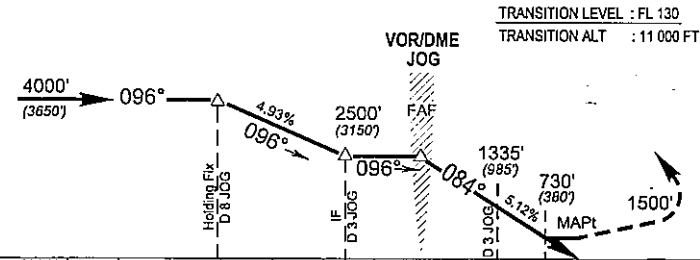
Figure 4: VOR/DME approach runway 09 Yogyakarta

Missing the crew briefing and no approach chart available might have made the PF not familiar with the VOR/DME runway 09 approach path.

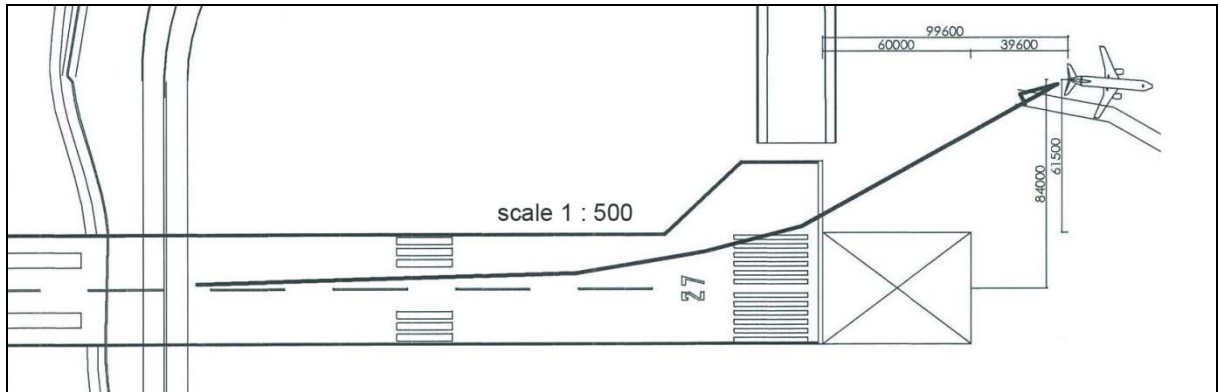
Figure 7: Location (source from AP I)

The aircraft stopped at left side of runway.

Aircraft tail position was 75 meters from the end of runway and 54 meters left side of runway centreline.
