NATIONAL TRANSPORTATION SAFETY COMMITTEE

Aircraft Serious Incident Investigation Report

PT. Garuda Indonesia

Boeing 737-300; PK-GGO

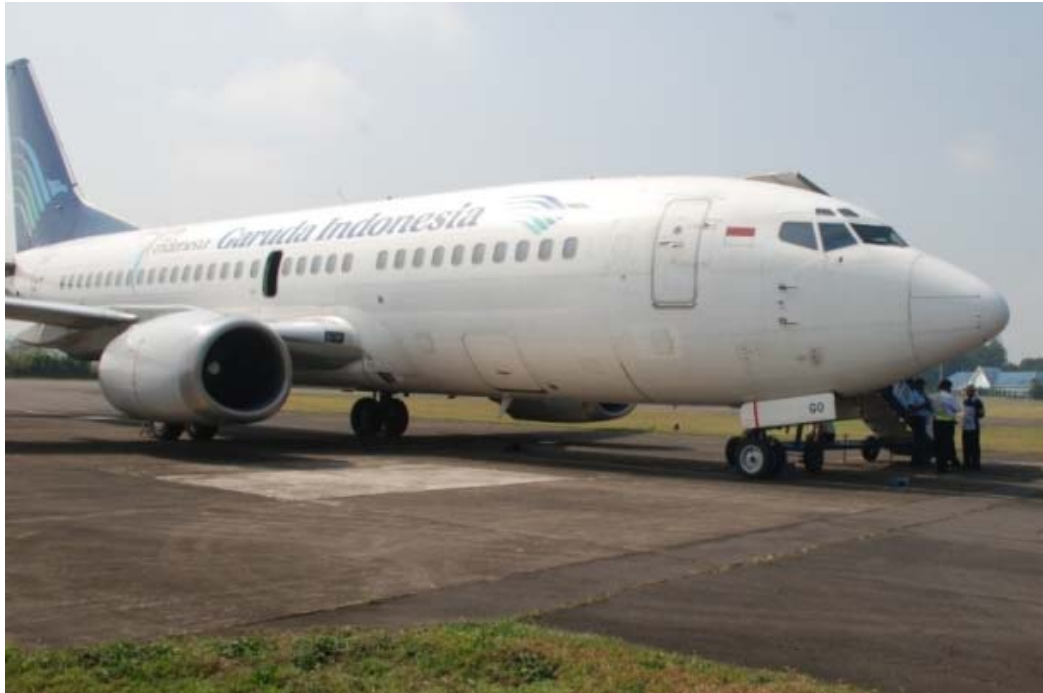
Figure 2: Boeing 737-300 aircraft registration PK-GGO

During the visual inspection, found that nose wheel hub broken, left engine inlet cowling and several vane blades damaged. Based on the finding of the initial inspection, the aircraft was grounded for further damage assessment and repair.
