FINAL
KNKT.11.02.05.04

Aircraft Accident Investigation Report

PK-LHH

Boeing 737-900ER

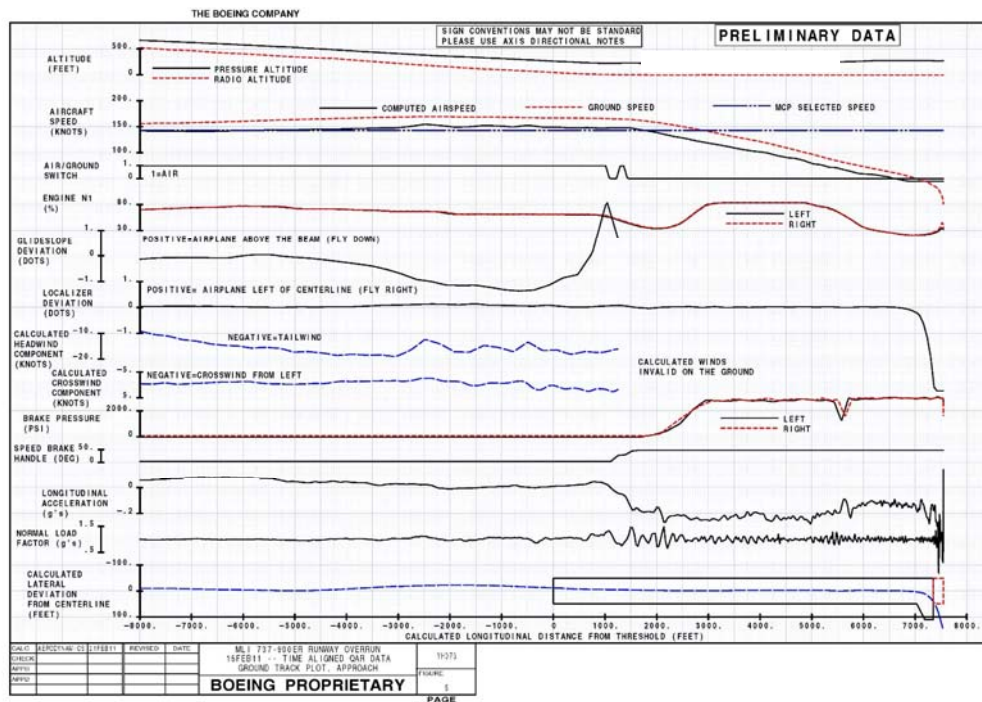
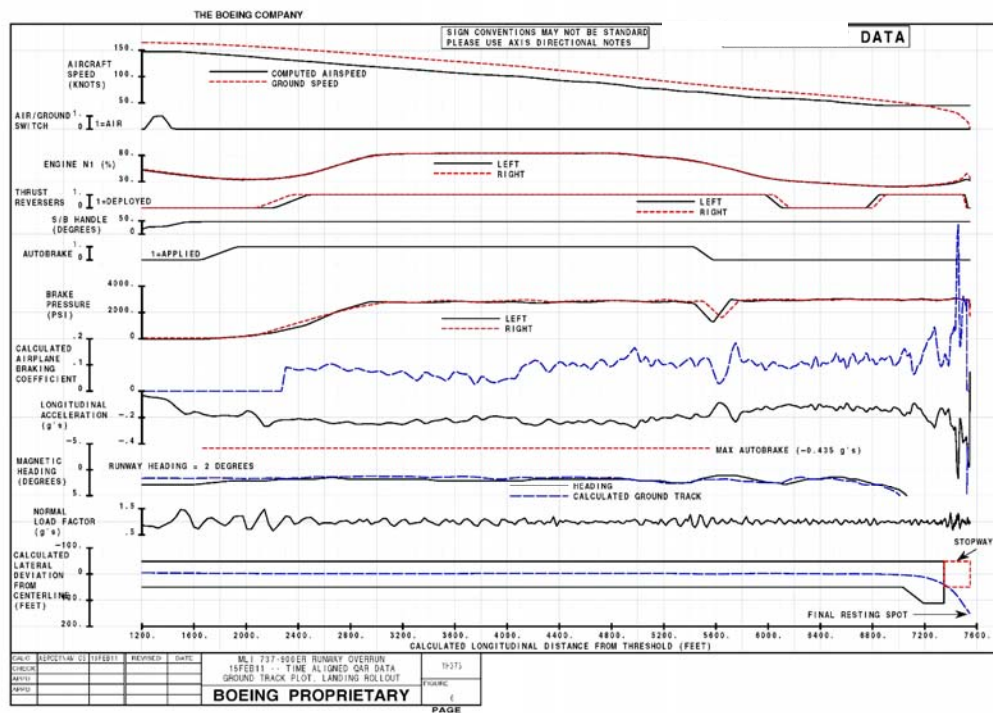
Figure 5: FDR data with special information during landing roll

The Boeing data base on DFDAU showed that the average calculated airplane braking coefficient was -1.5 instead of 0. This condition means that the friction between the wheel and runway surface was not sufficiently supporting the aircraft deceleration.
