**KOMITE NASIONAL KESELAMATAN TRANSPORTASI
REPUBLIC OF INDONESIA**

Aircraft Serious Incident Investigation Report

Boeing 737-500; PK-MDT

26 December 2011

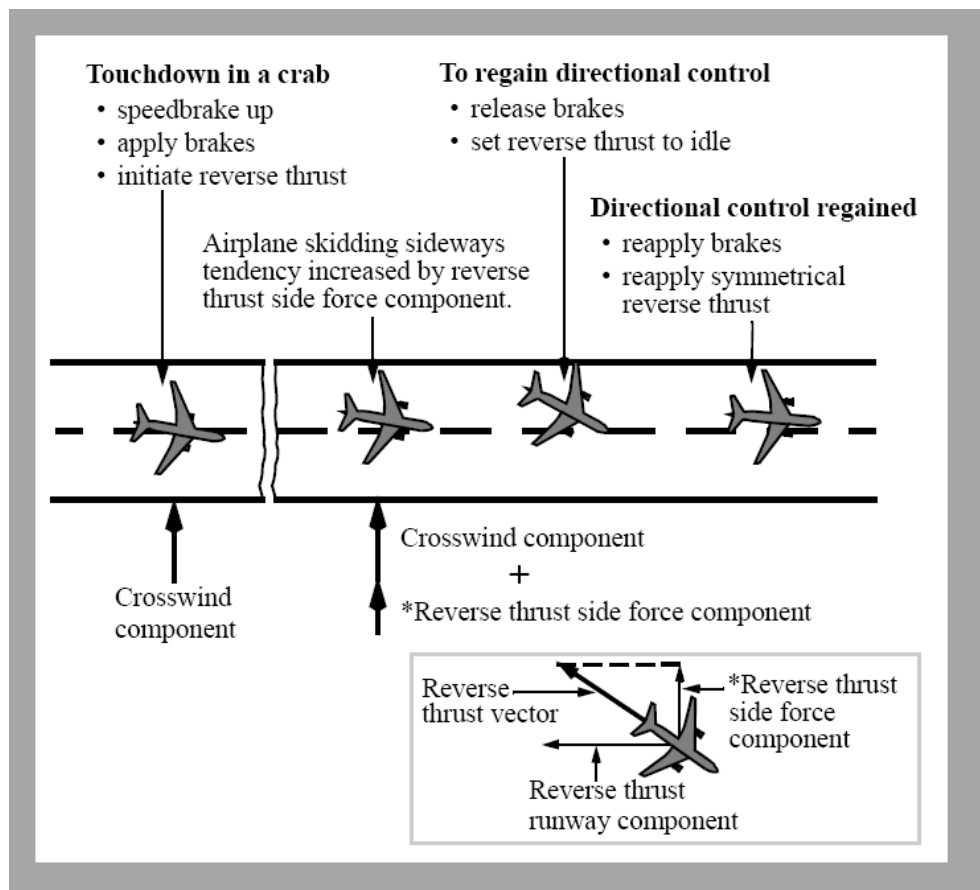
Reverse Thrust and Crosswind (All Engines)

This figure shows a directional control problem during a landing rollout on a slippery runway with a crosswind. As the airplane starts to weathervane into the wind, the reverse thrust side force component adds to the crosswind component and drifts the airplane to the downwind side of the runway. Also, high braking forces reduce the capability of the tires to corner.

To correct back to the centerline, release the brakes and reduce reverse thrust to reverse idle. Releasing the brakes increases the tire-cornering capability and contributes to maintaining or regaining directional control. Setting reverse idle reduces the reverse thrust side force component without the requirement to go
