FINAL
KNKT.11.09.17.04

Aircraft Accident Investigation Report

**PT. ASI Pudjiastuti Aviation
Cessna 208 B Grand Caravan ; PK-VVE
Notnare Village, Distrik Samenage,
Yahukimo, Papua
Republic of Indonesia**

9 September 2011

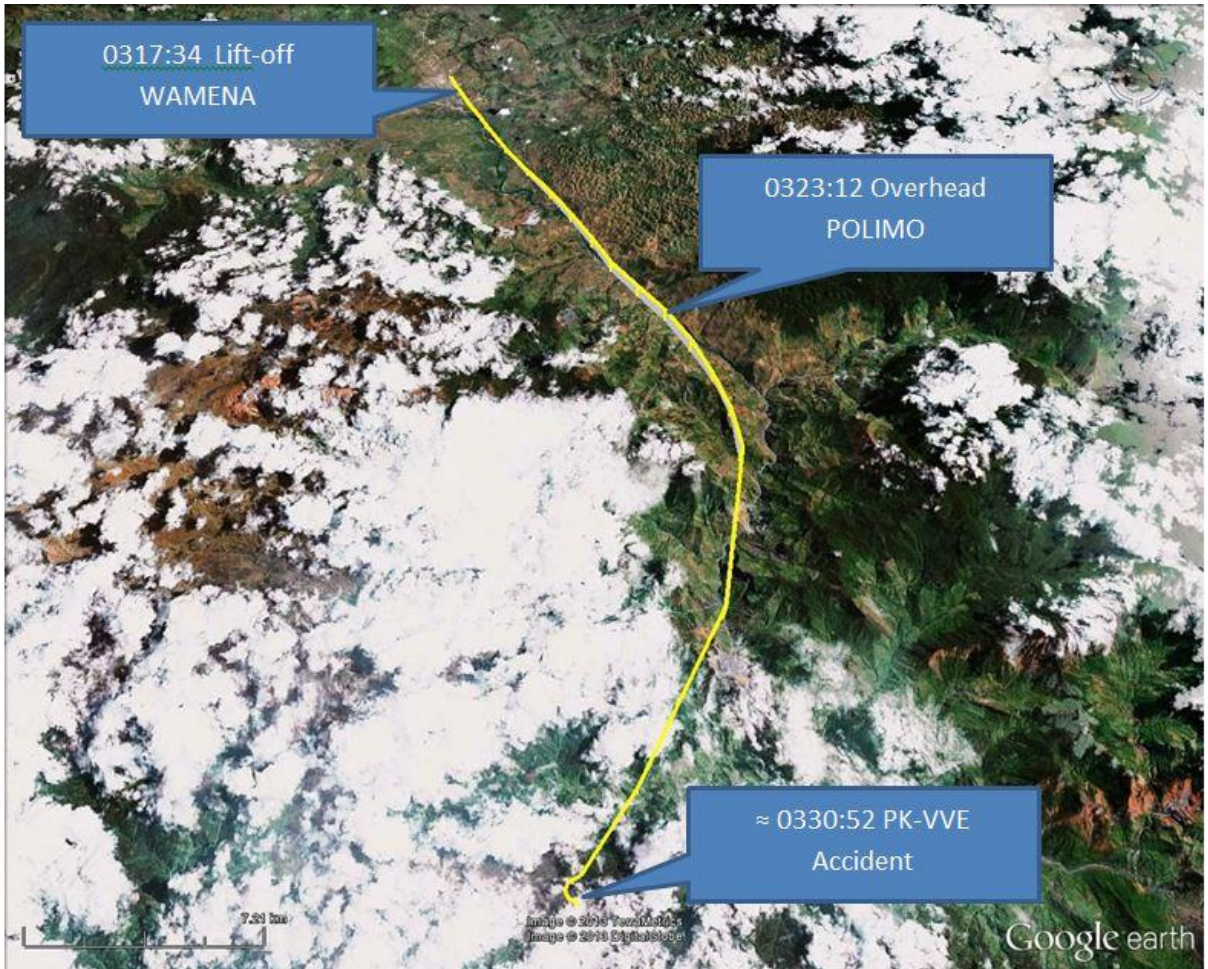
Figure 2: PK-VVE accident flight track and events (Source: GPS tracking and EGPWS data)

UTC time	Event	Source
0330:50	<p>Activation of EGPWS mode one ‘PULL UP’ alert. The aircraft had ceased descending. The left roll was reducing with an angle of bank of 16°. The aircraft track was 127 °M</p> <p>Altitude: 9,045 feet IAS 104 knots</p> <p>Engine torque: 464 ft/lbs Engine Ng: 61.8 % ITT: 534°C</p>	EGPWS ECTM
0330:51	<p>Activation of EGPWS mode one ‘SINK RATE’ alert. The aircraft was rolling through a wings level attitude.</p> <p>Altitude: 9,194 feet IAS 52 knots</p> <p>Engine torque: 193 ft/lbs Engine Ng: 60.7 % ITT: 549°C</p> <p>(This data was most likely affected by the collision with the terrain)</p>	EGPWS ECTM
0330:53	<p>Activation of EGPWS ‘TERRAIN’ caution.</p> <p>End of recorded data.</p>	EGPWS

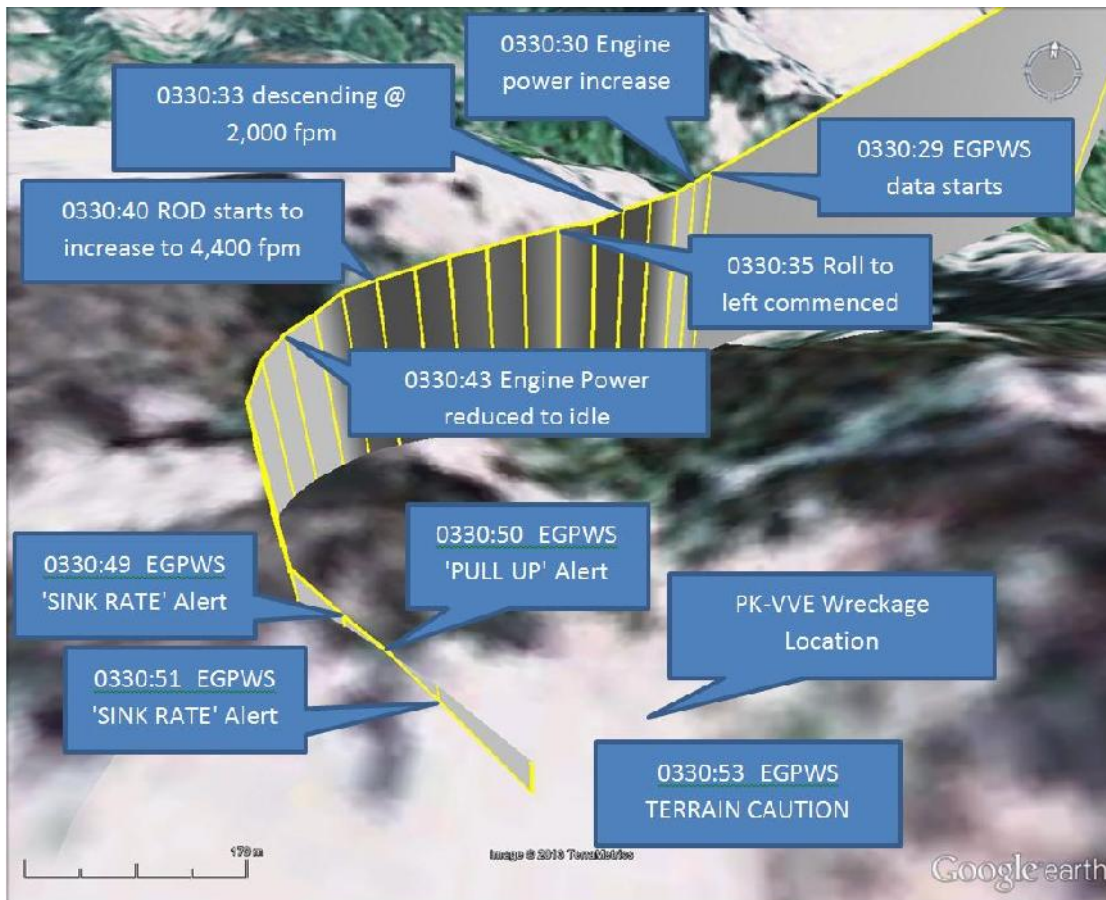
Figure 4: PK-VVE accident flight track and events 0330:29 to end of data (Source: EGPWS and ECTM data)

0330:43	Engine power started to reduce to about flight idle. The aircraft was continuing in the left turn with an angle of bank of 35°. Altitude: 9,652 feet IAS 91 knots Engine torque: 1,501 ft/lbs Engine Ng: 99.2 % ITT: 740°C	EGPWS ECTM
0330:47	The engine power was at idle with the aircraft continuing in the left turn at an angle of bank of 46°. Altitude: 9,202 feet IAS 104 knots Engine torque: 509 ft/lbs Engine Ng: 66.8 % ITT: 534°C	EGPWS ECTM
0330:49	Activation of EGPWS mode one 'SINK RATE' alert. The aircraft was banked to the left with an angle of bank of 46° and commenced rolling to the right. The rate of descent started to reduce. Altitude: 9,058 feet IAS 122 knots Engine torque: 549 ft/lbs Engine Ng: 63.0 % ITT: 530°C	EGPWS ECTM

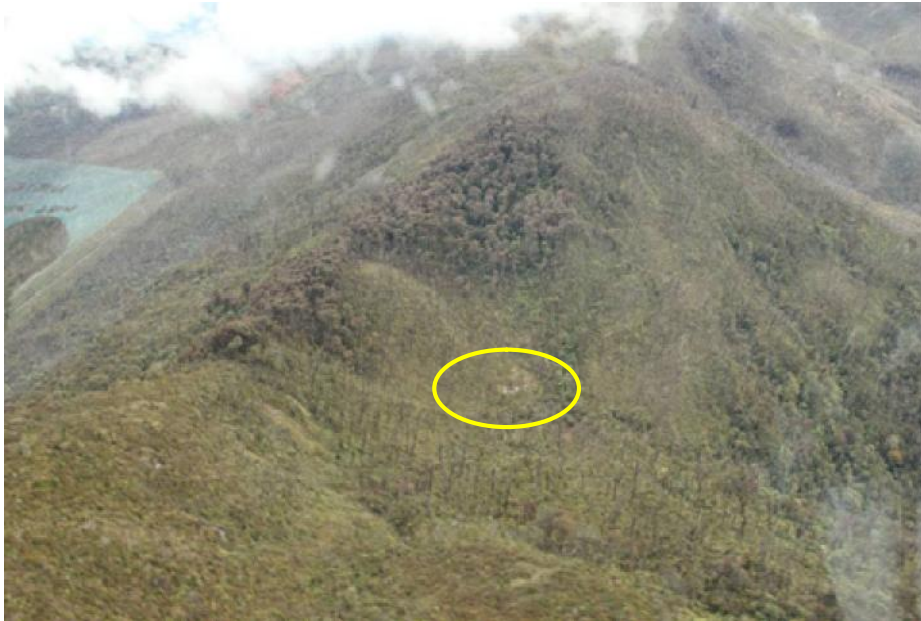
Figure 6: Accident location

On 10 September 2011, a Search and Rescue team and local people commenced a rescue operation. Two days later, the SAR team and local people reached the accident site, which was located on the side of the mountain. Both of the persons on board were fatally injured and the aircraft was destroyed. On 14 September 2011, a PT ASI Pudjiastuti Aviation helicopter evacuated the deceased.

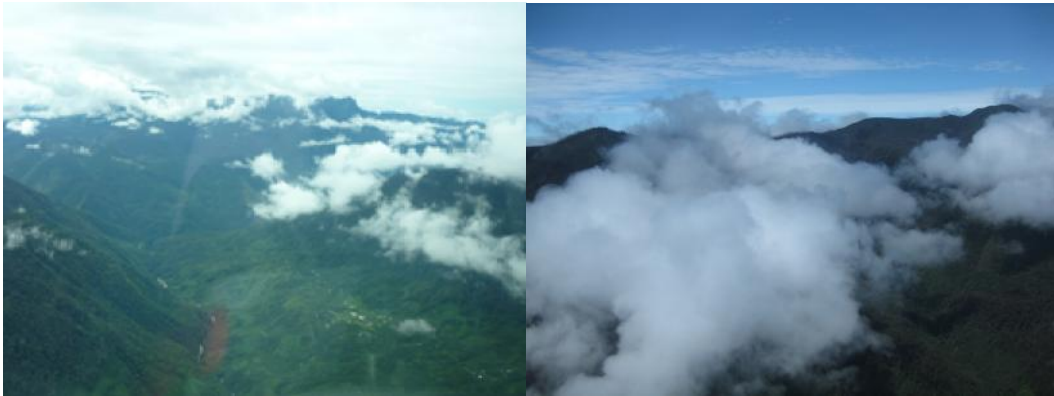
Figure 10: Possible weather in the accident area

A review of the recorded data indicated that during the climb to 9,838 feet. the aircraft was encountering a south-easterly wind of about 20 knots. This wind speed could result in turbulence being encountered over mountainous terrain. The wind information was derived from a comparison of true airspeed, groundspeed and track. True airspeed was calculated from ECTM indicated airspeed, pressure altitude, and ambient temperature. Groundspeed and track data was recorded by the flight tracking system.

Figure 5 illustrates the possible weather as described by other pilots on the day of the accident. This is to illustrate that the mountains were visible in Visual Meteorological Conditions.

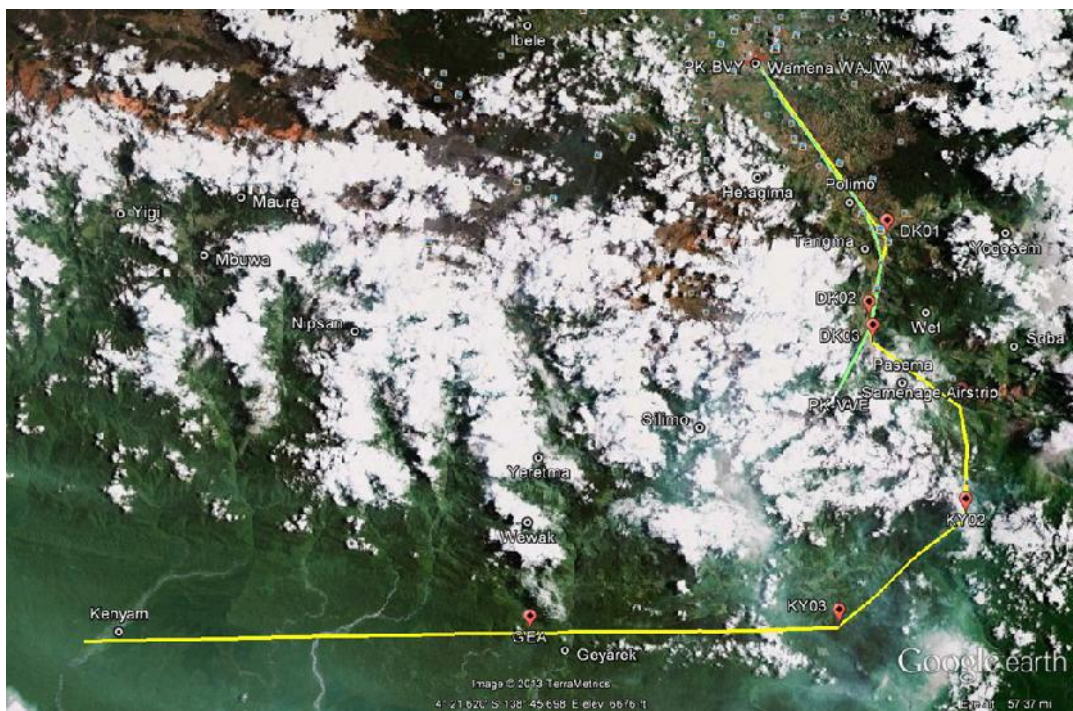
Figure 17: Accident flight route (green track) and VFR flight route (yellow route)

The operator also reported that the Pilot in Command of PK-VVE had flown the Wamena – Kenyam route a few times before, but never using the full Wamena-Kenyam-Wamena GPS route guide as depicted as the yellow track in figure 12.

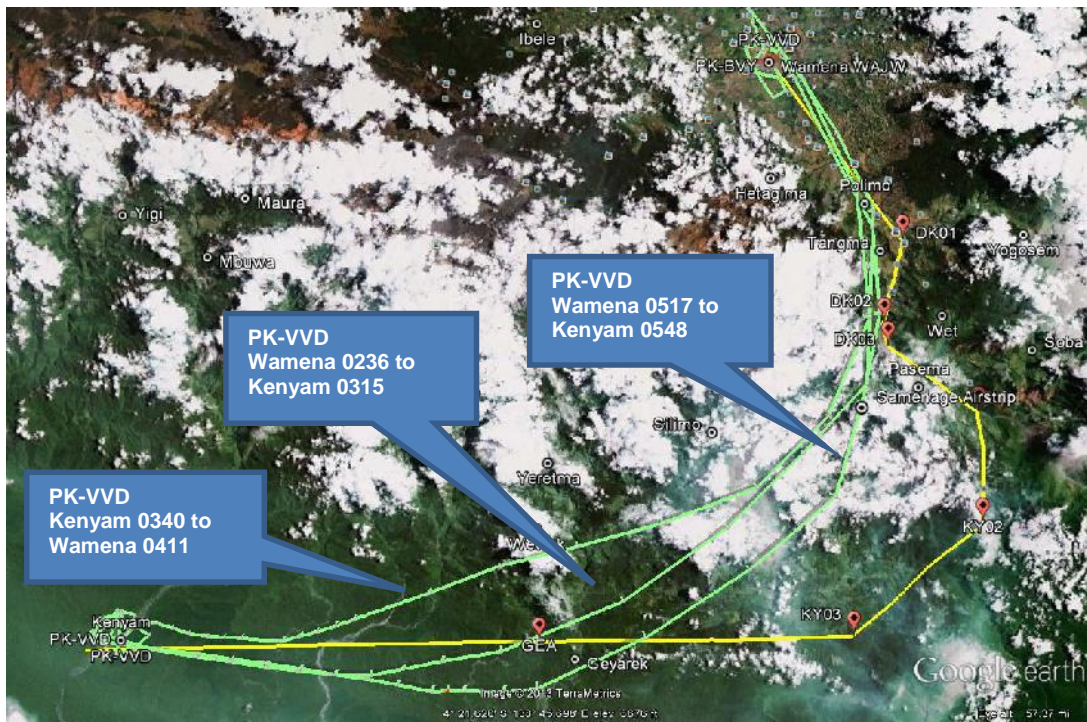
Figure 18: GPS tracks of other flights between Wamena and Kenyam on 9 September 2011

The operator reported that there was an opinion within the company that Caravan pilots were left to some degree, to their own devices, to analyze the best way to tackle mountain flying. A review of flight tracking data of flights conducted by the pilot in command, including while undergoing training, showed that the pilot flew the more direct route between Wamena and Kenyam. This route was also flown by other company pilots on the day of the accident as shown as green tracks in figure 13. These flights were operated between 11,200 feet and 12,500 feet over the high terrain along the route. The operator's route guide specified that flights over the high terrain enroute from Wamena to Kenyam should be conducted at 11,500 feet and stated that 'IMC climb not below 9000 feet at Polemo'.
