**Aircraft Accident Investigation Report**

**Wings Flying School**

**Cessna 172P; PK-WTF**

**19 December 2011**

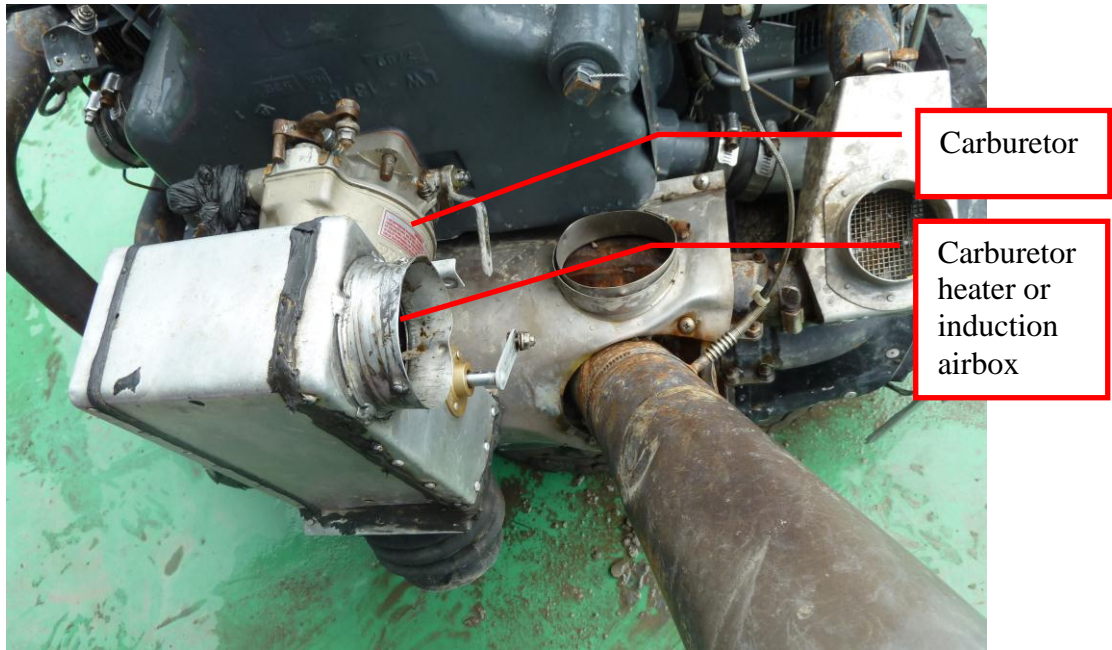
**Figure 6: Actual carburetor and carburetor heater installation**

Investigation conducted examination to the engine to determine the cause of the engine failure. The engine examination did not find any abnormality. The examination of induction system found a piece of rubber at the inside of the throttle chamber of the carburetor with dimension of 12 cm length and 0.8 cm width that believed originated from the flapper valve of the induction box.

The detachment of the rubber presumably due to repeated bending action against the box wall at "CLOSE" position caused fatigue to the rubber.

The presence of the rubber in the throttle chamber interrupted the supply of fuel air mixture to the piston chamber and resulted in the improper combustion. The improper combustion was identified by the pilot as the engine hesitation.

The following figure showed the condition of the induction airbox attached to the engine.

The inspection revealed there was a piece of rubber in the carburetor heater or induction airbox with dimension of 12 cm length and 0.8 cm width (figure 7) in the throttle chamber of the carburetor.
