FINAL
KNKT.12.10.22.04

Runway Excursion Investigation Report

**PT. Sriwijaya Air
Boeing 737-400; PK-CKN
Supadio International Airport
Pontianak, West Kalimantan
Republic of Indonesia**

19 October 2012

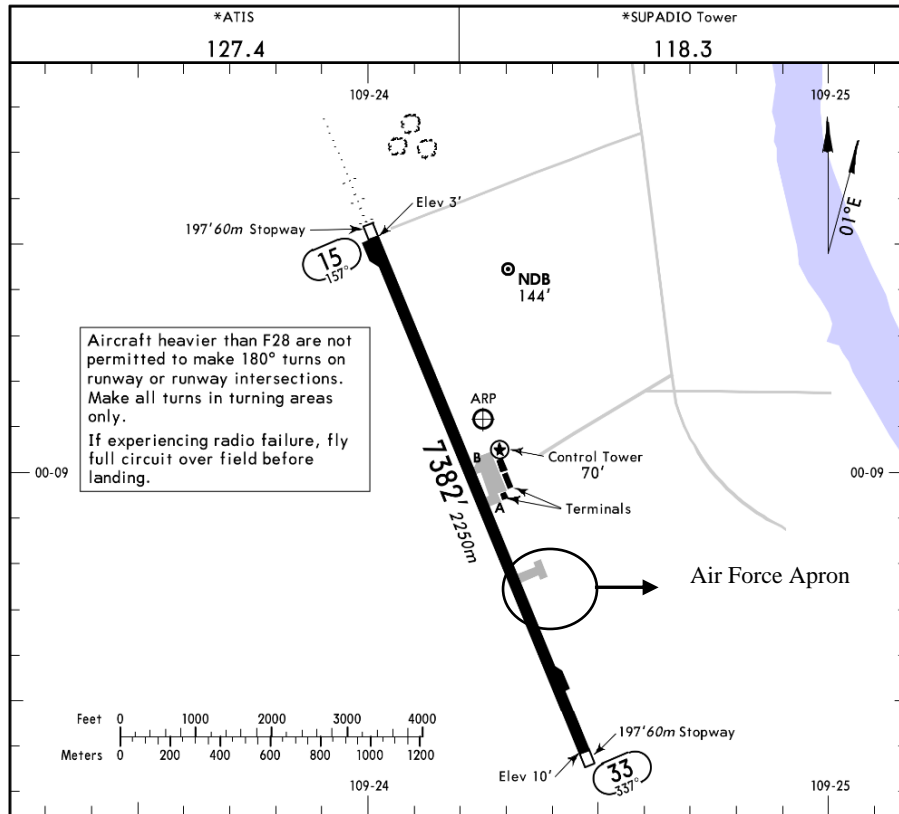
1.10 Aerodrome Information

Airport Name	: Supadio International Airport
Airport Identification	: WIOO
Coordinate	: 00°08'53"S 109°24'15"E
Elevation	: 10 ft / 32°C
Airport Operator	: PT. Angkasa Pura II (Persero)
Runway Direction	: 156° and 336° (15-33)
Runway Length	: 2250 m (7382 ft)
Runway Width	: 45 m
Surface	: Asphalt concrete
Longitudinal Slope	: 0.03% up to runway 15
Transverse Slope	: 1%
