**KOMITE NASIONAL KESELAMATAN TRANSPORTASI
REPUBLIC OF INDONESIA**

Aircraft Serious Incident] Investigation Report

PT. Wings Abadi Airlines

ATR 72-212A; PK-WFK

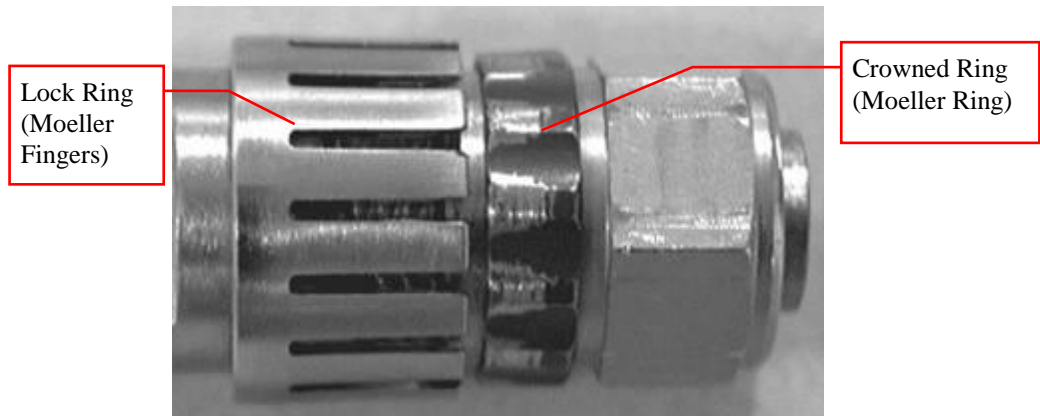
Figure 9: Fuel Nozzle locking devices

The Service Experience also provides the correct alignment of the fuel nozzle locking devices that referred as "B-Nut".

The B-Nut consists of the crowned ring (Mueller ring) and lock ring (Moeller Fingers) as shown in the figure below.

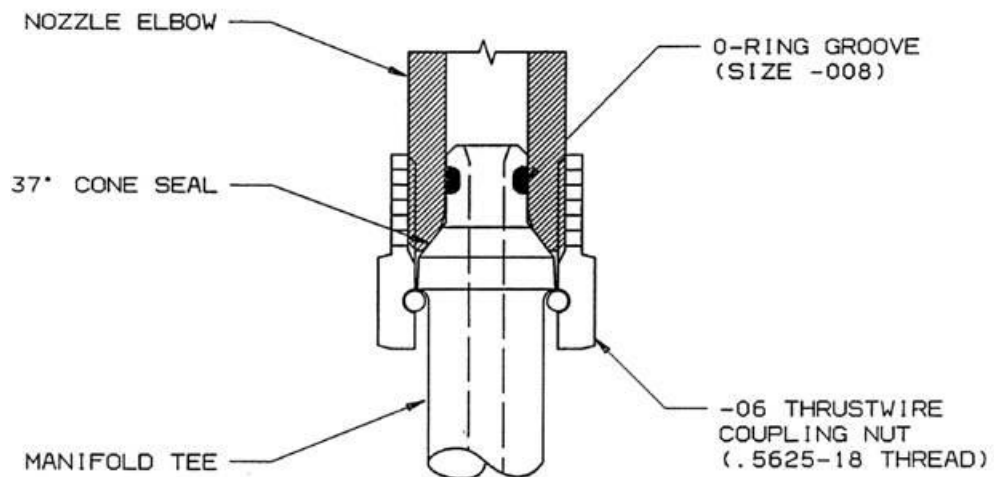
Figure 10: Sealing configuration of the fuel nozzle

The service experience is also to provide the awareness of the O-ring as part of the sealing to the fuel nozzle since the O-ring prone to wear if the installation is not proper.
