**PRELIMINARY**  
KNKT.12.11.25.04

**Aircraft Serious Incident Investigation Report**

**PT. Metro Batavia (Batavia Air)  
Boeing 737 - 300; PK-YVZ  
Supadio Airport, Pontianak, Kalimantan  
Republic of Indonesia  
22 November 2012**

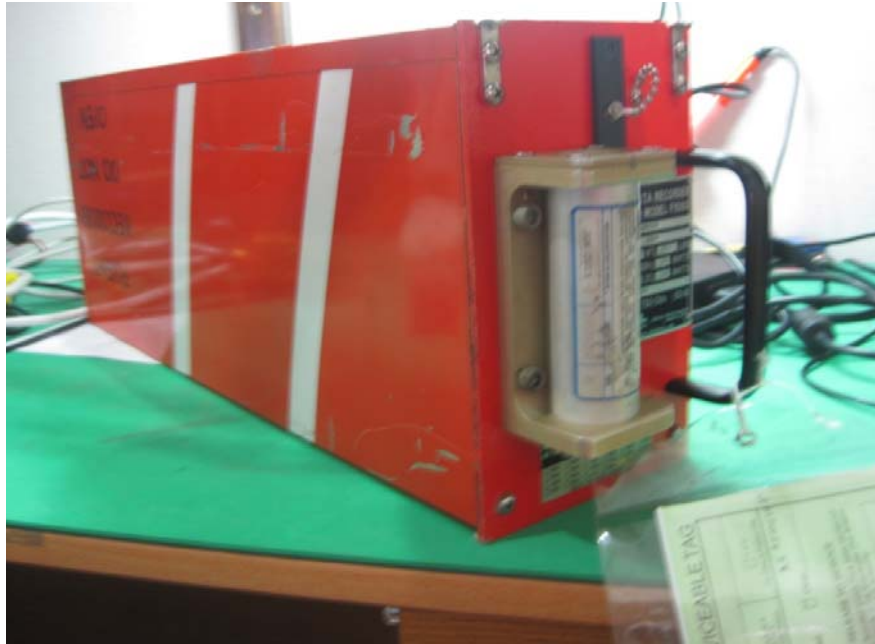
**Figure 2 PK-YVZ Flight Data Recorder**

Manufacturer	: Fairchild, USA
Type	: Solid Stated
Part Number	: S 603-1000-00
Serial Number	: 00328

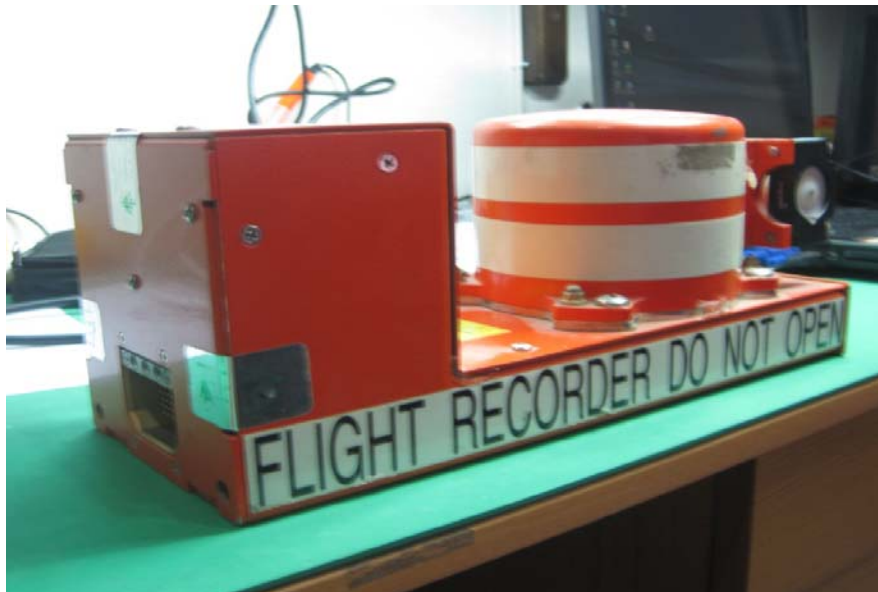
**Figure 3 PK-YVZ Cockpit Voice Recorder**

Manufacturer	:	L3 Communication, USA
Type	:	Solid Stated
Part Number	:	2100-1020-02
Serial Number	:	000532512

Both recorders were recovered from aircraft at Soekarno Hatta Airport by Batavia Air personnel. The day after tomorrow of the serious incident, the NTSC investigator take over and sent these recorders to the NTSC laboratory. The NTSC have been successfully downloaded.
