**KOMITE NASIONAL KESELAMATAN TRANSPORTASI
REPUBLIC OF INDONESIA**

Aircraft Accident Investigation Report

PT. Wings Abadi Airline

ATR 72-212A (500 Version); PK-WFV

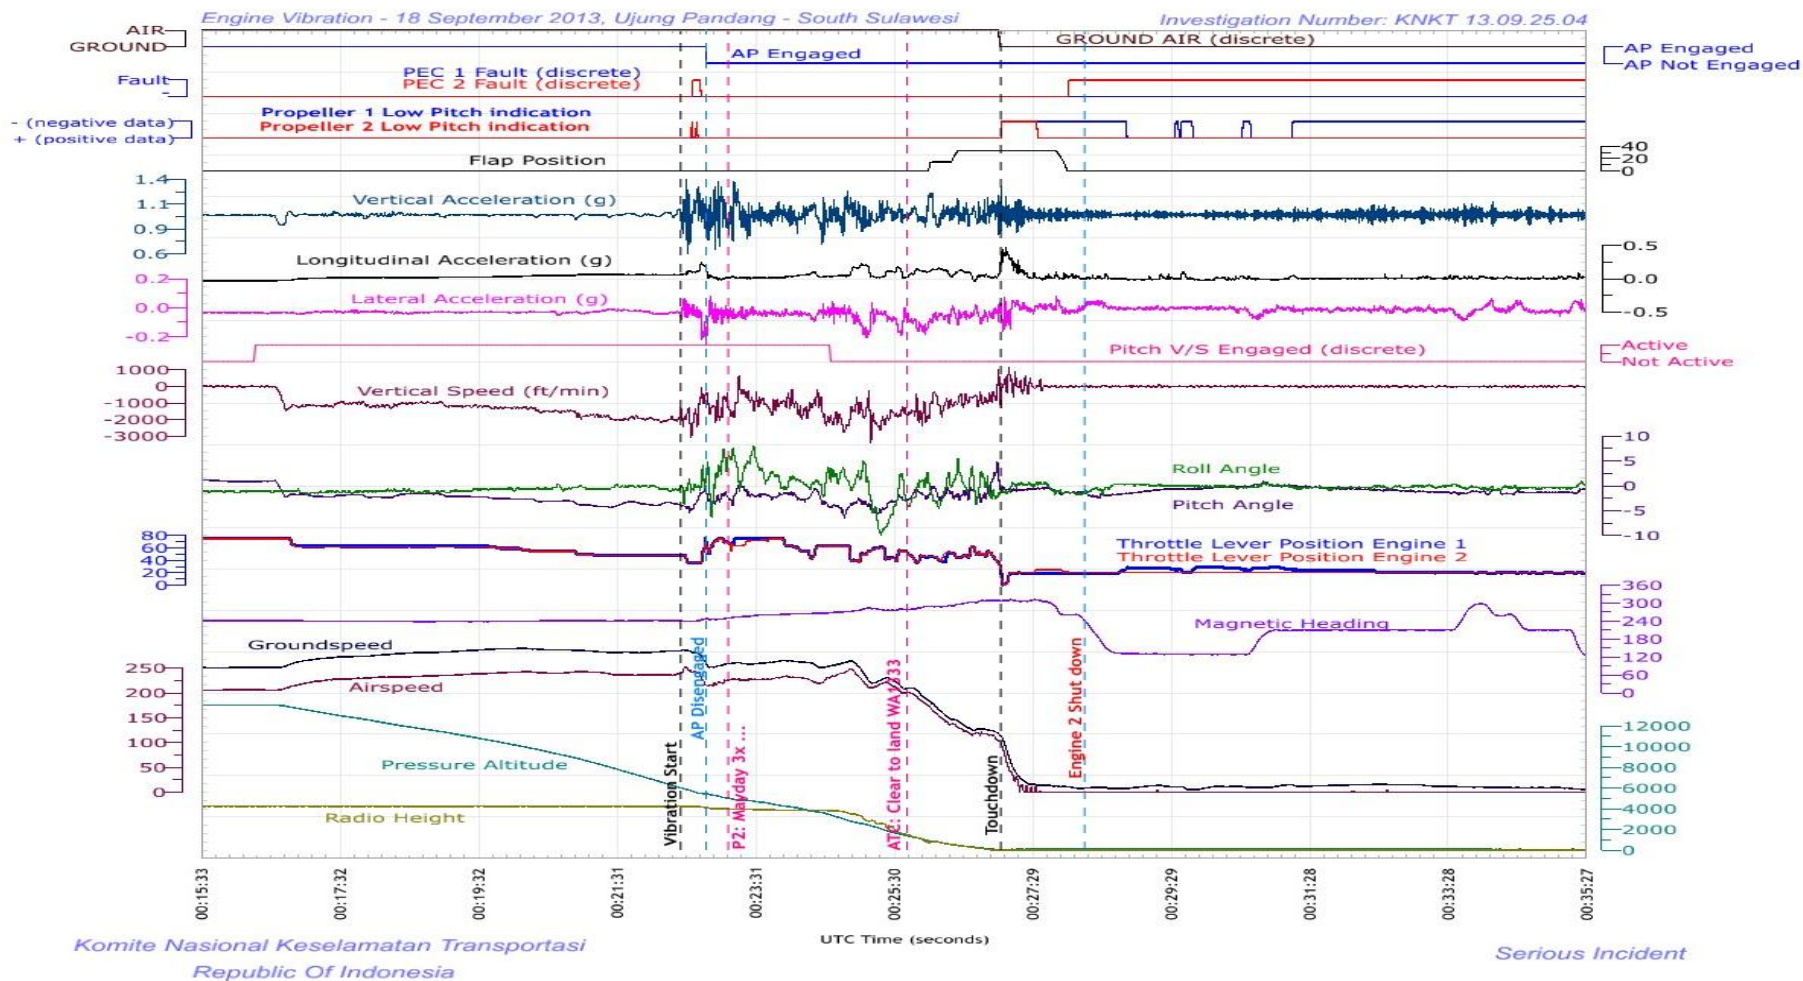
Figure 17: The FDR data started from the aircraft on descent from 12,000 feet until aircraft stop.

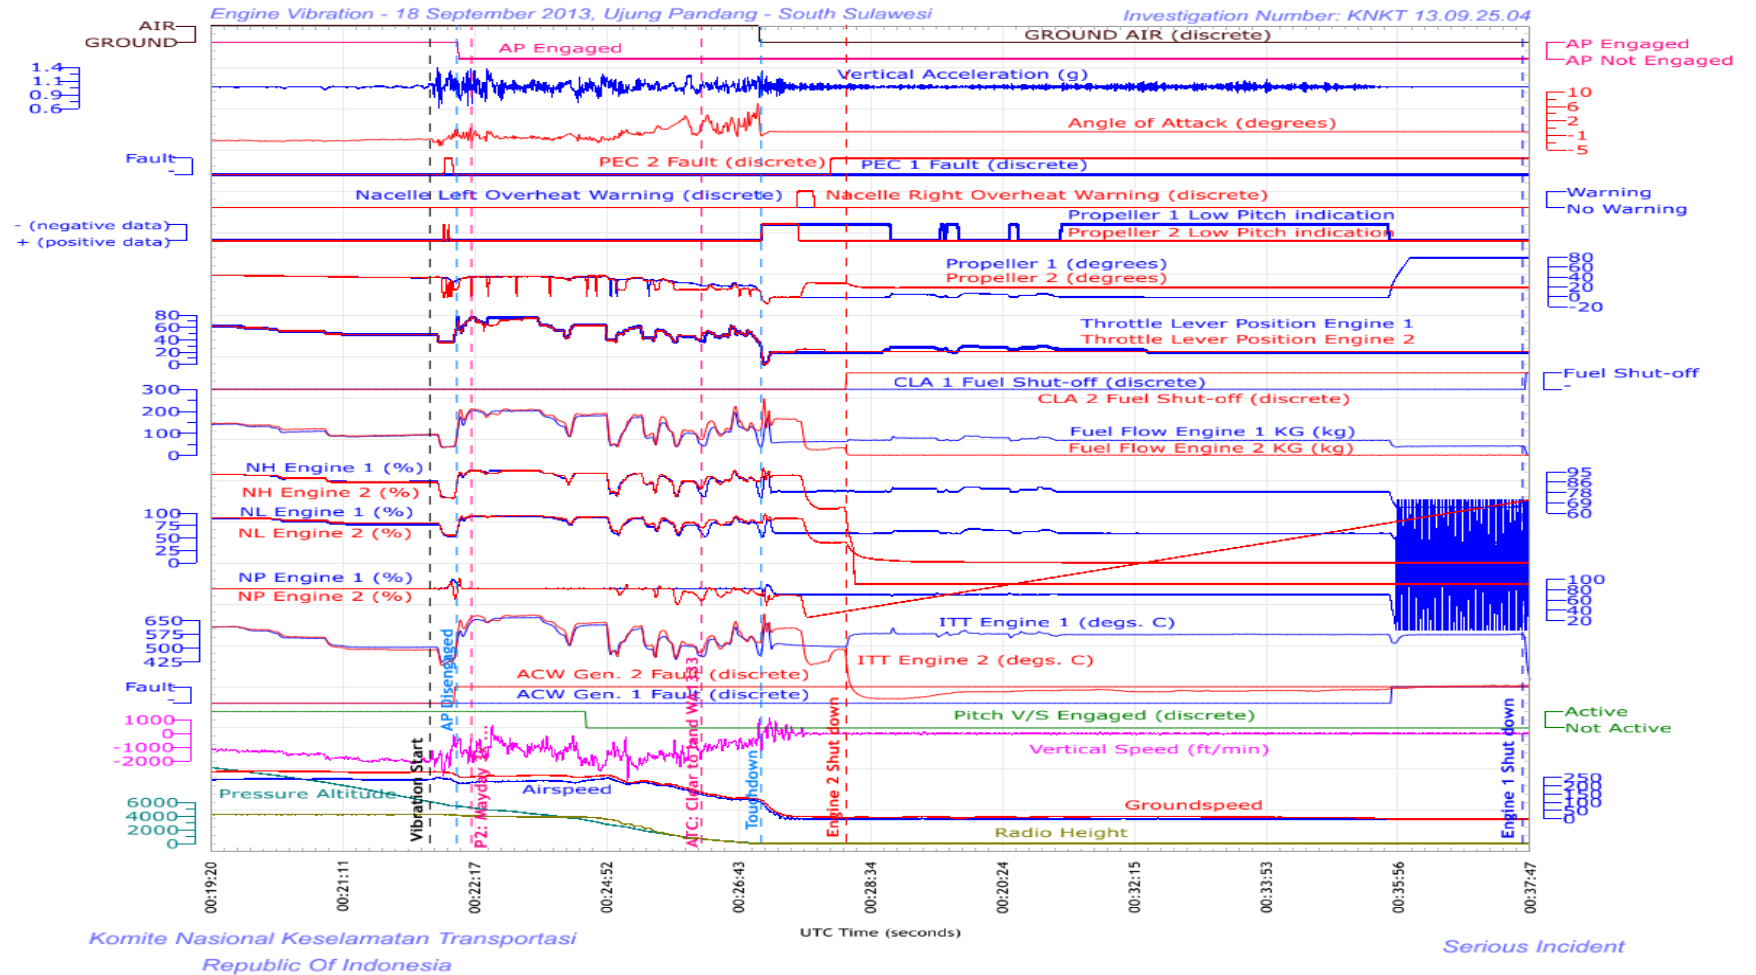
Figure 18: The FDR data during the event of the vibration

Since the vibration started until the aircraft touched down, the propeller blade angle started to increase from 38° to 40°. The moving spike to zero of the right propeller blade angle is the expected response for a failure of the blade angle measurement system.

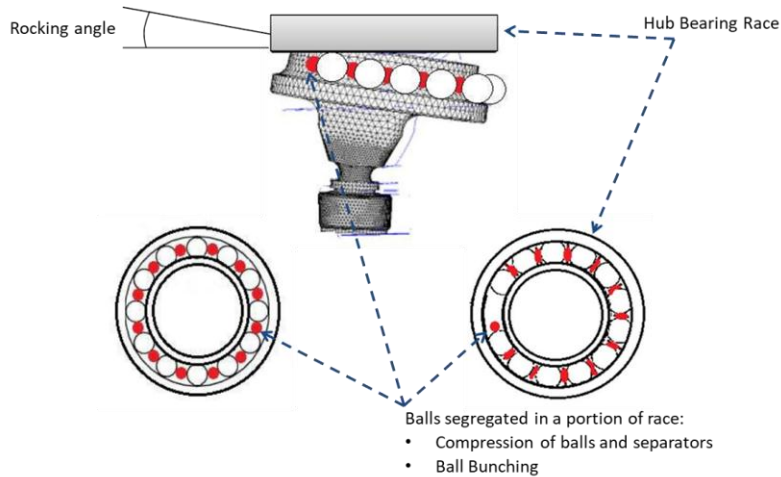
- *Once discovered, issues could be recreated / duplicated*
- *Analytical work developed a kinematic theory*
 - *Labeled “Ball Bunching”*
- *Increased friction issue had not been observed on any other propeller applications (including the 568F)*

Figure 30: Ball bunching effect
