FINAL
KNKT.13.11.29.04

Runway Incursion Investigation Report

**Indonesia Air Asia and Batik Air
Airbus A 320 (PK-AXG) and
Boeing B 737-900ER (PK-LBH)
Adisutjipto International Airport, Yogyakarta
Republic of Indonesia
20 November 2013**

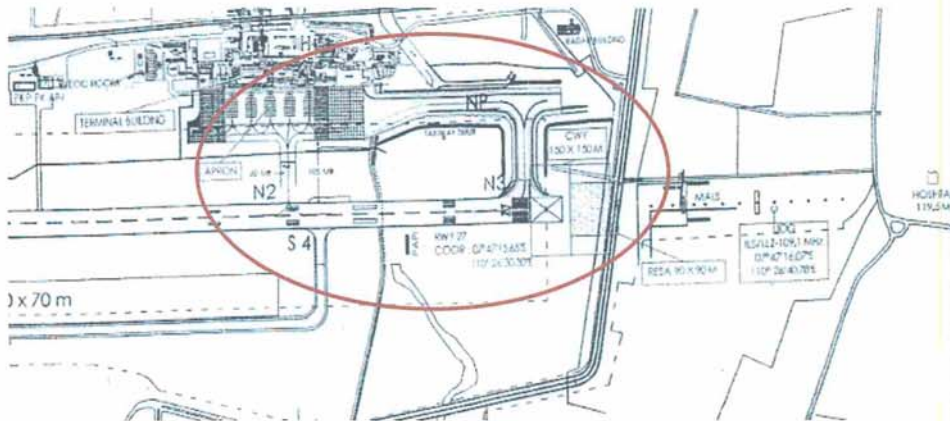
**DATA TAXIWAY N3 DAN NORTH PARALLEL (NP)
 DI BANDARA ADISUTJIPTO YOGYAKARTA**

Berdasarkan Draft Aircraft Runway Incursion Investigation Report Nomor KNKT.13.11.29.04 point " *Observation on the Adisutjipto International Airport Information* " disampaikan bahwa data yang diterima dari Local Airport sudah termasuk gambar taxiway N2, NP dan N3 sebagai berikut :
