FINAL
KNKT.13.04.09.04

Aircraft Accident Investigation Report

**PT. Lion Mentari Airlines (Lion Air)
Boeing 737 - 800; PK-LKS
Ngurah Rai International Airport, Bali
Republic of Indonesia
13 April 2013**

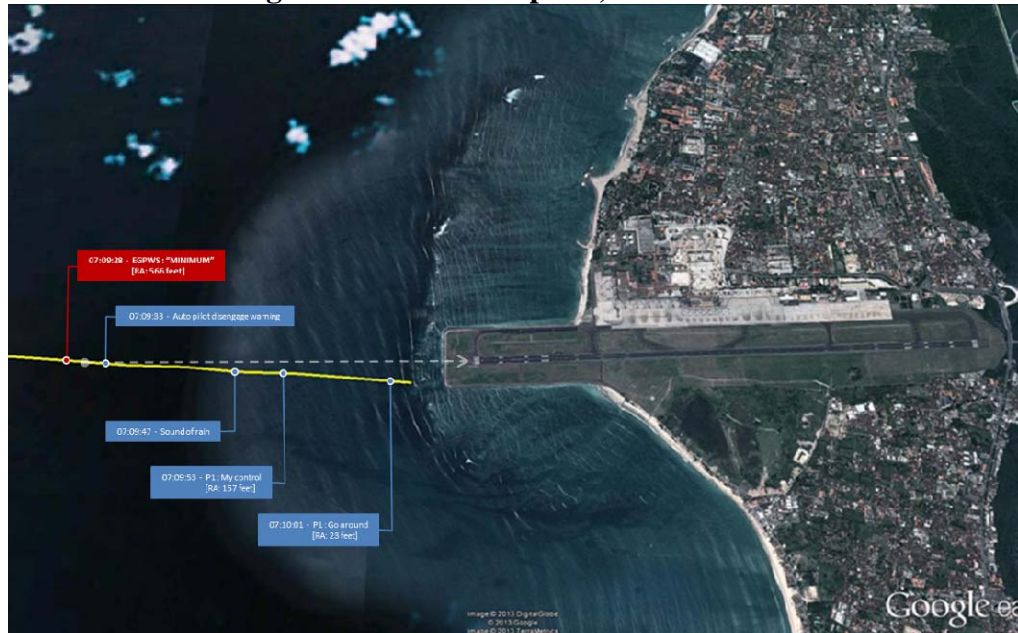
Figure 13: Aircraft flight path superimposed to Google Earth

From figure 13 it was indicated that the flight from minimum descent altitude (MDA) still following the VOR approach lateral configuration (091°), rather than lining up to the runway lateral orientation (087°).

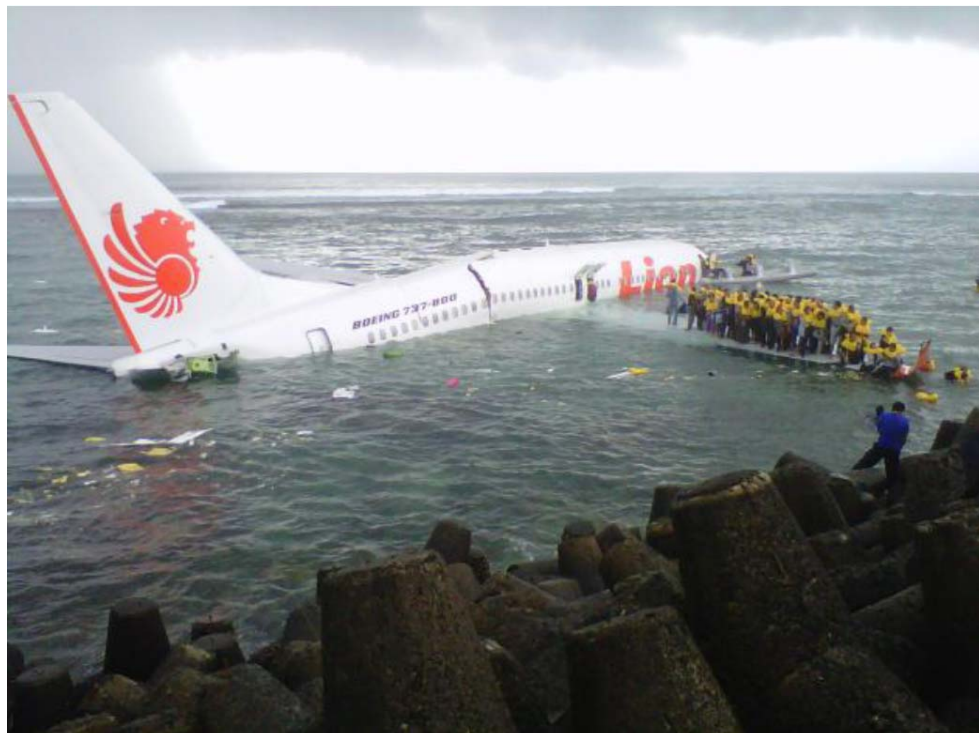
Figure 17: The evacuation process

At 0713 UTC, the rescue team departed from the ARFF station and arrived at 0715 UTC. The ARFF deployed 4 foam tender units, 1 ambulance and 2 rescue tender units. After the fire brigade arrived at the crash site, the airport was reopened allowing several aircraft which were holding to depart and land. Subsequently at 0750 UTC, the airport operation was closed until 0850 UTC to provide access of the evacuation process of the passengers to the terminal.

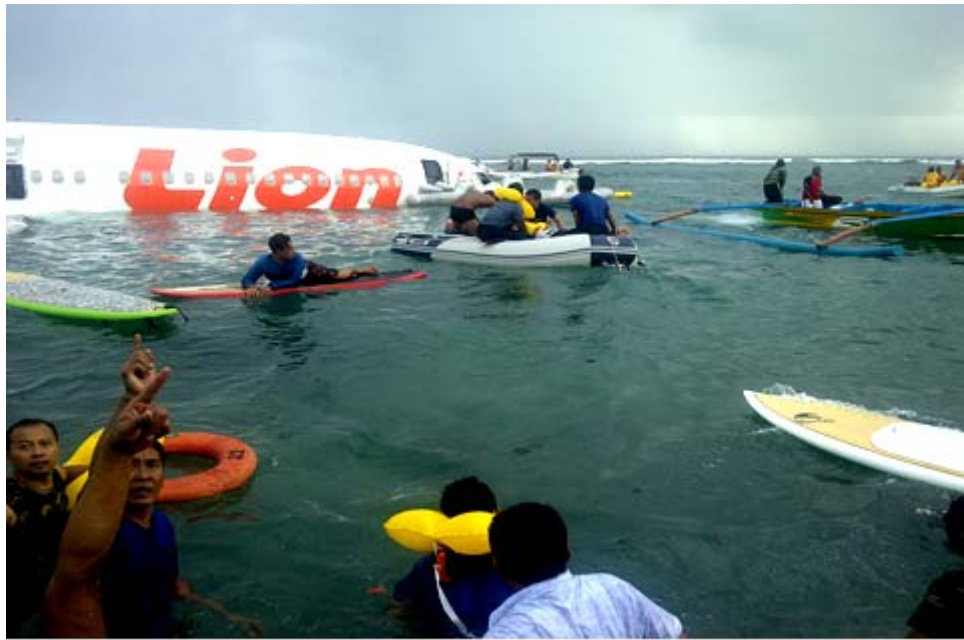
Figure 18: The situation during evacuation process

At 0717 UTC, the local armed forces, police, SAR agency and local people supported the evacuation operation.
