**FINAL**  
KNKT.13.05.13.04

**Aircraft Accident Investigation Report**

**PT. Nusantara Buana Air  
Casa 212-200; PK - TLG  
Sultan Babullah Airport; Ternate  
Republic of Indonesia  
10 May 2013**

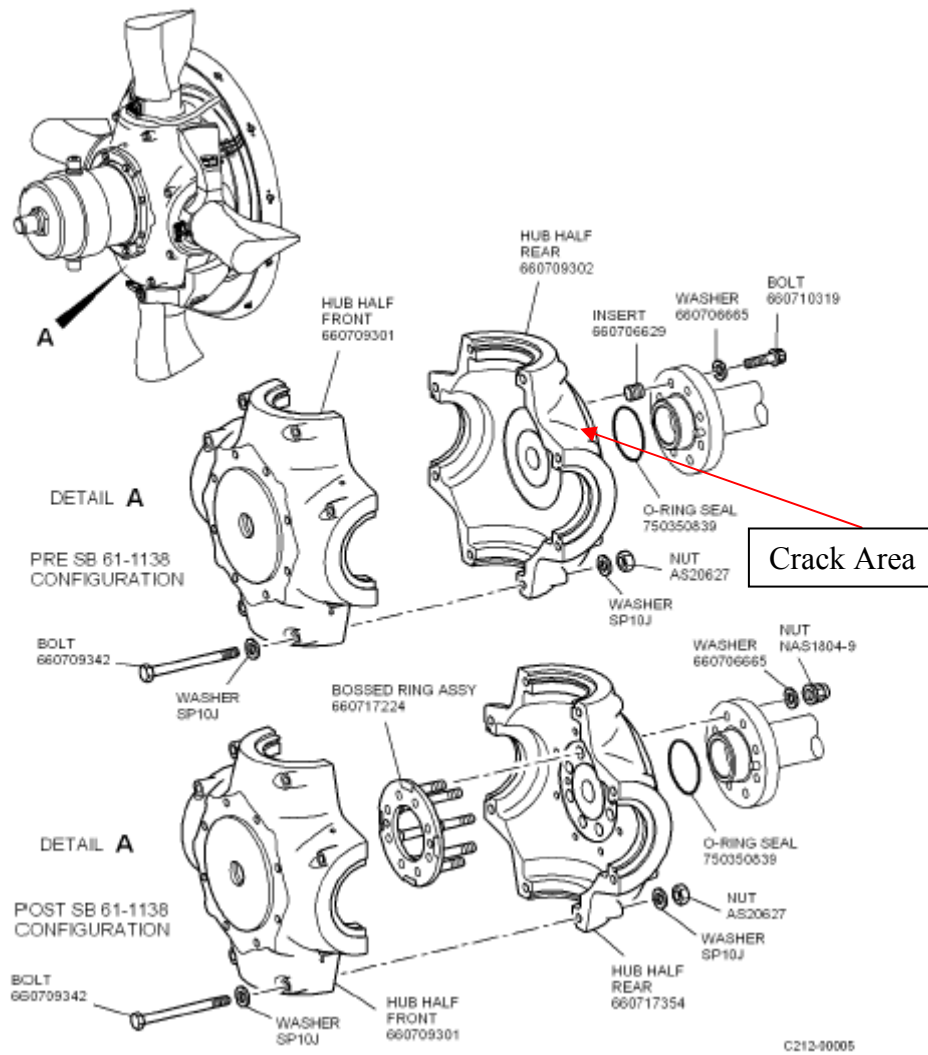
**Figure 10: Detail of propeller assembly**

Further examination of the left rear propeller hub half was found crack about 70%.
