FINAL
KNKT.14.12.29.04

Aircraft Accident Investigation Report

**PT. Indonesia Air Asia
Airbus A320-216; PK-AXC
Karimata Strait
Coordinate 3°37'19"S - 109°42'41"E
Republic of Indonesia
28 December 2014**

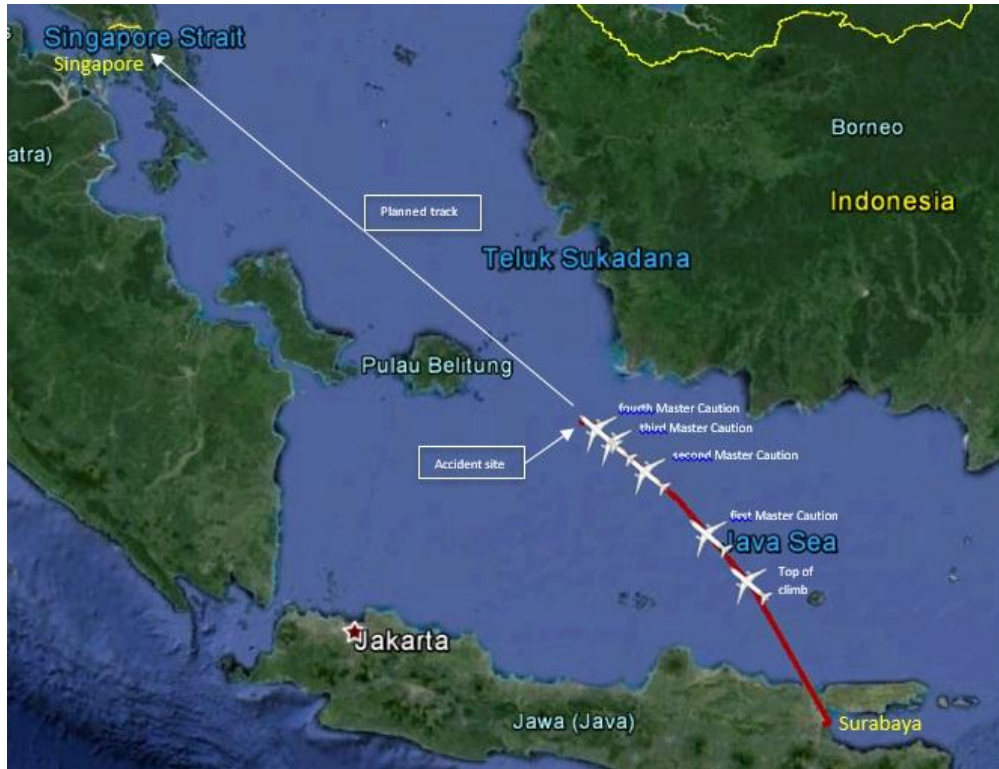
Figure 2: The aircraft flight track

At approximately 29,000 feet the aircraft attitude was wings level with pitch and roll angles of approximately zero with the airspeed varied between 100 and 160 knots. The Angle of Attack (AOA)⁵ was almost constant at approximately 40° up and the stall warning continued until the end of recording. The aircraft then lost altitude with an average rate of 12,000 feet per minute until the end of the recording.

At 2318 UTC, the aircraft disappeared from the Jakarta Radar controller screen. The aircraft last position according to the Automatic Dependent Surveillance-Broadcasting (ADS-B) radar was on coordinate 3°36'48.36"S - 109°41'50.47"E and the aircraft altitude was approximately 24,000 feet.

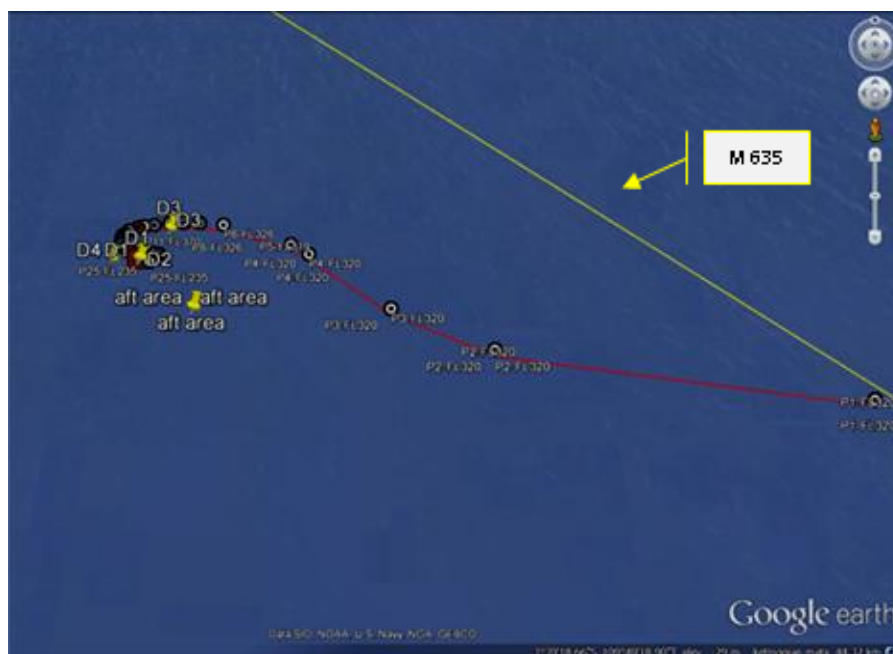
Figure 17: Automatic Dependent Surveillance – Broadcast (ADS-B) data superimposed to Google earth

Based on the Automatic Dependent Surveillance-Broadcast (ADS-B) data from the Air Traffic Control data superimposed to Google earth showed that the aircraft deviated to the left from the airway M635.

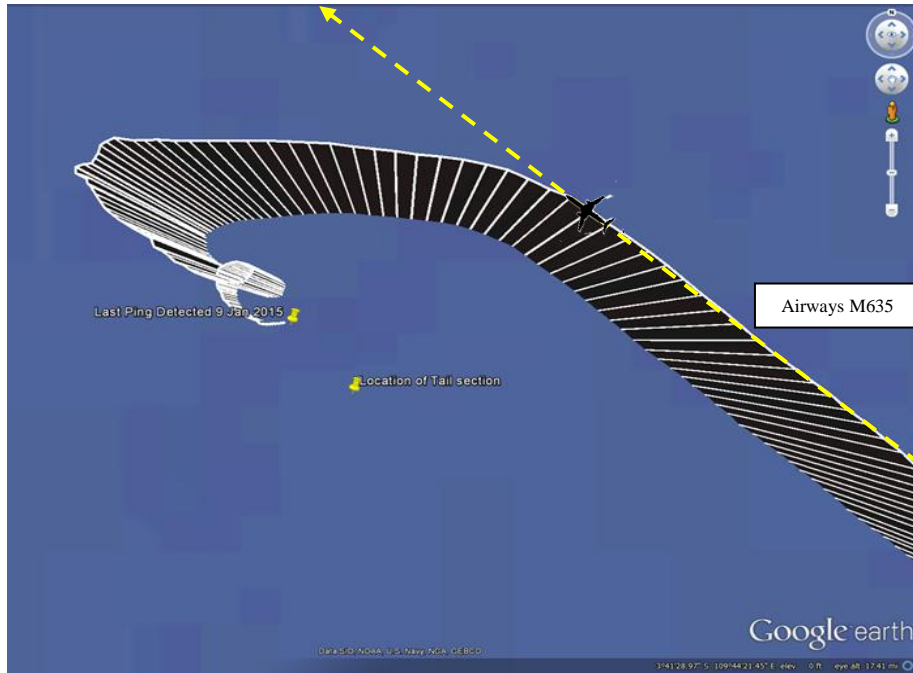
Figure 19: Flight path based on FDR data superimposed to the Google Earth

The FDR data showed that while the aircraft was cruising at an altitude of 32,000 feet in normal condition, the aircraft then deviated to the left from airway M635. The master caution triggered by both RTLU problems activated 4 times. The fifth master caution was related to the FAC 1 FAULT activating. The sixth master caution was triggered by the FAC 1+2 FAULT and followed by the autopilot and auto-thrust disengaged and flight control law reverted from Normal Law to Alternate Law.

Subsequently the aircraft entered a steep turn and climb, eventually reaching high angle of attack, the stall warning activated and continued until the end of the recording. The FDR and CVR recording ended at 2320:35 UTC.

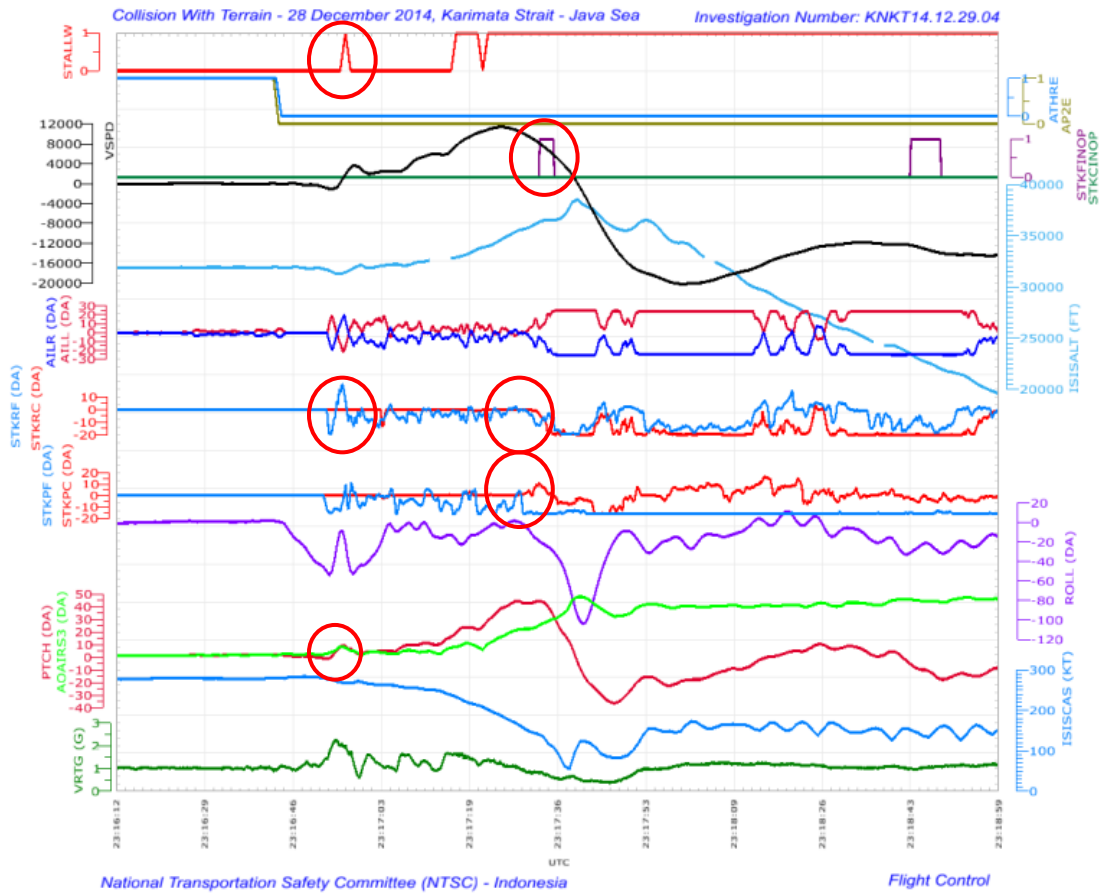
Figure 22: Pilots inputs on side stick

- o Flight control law reverted from Normal Law to Alternate Law
 - o Rudder deflected 2° and aileron deflection 0°.
- The aircraft started to roll.
- At 2316:54 UTC the FAC 2 was back to ON and all fluctuating parameters stopped. The autopilot and auto thrust remained disengaged. Flight control law remained in Alternate Law.

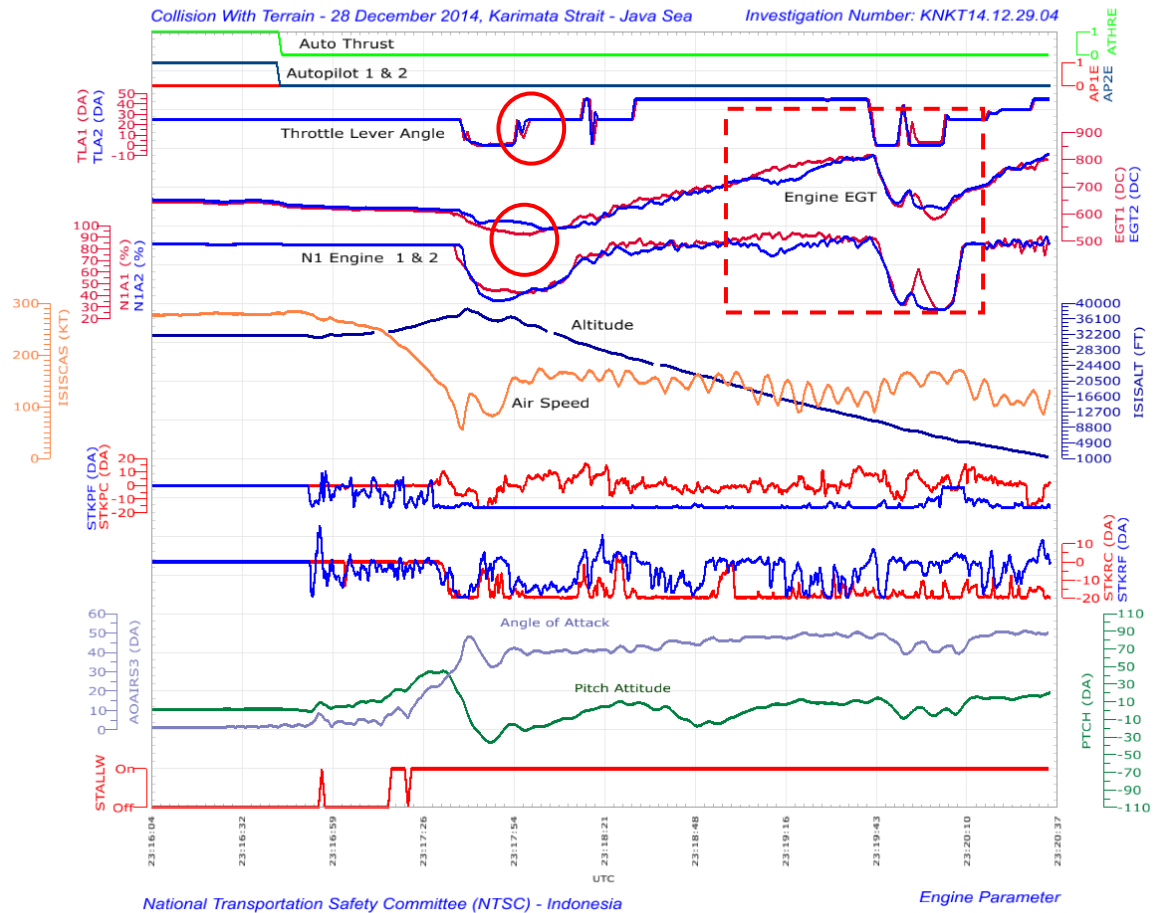
Figure 23: Thrust levers and side-sticks movement

- At 2317:41 UTC the aircraft reached the highest altitude of 38,500 feet (ISIS) and largest roll angle at 104° to the left. The aircraft then descended with a rate up to 20,000 feet per minute momentarily afterward the rate of descent was recorded at average of 12,000 feet per minute until the end of recording.

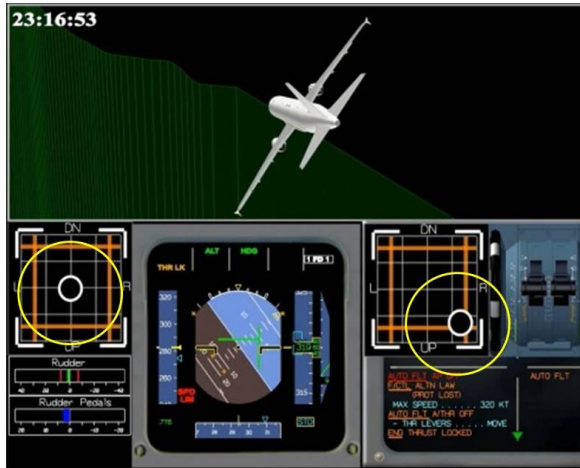
Figure 25: Aircraft rolled 54° to the left

Speed (knots)	277 (ISIS)	282 (CAS)
Alt (feet)	31952	
Rudder	2°	
Roll	54°	
Pitch	-1.1°	
AOA	3.5°	
VS(fpm)	-1088	
N1	83%	
EGT	622 °C	
Sidesticks	PIC P: 0° R: 0°	SIC P: -15° R: +19

Time (UTC)	From	To	Description
23:16:43	Warning		Auto pilot disengaged followed by cavalry charge (autopilot disengaged warning)
23:16:53	P1		“Oh my God”
23:16:54			The FAC 2 was re-energized
23:16:56	Warning		Stall warning activated for 1 second

Comment Reference	Reference chapter, page, paragraph	Commented extract	Reason for proposed change	Proposed amendment	Remarks
	4 th paragraph				
50	Selected significant events based on CVR and FDR (1.11.4), page 42, Figure 25 and associated table	Sidesticks: SIC: - P: -15° - R: 0°	The value given for the roll sidestick input by the SIC does not correspond to the one seen on Figure 25.	Sidesticks: SIC: - P: -15° - R: (+/-)19°	Accepted
51	Selected significant events based on CVR and FDR (1.11.4), page 42, table between Figure 25 and Figure 26	23:16:45 UTC: Warning: Auto pilot disengaged followed by cavalry charge (autopilot disengaged warning).	The autopilot disengagement occurred at 2316:43 UTC.	23:16:43 UTC: Warning: Auto pilot disengaged followed by cavalry charge (autopilot disengaged warning).	Accepted
52	Selected significant events based on CVR and FDR (1.11.4), page 42, table between Figure 25 and Figure 26	23:16:53 UTC: P2: "Oh my God".	The CVR spectral analysis performed at the BEA shows that it is the PIC (P1) who said "Oh my God" at that time.	23:16:53 UTC: P1: "Oh my God".	Accepted

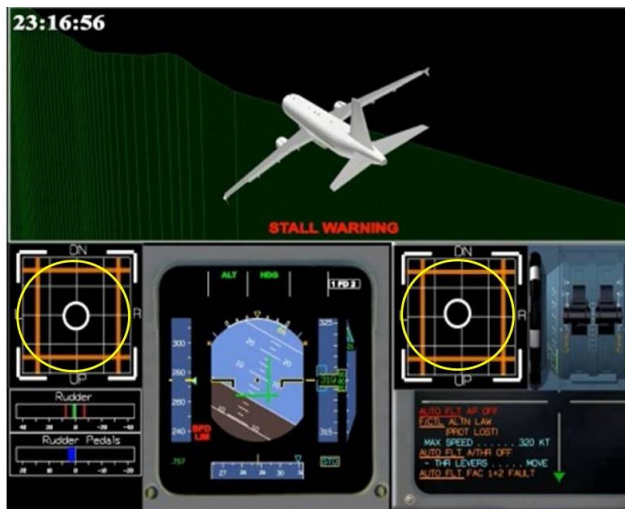
Figure 26: The first aural Stall warning activated

Speed (Knots)	268 (ISIS)	272 (CAS)
Altitude (Feet)	31980 (ISIS)	33900 (GPS)
Rudder	2°	
Roll	19.7°	
Pitch	9.5°	
AOA	8°	
VS (fpm)	2624	
N1	83%	
EGT	621 °C	
Side-sticks	PIC P: 0° R: 0°	SIC P: 7° R: +10°

Time (UTC)	From	To	Description
2317:02	P1		Gave instruction “level...level...level...” (4 times)
2317:15	P1		Gave instruction “pull down...pull down” (2 times)

2317:17	Warning		Aural stall warning announced with cricket sound. Change of external airflow sound.
2317:22	P1	P2	Gave instruction “pull down...pull down” (3 times)

53	Selected significant events based on CVR and FDR (1.11.4), page 42, table between Figure 25 and Figure 26	23:16:54 UTC: The FAC 2 back ON.	This statement is ambiguous and the reader could understand that FAC 2 push-button has been set to ON. Actually, at 2316:54 UTC, it is the FAC 2 Fail parameter that is set to 0, after the FAC 2 C/Bs being pushed. But FAC 2 push-button was not set to ON.	23:16:54 UTC: the FAC 2 was re-energized meaning that the FAC2 28VDC CB was reengaged. However because the FAC2 pushbutton on overhead panel was not put to OFF then ON, the FAC2 functions remained unavailable.	Accepted with rewording
54	Selected significant events based on CVR and FDR (1.11.4), page 42, table between Figure 25 and Figure 26	23:16:55 UTC: Warning: Stall warning activated for 1 second.	The first Stall warning occurred at 2316:56 UTC.	23:16:56 UTC: Warning: Stall warning activated for 1 second.	Accepted

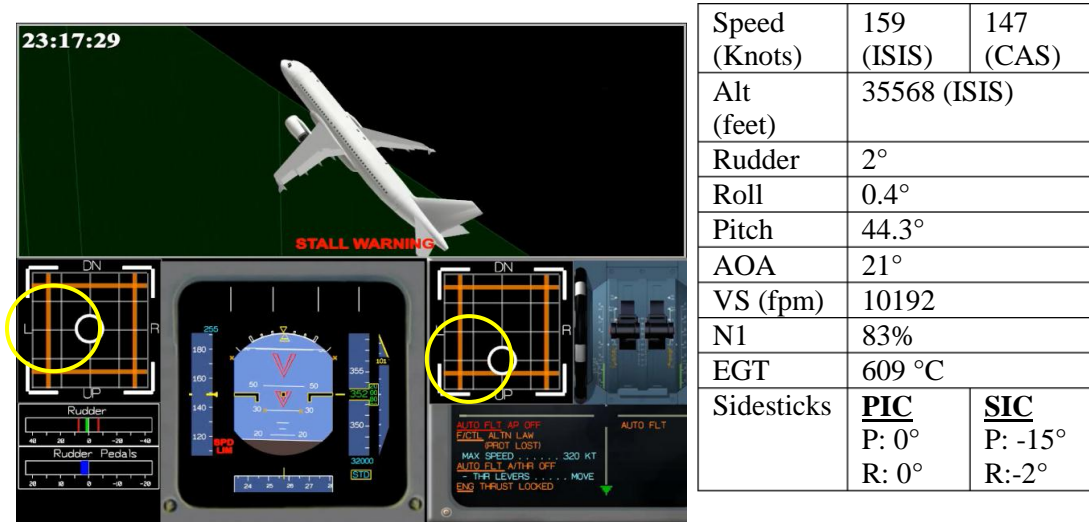
Figure 27: The aircraft attitude at the highest pitch angle

Time (UTC)	From	To	Description
2317:23	Warning		Aural stall warning activated with cricket sound and a sound similar to aircraft buffet continued until the end of recording.
2317:25	P1		Gave instruction “pull down...pull down”
2317:29	P2		<i>in French:</i> “What is going wrong”
			The left side stick input continued until the end of recording. Dual input on the side sticks continued until the end of recording.

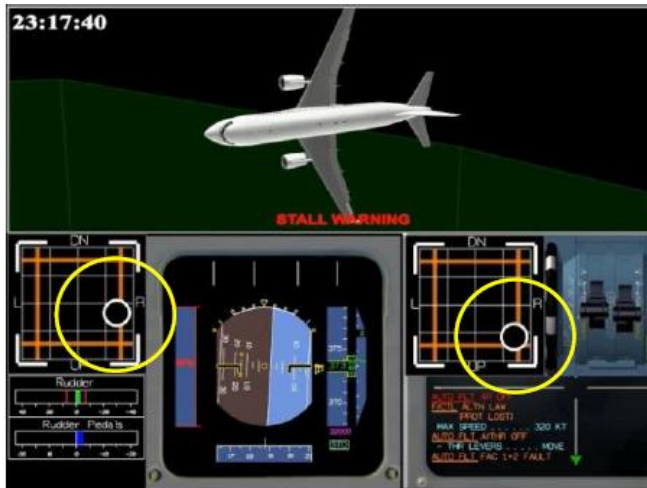
Figure 28: Aircraft in upset¹³situation

Speed (knots)	118 (ISIS)	0 (CAS)
Alt (Feet)	37796 (ISIS)	
Rudder	-5°	
Roll	-104 °	
Pitch	-20.7°	
AOA	46°	
VS (fpm)	-4784	
N1	52%	
EGT	563 °C	
Sidesticks	PIC P: -4° R: -20°	SIC P: -16° R: -17°

Time (UTC)	From	To	Description
2317:41	P1		“My God.”

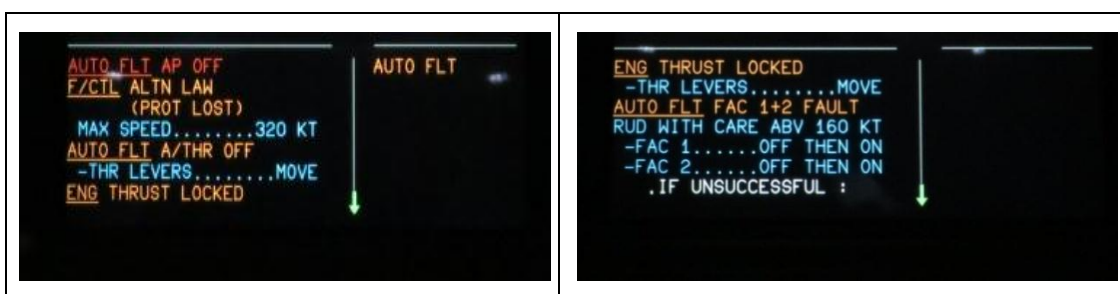
Figure 33: The page 1 and 2 of the ECAM messages after CBs of FAC 1 and 2 being reset

61	Flight Simulation 1 (1.16.1), page 50, Figure 33	Figure 33: Display of the ECAM message during RTLU 1+2 malfunction	The ECAM message displayed on Figure 33 contains FAC 1 FAULT that does not correspond to RTLU 1+2 malfunction.	The BEA suggests replacing the ECAM message displayed on Figure 33 with the one corresponding to RTLU 1+2 malfunction only (cf. document "Flight synopsis-phase1-withECAM" provided to KNKT during the meeting of July 2015).	Accepted
62	Flight Simulation 1 (1.16.1), page 51	Figure 36 + During stall the PFD indicated: - Flight director commanded to set pitch up (climb); - Vertical Speed Indicator indicated down; - Speed below stalling speed.	This paragraph is ambiguous and the reader could understand that the statements of these three bullets and what is seen on Figure 36 represent exactly what happened during the accident flight. The behavior of the aircraft in a situation of stall at high angle of attack is not known. Therefore the the are are not representative at all of the real aircraft in a situation of a developed stall and cannot serve as a reference in this investigation.	The BEA suggests to suppress the figure 36 and the following sentences : During stall the PFD indicated: Flight director commanded to set pitch up (climb); Vertical Speed Indicator indicated down; Speed below stalling speed.	Accepted

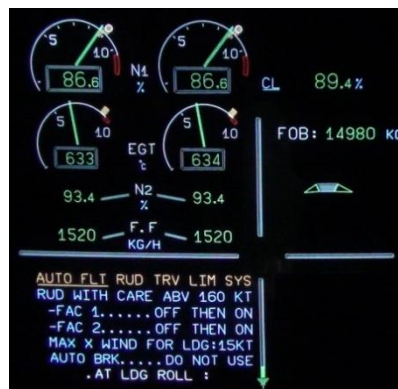
Figure 34: The ECAM messages after RTLTLU 1 and 2 fault

As requested by the KNKT, BEA and Airbus performed the simulator session which referred to FDR data on the engineering simulator. The simulation intended to recreate ECAM messages appeared on the accident flight. The ECAM message during the RUD TRIM LIM SYS problem is presented in the following figure:
