FINAL
KNKT.14.01.02.04

KOMITE NASIONAL KESELAMATAN TRANSPORTASI

Runway Incursion Investigation Report

**PT. Sriwijaya Air
Boeing 737-300; PK-CKL
Juanda International Airport Surabaya
Republic of Indonesia
27 January 2014**

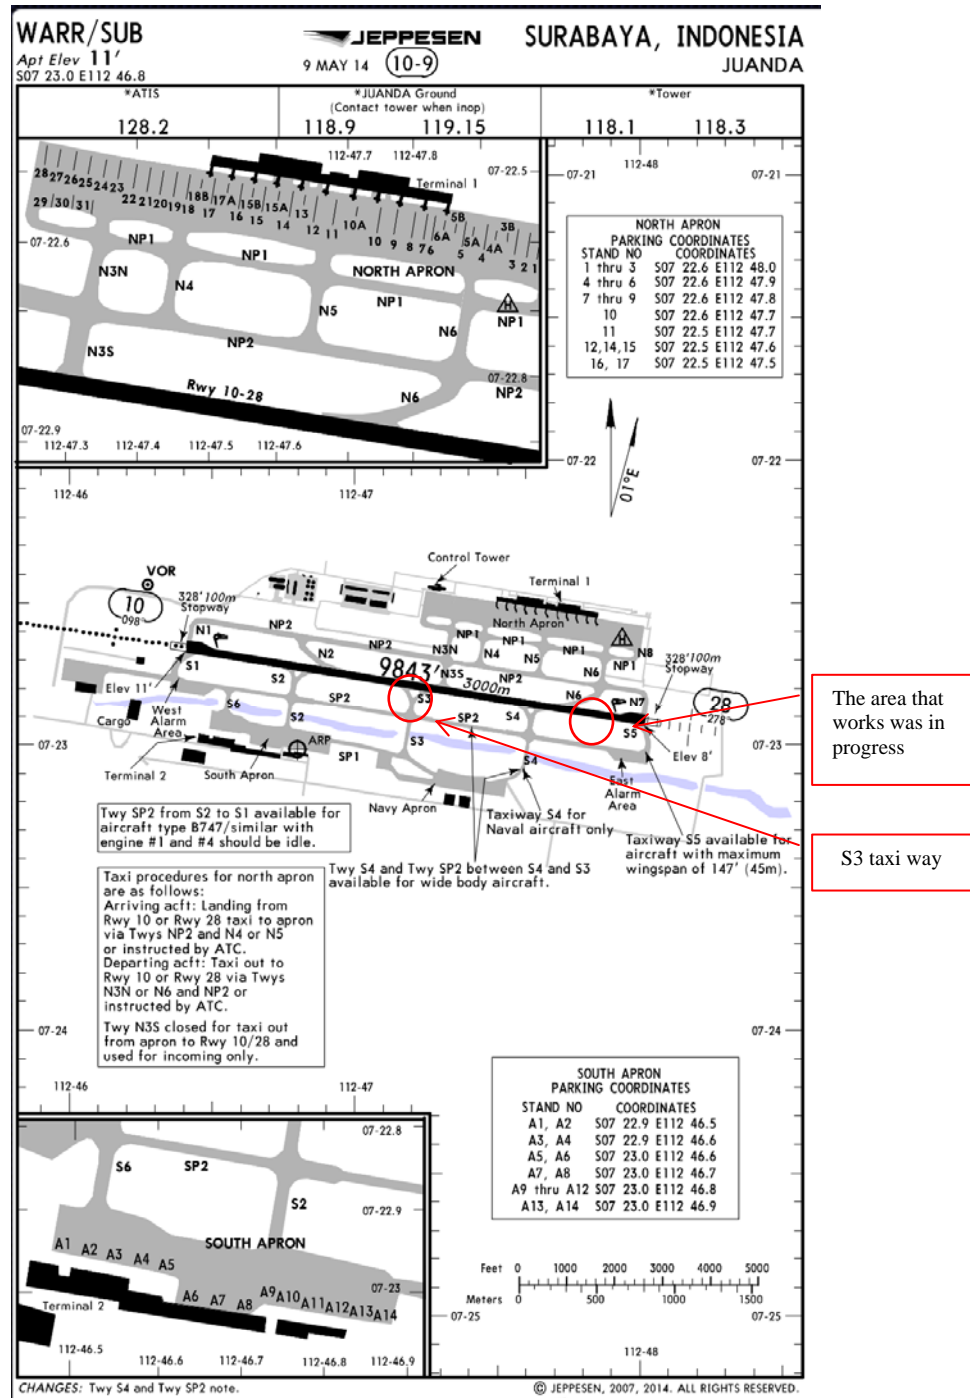
Figure 6: Aerodrome chart

The airport layout shows the runway 28-10, SP2, S3 taxiway and the area of the work in progress on SP2.

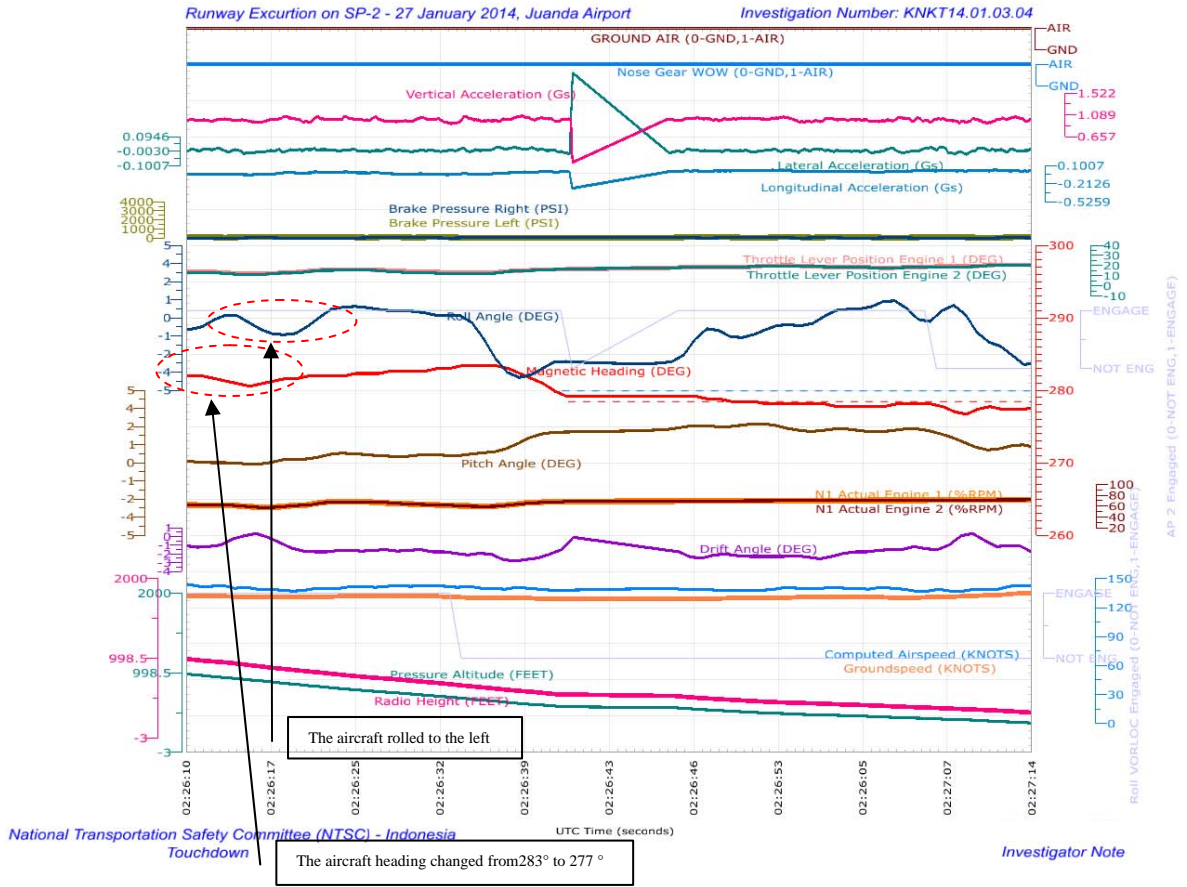
Figure 8: The FDR graph data on final approach

The investigation collected, read out and pointed all the relevant data, both from the graphic and tabular data from approximate of aircraft altitude 1,000 feet until the aircraft rolled on the surface.
