FINAL
KNKT.14.11.27.04

Aircraft Accident Investigation Report

**PT.Elang Nusantara Air (ENA)
S2R-T34 Thrush; PK- ELR
Near Manado;
North Sulawesi
Republic of Indonesia
30 November 2014**

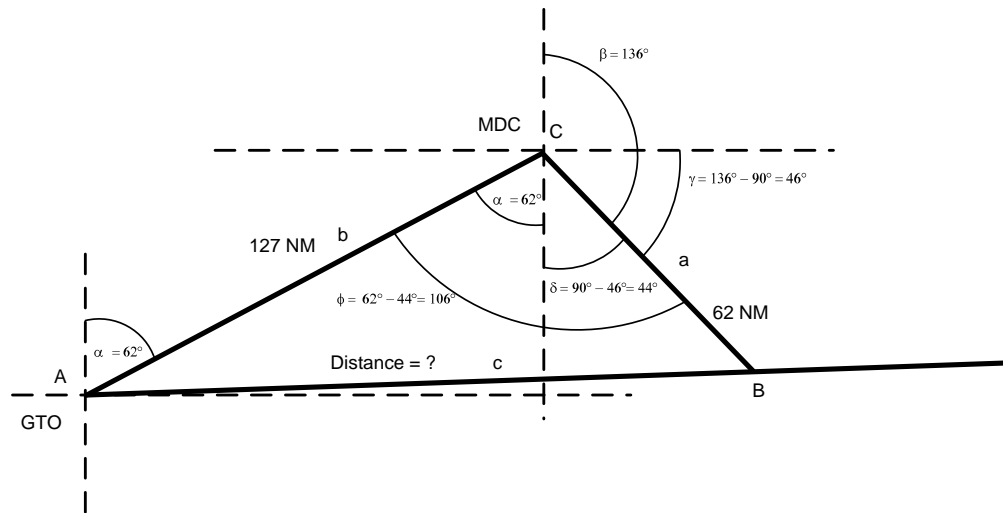
Figure 10 : Illustration for distance calculation

The pilot did not declare the reason for diversion to Sam Ratulangi Airport. The aircraft speed assumed in normal cruising speed of 126 MPH (108 Knots). The distance travelled since the airborne at 2323 UTC until the first contact to Manado Approach controller at 0138 was 243 miles.

Manado is 127 NM at 062° from Gorontalo, so $\alpha_1 = \alpha_2 = 62^\circ$
