**Aircraft Accident Investigation Report**

**PT. Cardig - Air**

**Boeing 737-300 F; Reg. PK-BBY**

**28 August 2015**

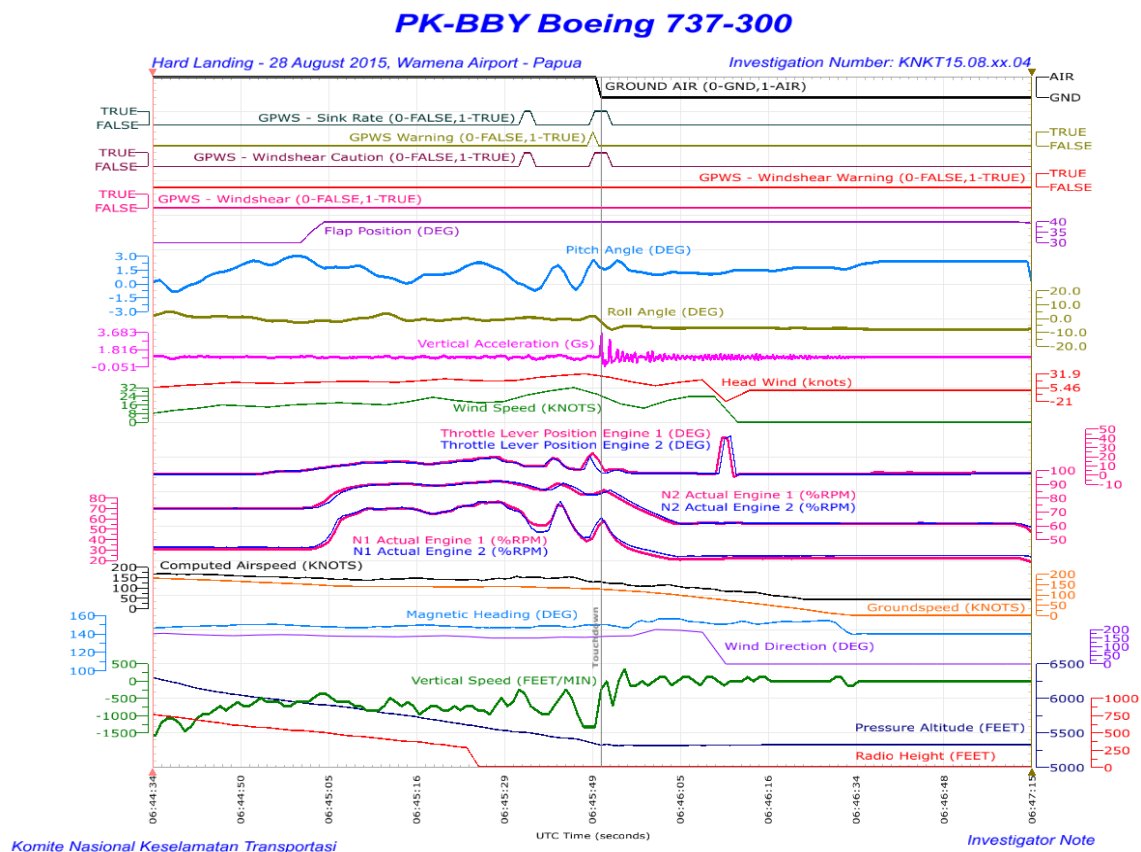
**Figure 6: The significant FDR parameters**

The aircraft was equipped with an Allied Signal Flight Data Recorder (FDR) with part number 980-4700-042 and serial number 2466. The recorder was transported to KNKT recorder facility for data downloading process. The FDR recorded 467 parameters which was containing 170 flights including the occurrence flight.

The FDR system of this aircraft was capable to record the vertical acceleration eight samples per second.

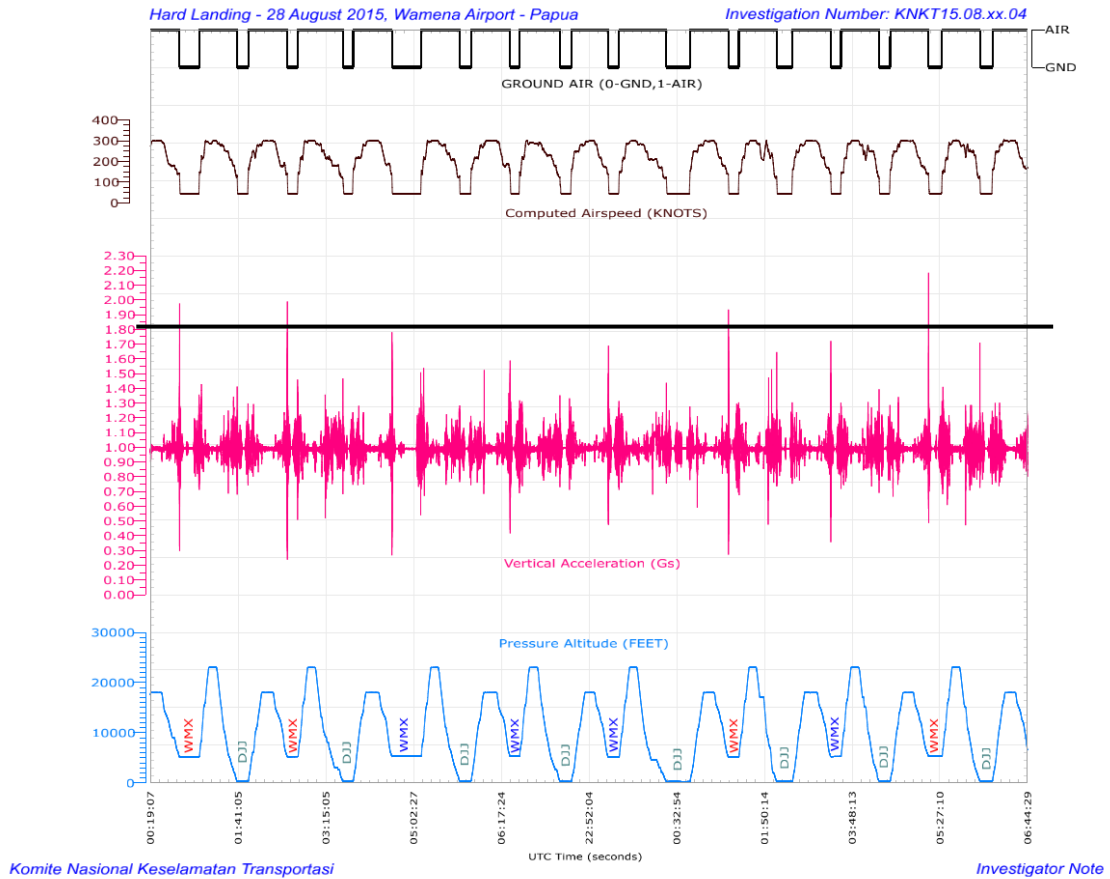
**Figure 7: The FDR data of last 6 hours 25 minutes**

The last 6 hours 25 minutes of FDR recorded 16 flight sectors including four events of the vertical acceleration exceeded 1.8 G during landing at Wamena.
