**KOMITE NASIONAL KESELAMATAN TRANSPORTASI
REPUBLIC OF INDONESIA**

Aircraft Accident Investigation Report

PT. Hevilift Aviation Indonesia

Sikorsky S-76C+; PK-FUP

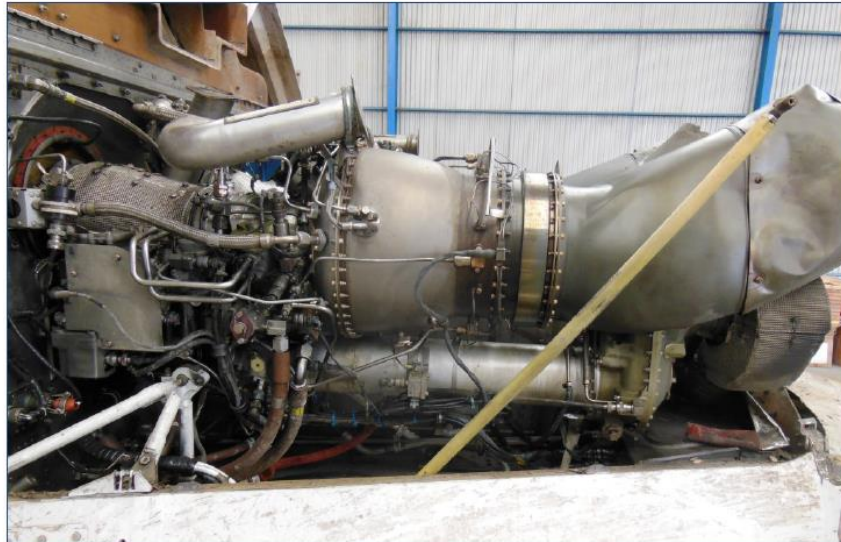
Figure 22: The whole engine as recovered.

The left engine was attached to the helicopter and appeared in good general condition.

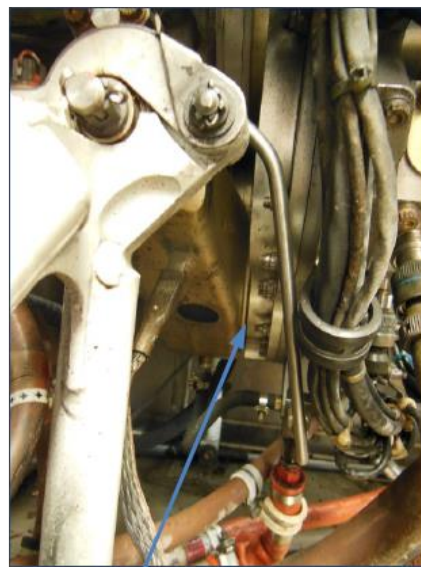
Play between support
yoke and casing

Figure 23: Play at the support yoke and casing

The accessories gearbox front casing exhibited some play with respect with the front support and five fixing screws (out of 11) were sheared and they were found on the engine bay floor along with their associated dowels thus indicating excessive lateral or vertical load at the time of impact.

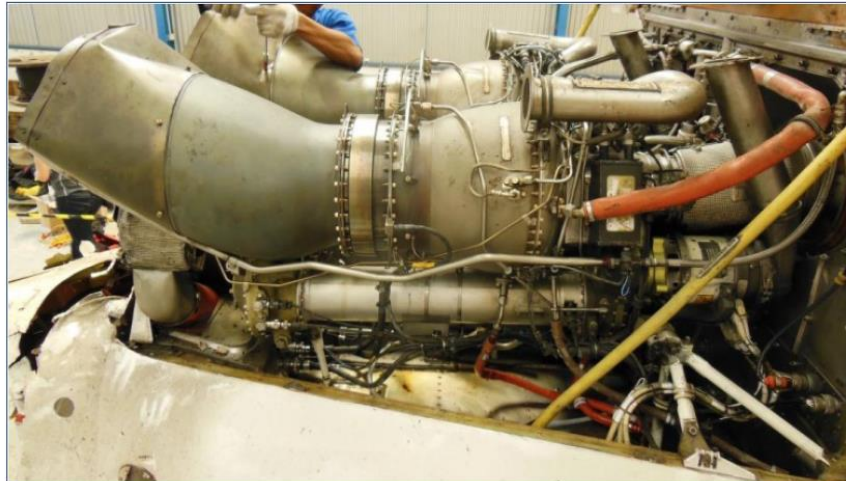
Figure 26: Right engine as recovered

The right engine was attached to the helicopter and appeared in good general condition.

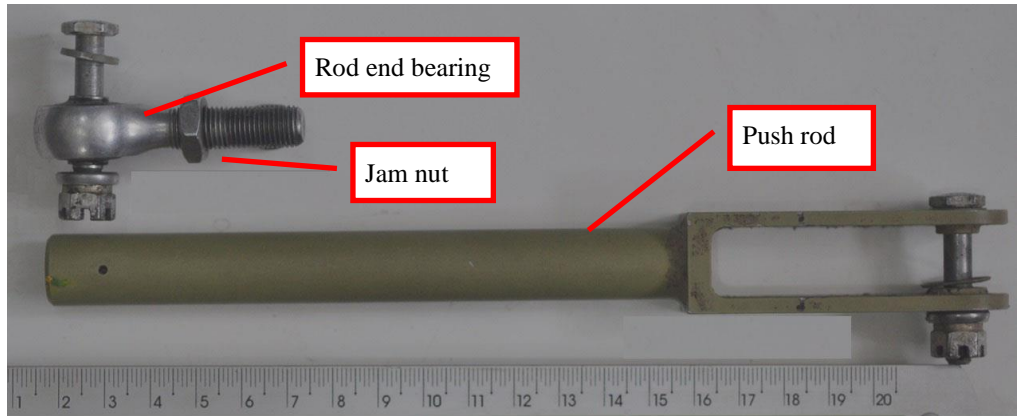
Figure 29: Push rod and rod end bearing with the jam nut

The rod end bearing connected to the push rod via threaded shank and locked by mean of jam nut. There was no locking device to secure the jam nut to prevent loosening from the push rod during the operation. The Aircraft Maintenance Manual (AMM) chapter 20 stated that the jam nut part number AN316-6R should be tightened by force of 165 inches pound for proper locking of the jam to the push rod.

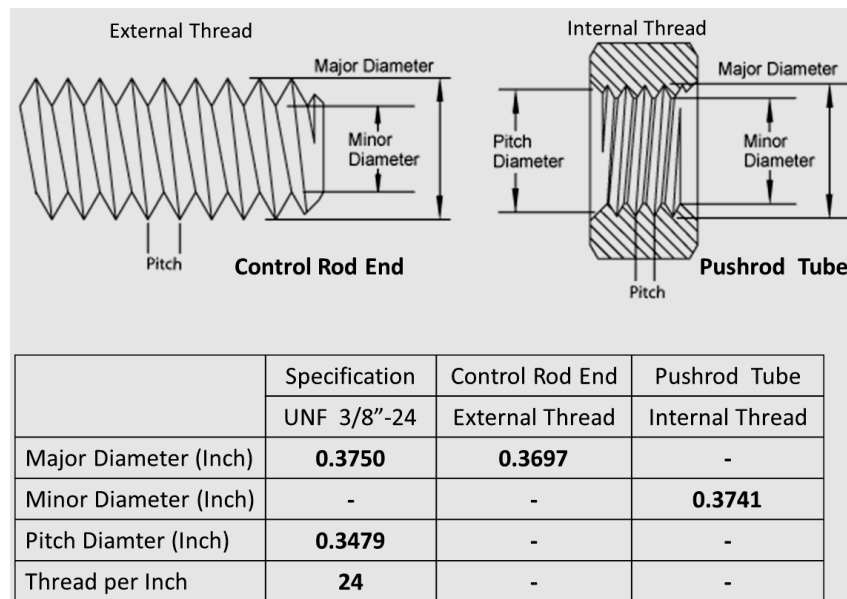
Figure 34: Pitch measurement

The major diameter of external thread on rod end bearing was 0.3697 inch that was smaller than the minor diameter of internal thread on push rod (0.3741 inch). The report stated that the major diameter of the rod end bearing below the jam nut was found 0.3718 inch. This showed that part of the rod end bearing thread that never contacted with the push rod or jam nut had bigger diameter.

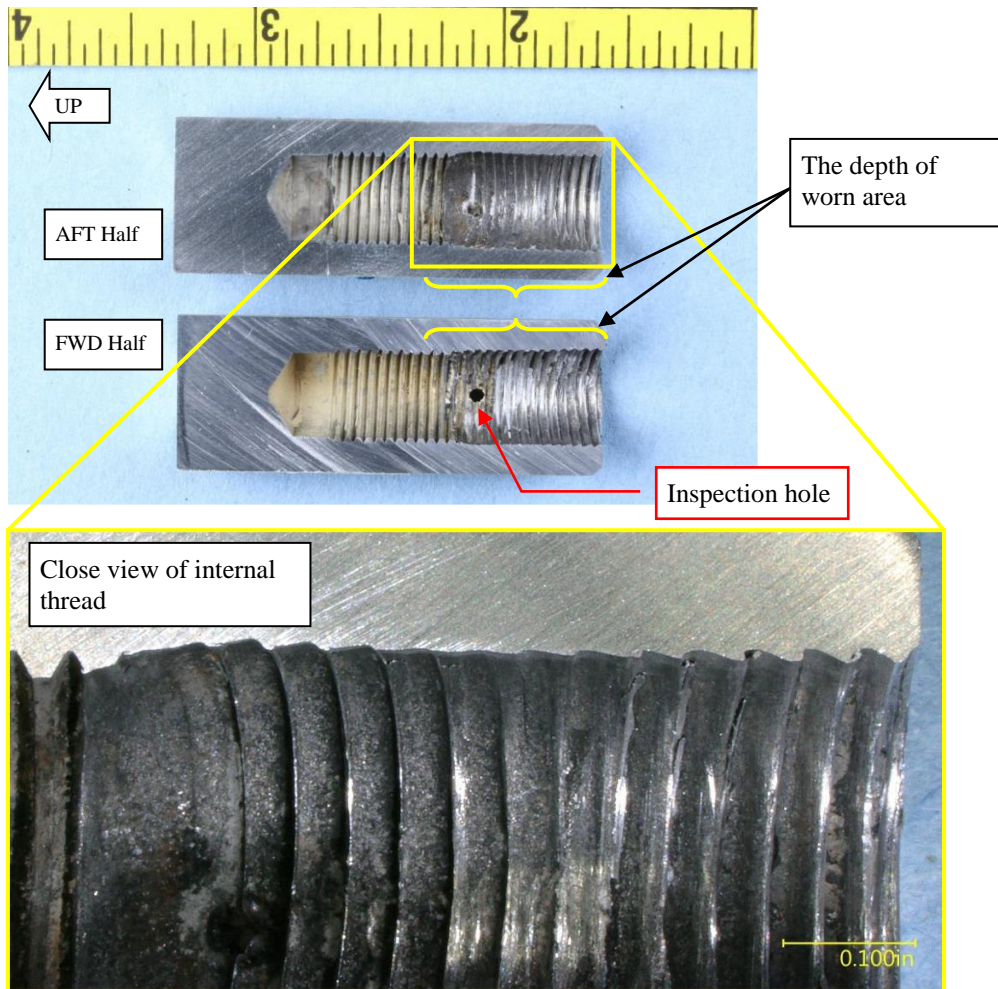
Figure 39: Close view of internal thread in the forward push rod assembly

As shown in the detail view in figure above, most of the threads were missing in the worn area. Asymmetric deformation was also observed on the edge of push rod internal thread. This finding explained the cause of detached rod end bearing from the push rod and found in separate pieces.

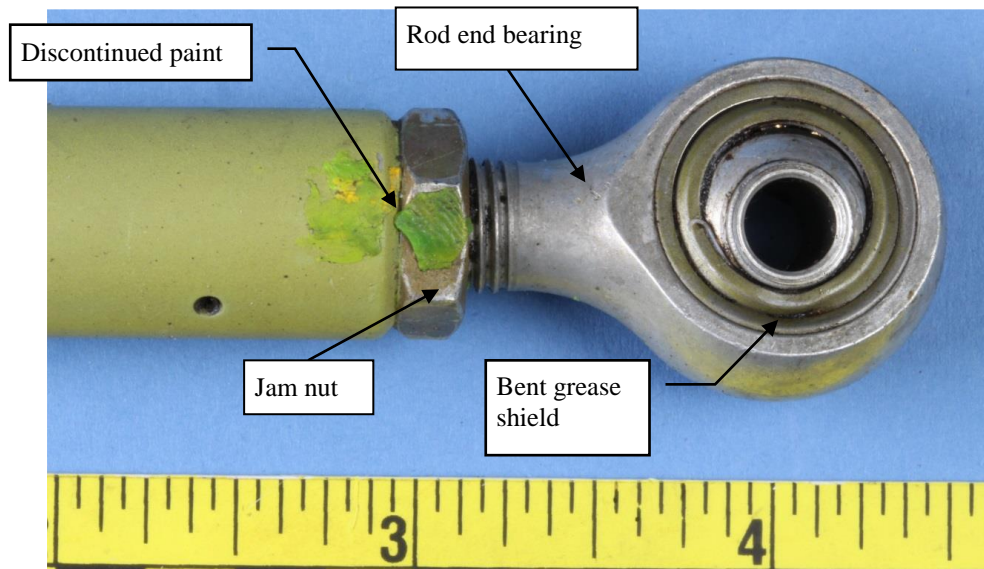
Figure 41: Rod end bearing of lateral push rod assembly

Green torque paint with underlying yellow torque paint was observed on the lower end of the lateral push rod and on the adjacent jam nut. The torque paint mark discontinued across the joint in figure above indicated there was torque change to the jam nut.

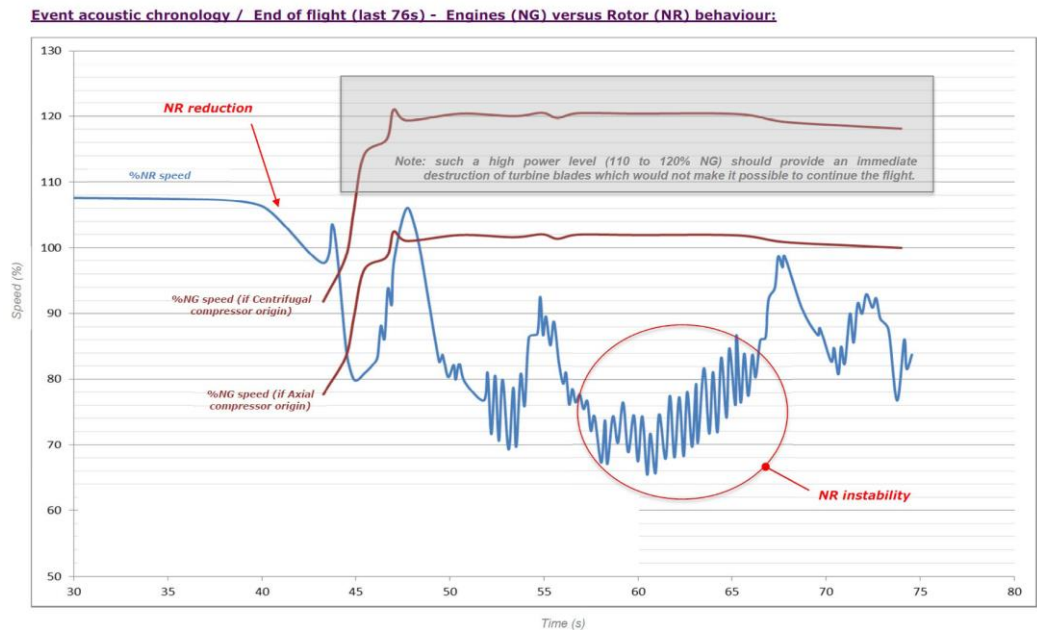
The unusual sound was recorded several seconds before the occurrence. The following figure represents the signature of the NG and NR of the last 76 seconds of the flight.

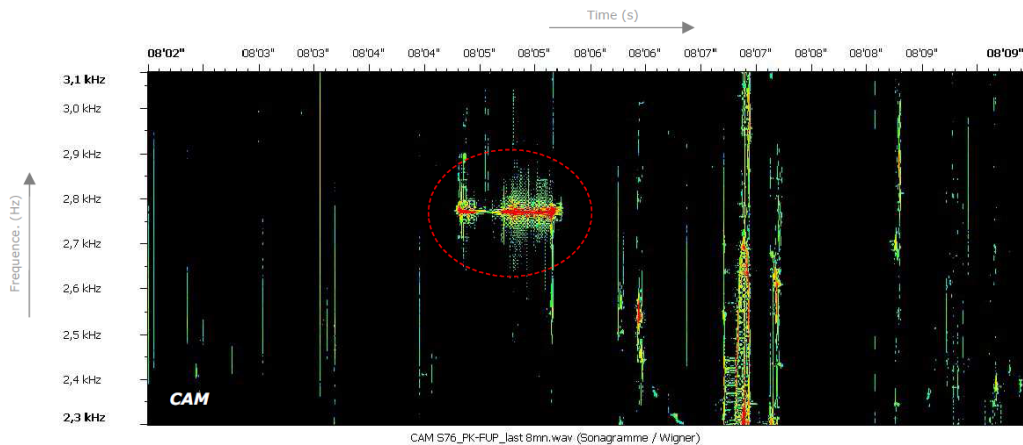
There was an audio warning which correlated with the altitude alert was recorded 32 second prior to occurrence. The spectrum of altitude alert is as follow:

One audio warning was heard 6 seconds after the start of the NR un-stability, i e at 32 seconds before the end of the CAM recording.

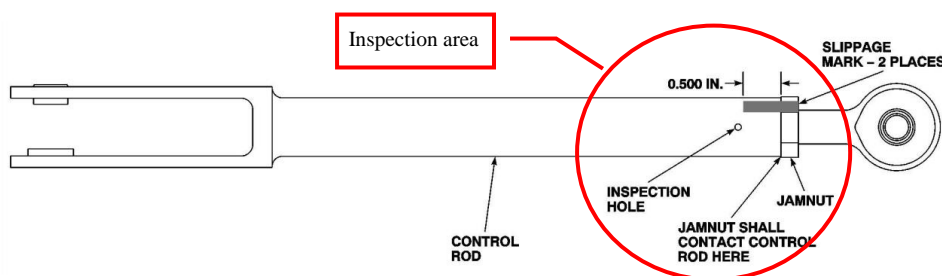
Figure 51: Illustration of push rod assembly to ensure the inspection hole is covered with the thread of rod end bearing

The ASB ordered to all Sikorsky S-76 helicopters to verify the inspection hole at the push rod using the lock wire with diameter of 0.020 inch, whether it can pass through the inspection hole at the push rod. If the lock wire passed through the inspection hole, the operator shall replace the push rod assembly. The illustrated of the inspection hole is shown in the figure below.

If lock wire does not pass through inspection hole the ASB requires the operator to inspect whether the jam nut it is seated against the control pushrod using the finger pressure for looseness. Finally, if the jam nut is properly seated against the push rod, the operator requested to provide torque paint (slipped mark) to the push rod and the jam nut.

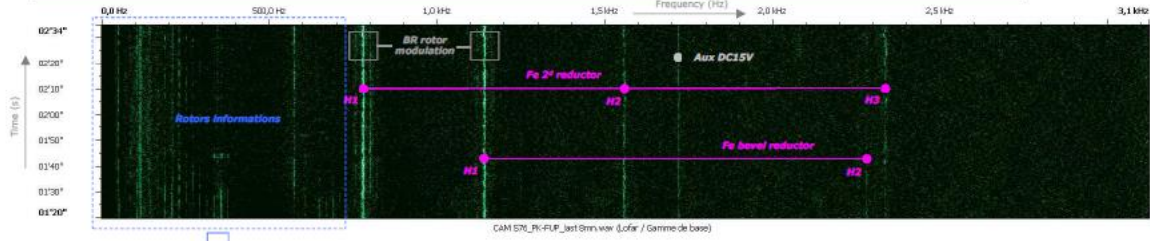
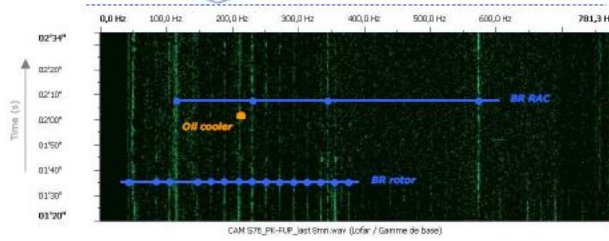
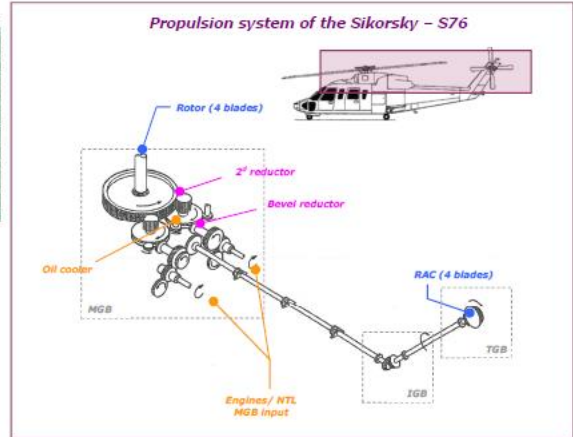
CAM recording of the event / Sample analysis - Detail of the S76C+ PK-FUP / MSN:760582 acoustic signature;

Spectral analysis of the CAM signal showed frequencies related to the main rotor, the tail rotor and reduction stages; **Main gear box inputs, frequencies coming from engines stages and engines auxiliaries, were not detected in the spectra.**

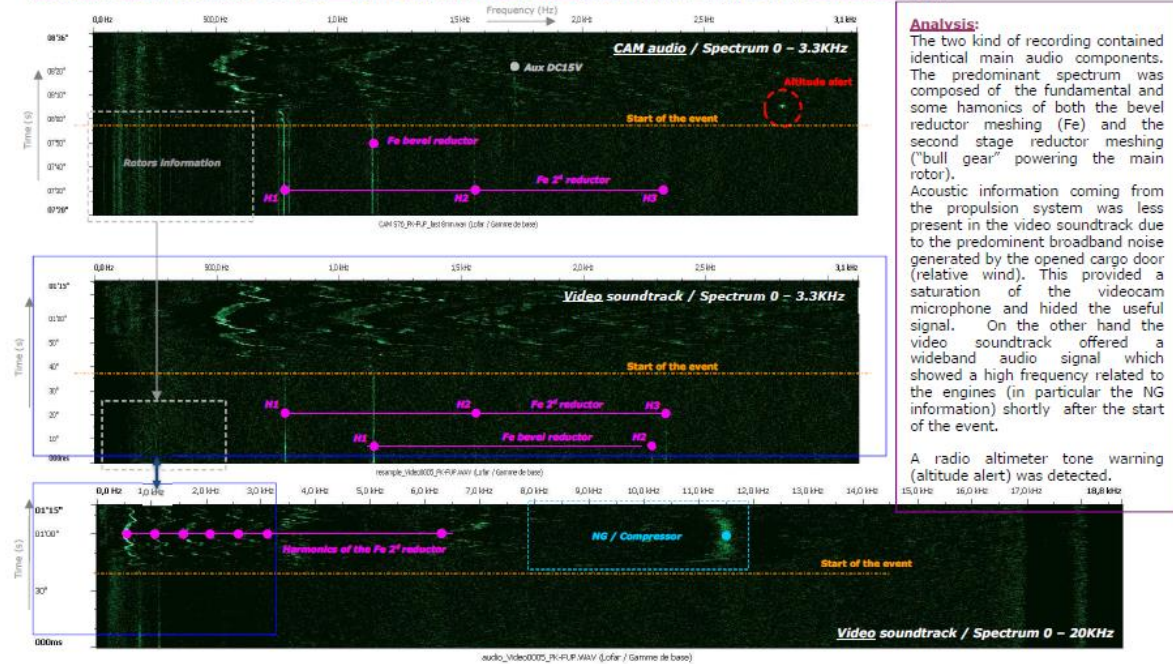
Comparison of frequency spectra / Video soundtrack versus CAM recording sample of the S76C+ PK-FUP.

The two kind of recording contained identical main audio components. The predominant spectrum was composed of the fundamental and some harmonics of both the bevel reductor meshing (Fe) and the second stage reductor meshing ("bull gear" powering the main rotor).

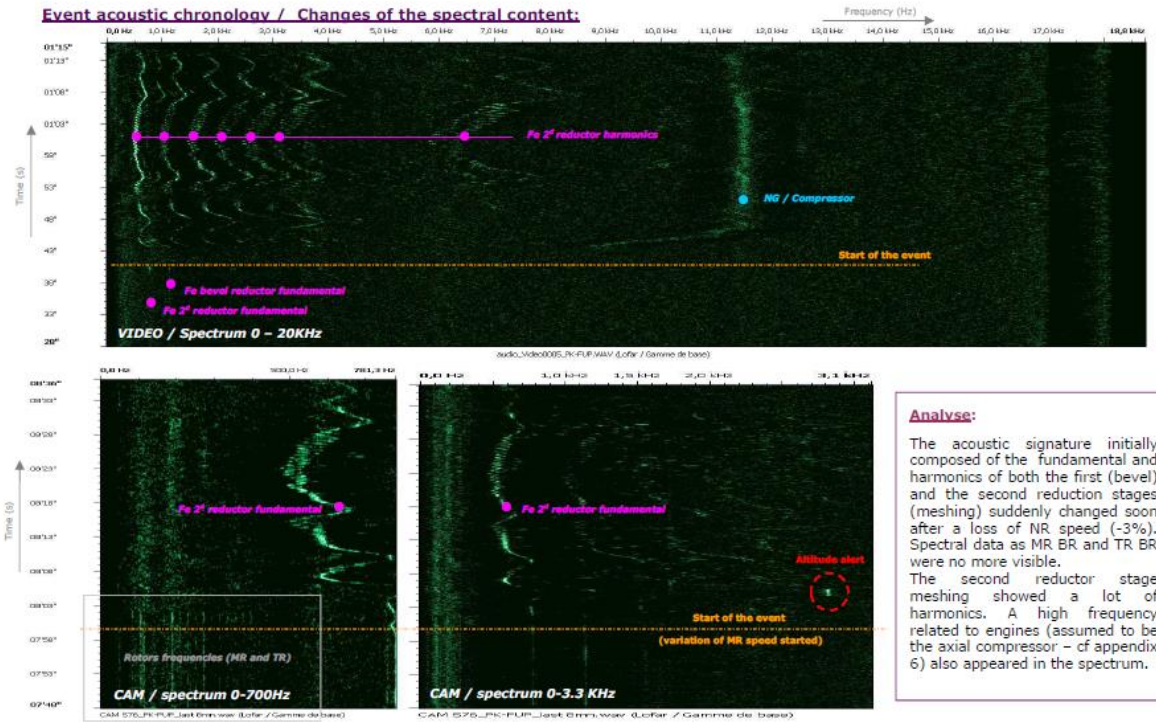
Event acoustic chronology / Changes of the spectral content:

Analyse:
 The acoustic signature initially composed of the fundamental and harmonics of both the first (bevel) and the second reduction stages (meshing) suddenly changed soon after a loss of NR speed (-3%). Spectral data as MR BR and TR BR were no more visible. The second reductor stage meshing showed a lot of harmonics. A high frequency related to engines (assumed to be the axial compressor - cf appendix 6) also appeared in the spectrum.

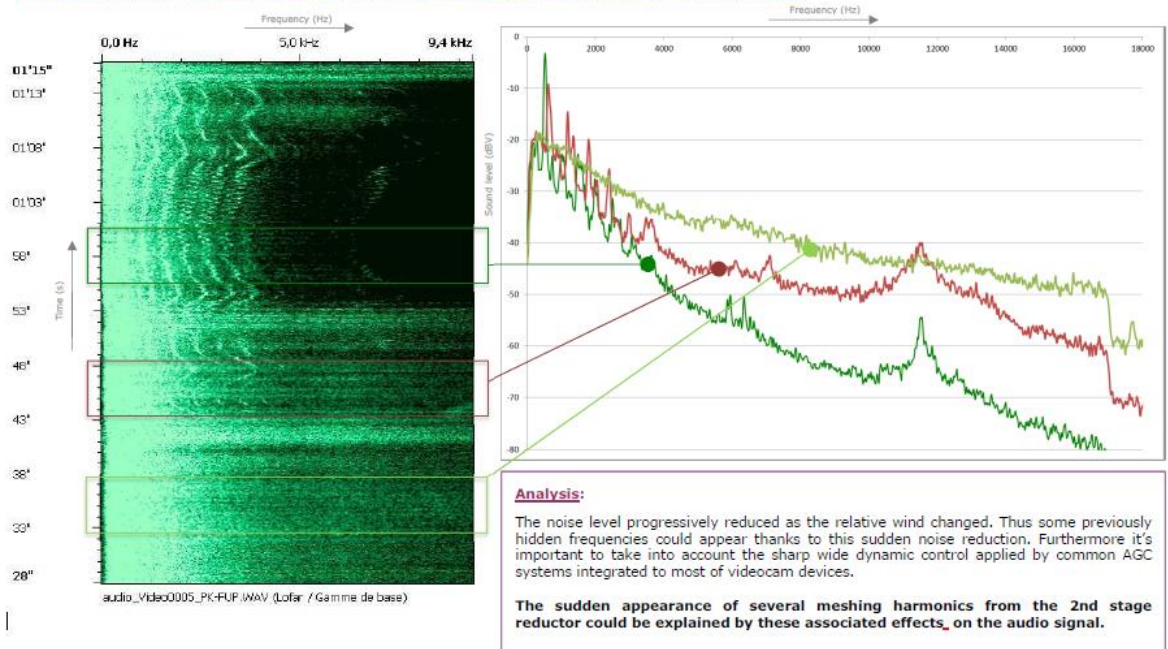
Event acoustic chronology / Wideband noise measurement and evolutions – SPL spectrum:

Analysis:
 The noise level progressively reduced as the relative wind changed. Thus some previously hidden frequencies could appear thanks to this sudden noise reduction. Furthermore it's important to take into account the sharp wide dynamic control applied by common AGC systems integrated to most of videocam devices.
The sudden appearance of several meshing harmonics from the 2nd stage reductor could be explained by these associated effects on the audio signal.

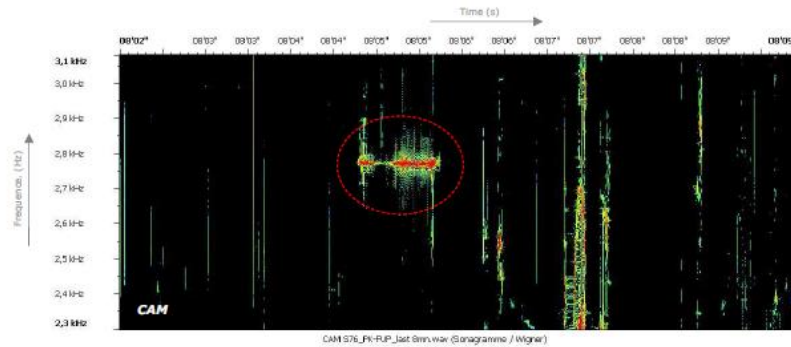
APPENDIX Z**Event acoustic chronology / Audio warning :**

One audio warning was heard 6 seconds after the start of the NR un-stability, i.e. at 32 seconds before the end of the CAM recording.
