**KOMITE NASIONAL KESELAMATAN TRANSPORTASI
REPUBLIC OF INDONESIA**

FINAL
KNKT.15.08.18.04

Aircraft Accident Investigation Report

Airbus 330-200; PK-GPO

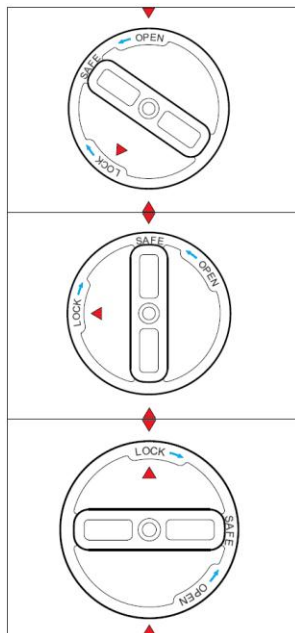
Figure 4: The refrigeration unit

The door was fitted with a red secondary latch should be put in the LOCK position during take-off and landing (Figure 4). The door was also fitted with a pressure relief valve, which would open to relieve pressure differences between the inside and outside of the unit.

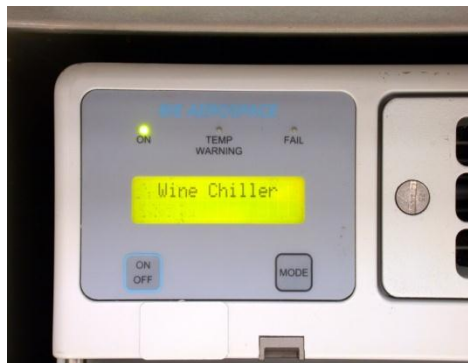
Figure 5: The front panel display

The refrigeration unit was equipped with a display at the front panel showing the active mode selection, warning and failure indication (Figure 5).

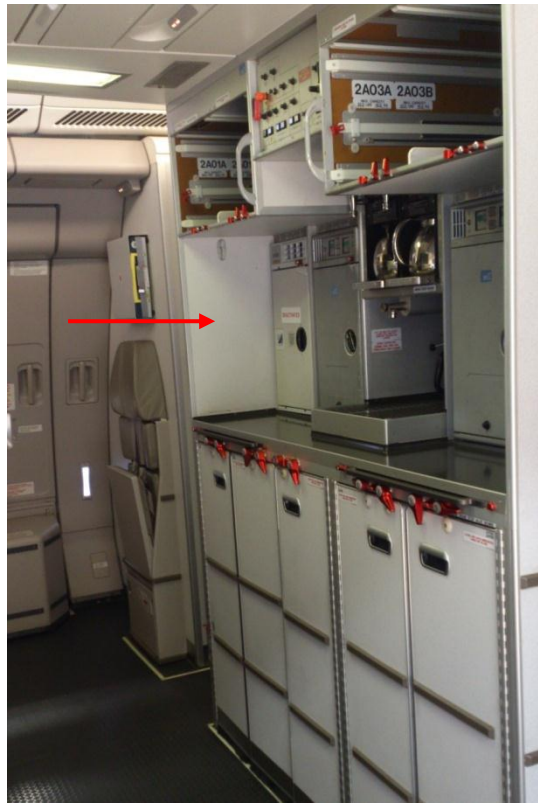
Figure 6: The location of the refrigeration unit in middle galley

After the aircraft landed at Jakarta, the failed refrigeration unit was brought to Garuda Maintenance Facilities for further test and inspection. A functional test on the refrigeration unit revealed that the refrigeration system operated normally.
