**KOMITE NASIONAL KESELAMATAN TRANSPORTASI
REPUBLIC OF INDONESIA**

KNKT.15.08.16.04

Aircraft Accident Investigation Report

PAC-750XL; PK-KIG

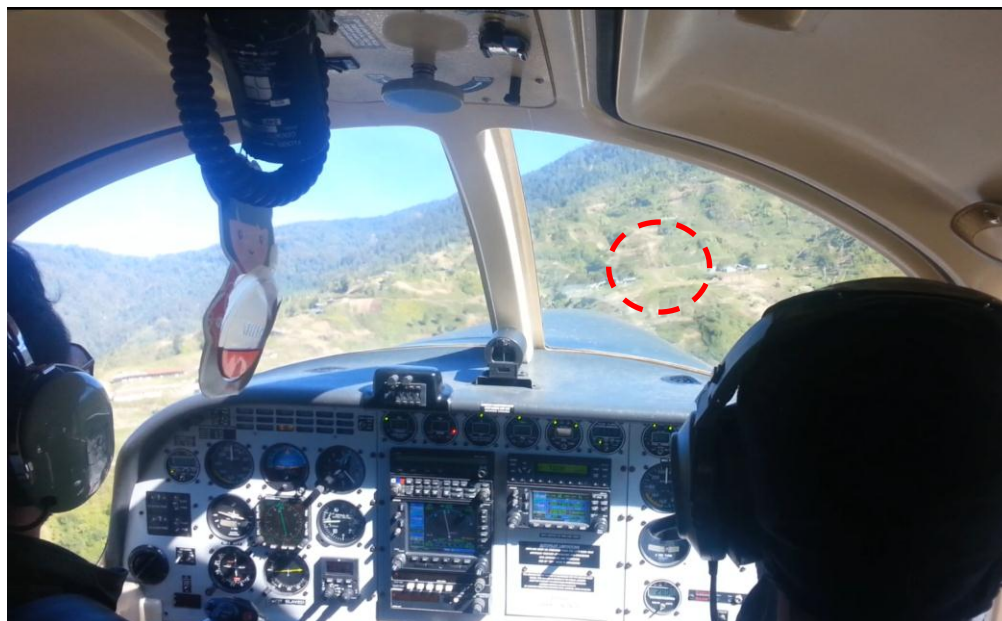
Figure 2: The weather condition from the video footage and the aircraft position toward Ninia (red dash circle)

According to witnesses the weather was clear and the wind was calm. The video footage from the aircraft showed that the weather was clear and met the requirement for Visual Flight Rules (VFR) flight.

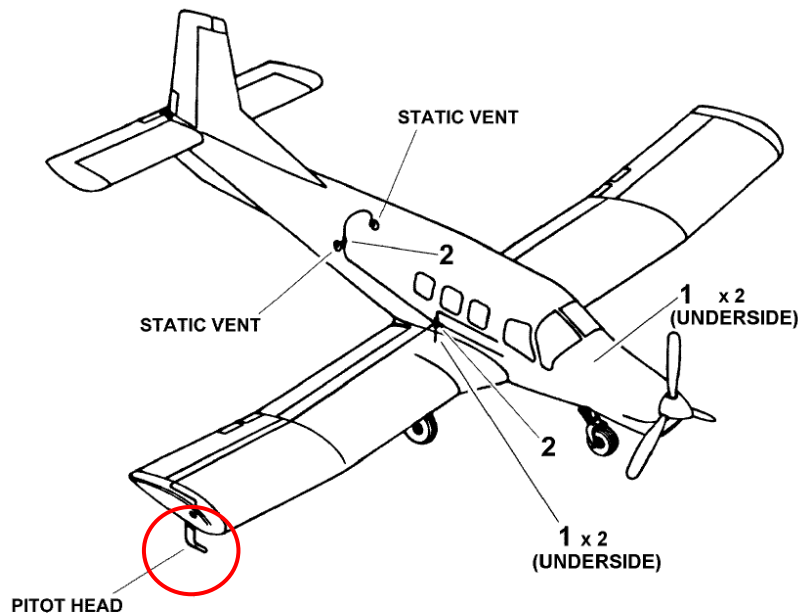
FIGURE 301 PITOT / STATIC SYSTEM

TROUBLE	PROBABLE CAUSE	REMEDY
<i>Airspeed indicator fails to indicate</i>	<i>Pitot head blocked.</i> <i>Obstruction in Pitot line.</i> <i>Water in Static system.</i> <i>Pitot line kinked or disconnected.</i>	<i>Remove and inspect all lines and fittings. Remove obstruction or replace as required.</i> <i>Drain Static system.</i> <i>Check all Pitot lines and repair as required.</i>

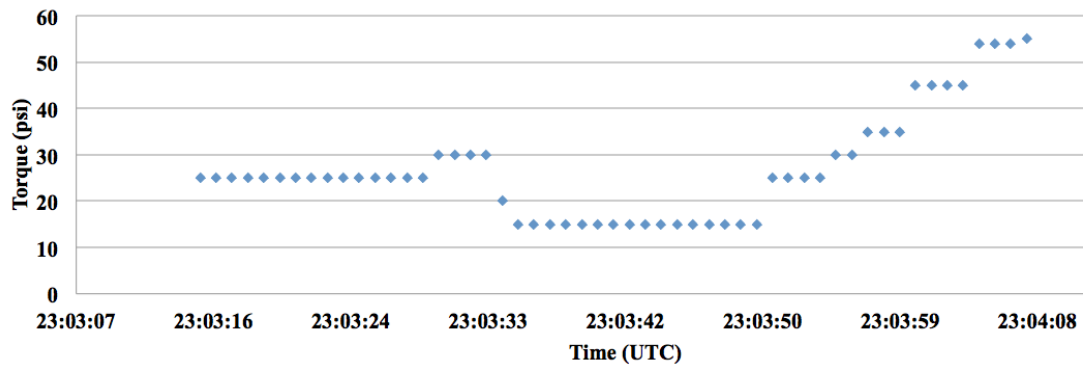
Figure 16: The predicted engine torque

The figure below shows the predicted engine torque (psi) and altitude (feet) for the last 52 seconds prior to impact.
