**KOMITE NASIONAL KESELAMATAN TRANSPORTASI
REPUBLIC OF INDONESIA**

Aircraft Accident Investigation Report

Etihad Airways

Airbus A330 -243; A6-EYN

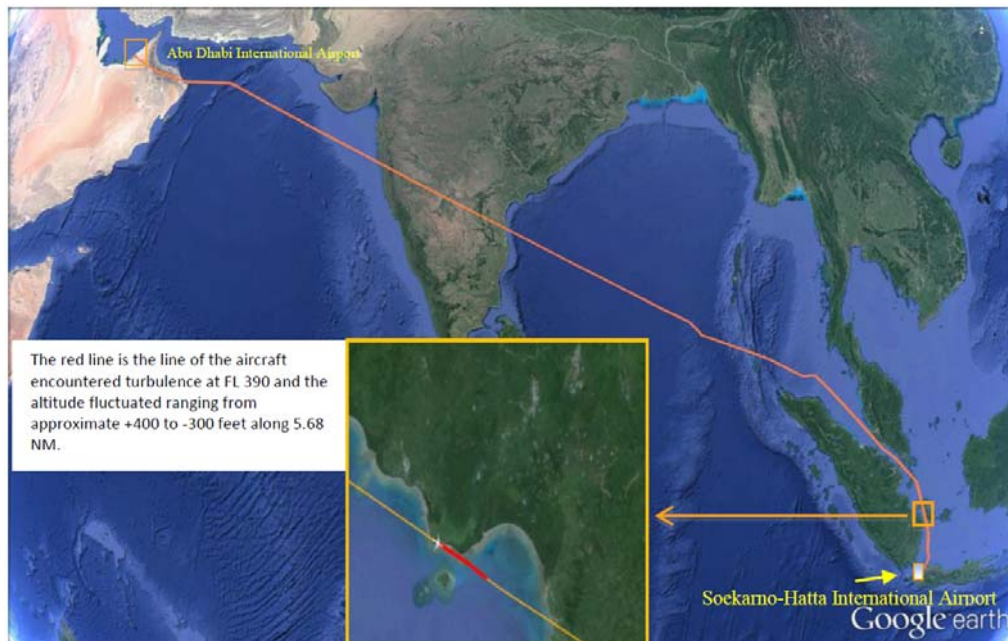
Figure 1: The flight track and the area of the aircraft encounter severe turbulence

At 06:40:10 UTC, while the cabin manager was in the cockpit and the other cabin crew were preparing for arrival procedure, the aircraft encountered severe turbulence³. The aircraft vertical speed fluctuated between -2,500 and +2,000 feet/minute and the SIC turned ON the seat belt sign.

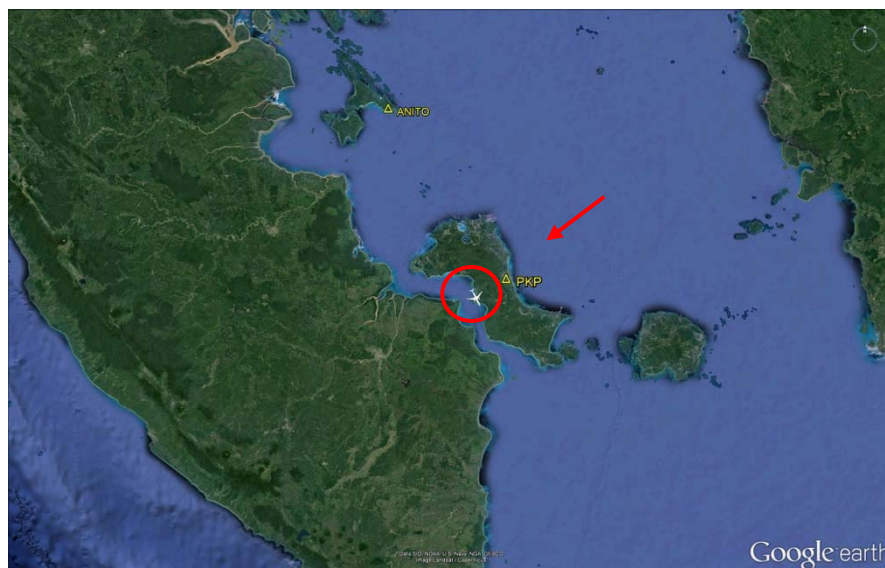
Figure 9: The area where the aircraft experienced in severe turbulence

The Airbus participated in this investigation as advisor to the accredited representative. The Airbus had provided to the KNKT the report of research to the FDR data of the accident flight. The report stated that the beginning of the turbulence started on 06:40:10 UTC at coordinate of -2.37562179° ($2^{\circ} 22' 32.24''$ S); 105.81275920° ($105^{\circ} 48' 45.9''$ E). The location would have been in the area near Bangka Island.
