PRELIMINARY
KNKT.16.05.14.04

Aircraft Serious Incident Investigation Report

**Hong Kong Airlines
Airbus 330-223; B-LNE
Near Banjarmasin
Republic of Indonesia
6 May 2016**

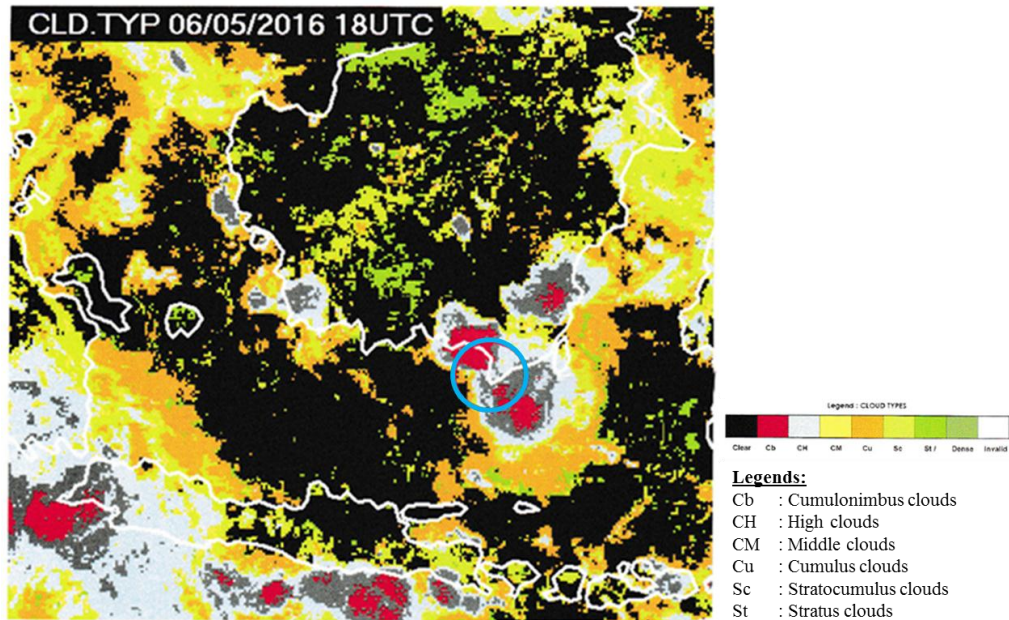
Figure 4: Clouds type satellite imagery on occurrence area (blue circle)

The Badan Meteorologi Klimatologi dan Geofisika/BMKG (Indonesia Meteorology Climatology and Geophysics Agency) provided satellite image clouds type surrounded the occurrence area at 1800 UTC (figure 4).

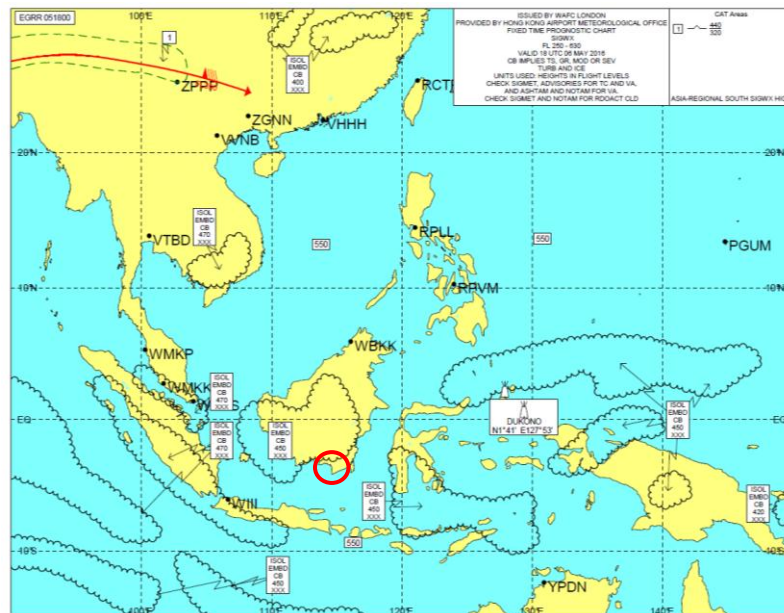
Figure 5: Prognosis chart FL250-630 valid for 6 May 2016 at 1800 UTC

According to the prognosis chart, the area of turbulence event (red circle on figure 4) was not included in the area of potential development of cumulonimbus clouds.

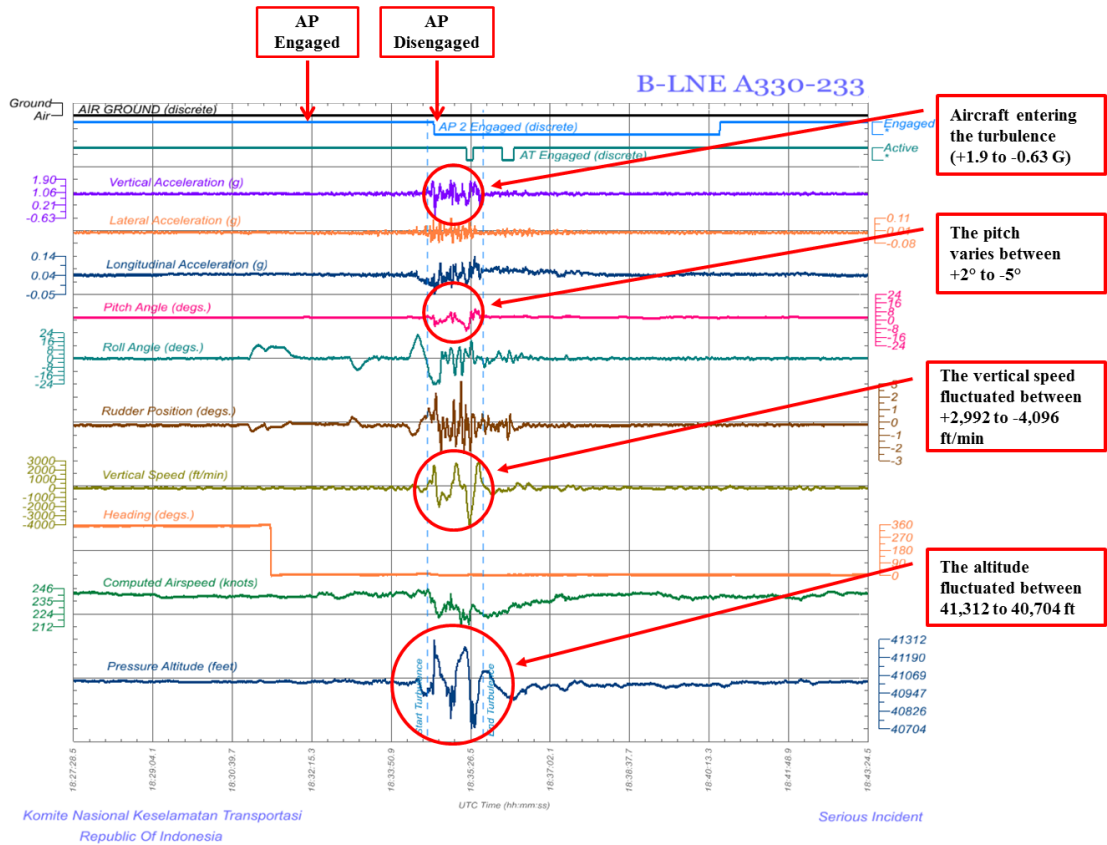
Figure 7: The significant FDR parameters

The aircraft was equipped with Honeywell Flight Data Recorder (FDR) with part number 980-4700-042 and serial number 19544. The FDR was successfully downloaded in KNKT recorder facility and recorded 1,171 parameters and approximately 27 hours of aircraft operation, which was containing 6 flights including the turbulence flight.
