**KOMITE NASIONAL KESELAMATAN TRANSPORTASI
REPUBLIC OF INDONESIA**

KNKT16.05.14.04

Aircraft Serious Incident Investigation Report

**Hong Kong Airlines
Airbus 330-223; B-LNE
Near Banjarmasin
Republic of Indonesia
6 May 2016**

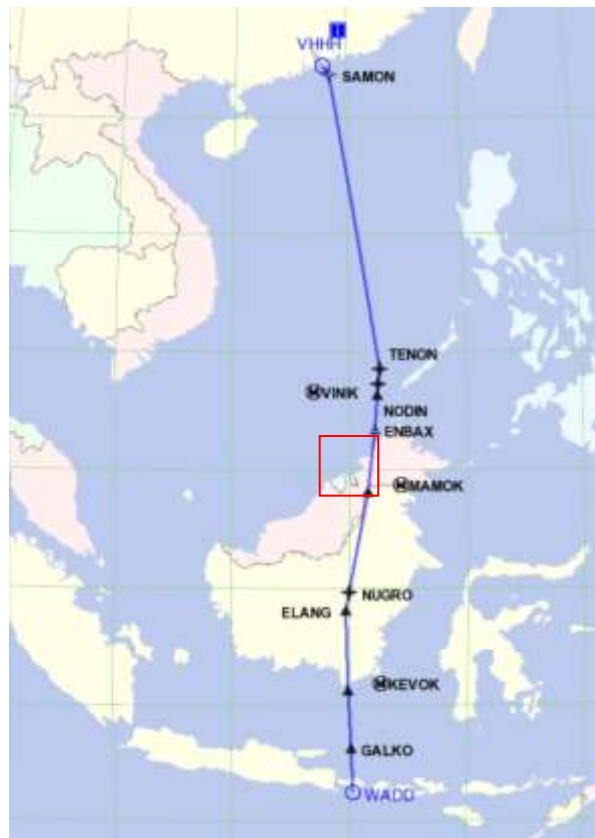
Figure 1: The flight plan route and the area of turbulence (red box)

On 6 May 2016, an Airbus A330-223 aircraft, registered B-LNE, was being operated by Hong Kong Airlines as a passenger scheduled flight from I Gusti Ngurah Rai International Airport (WADD), Bali, Indonesia¹ to Hong Kong International Airport (VHHH), Hong Kong with flight number CRK6704 (Figure 1).

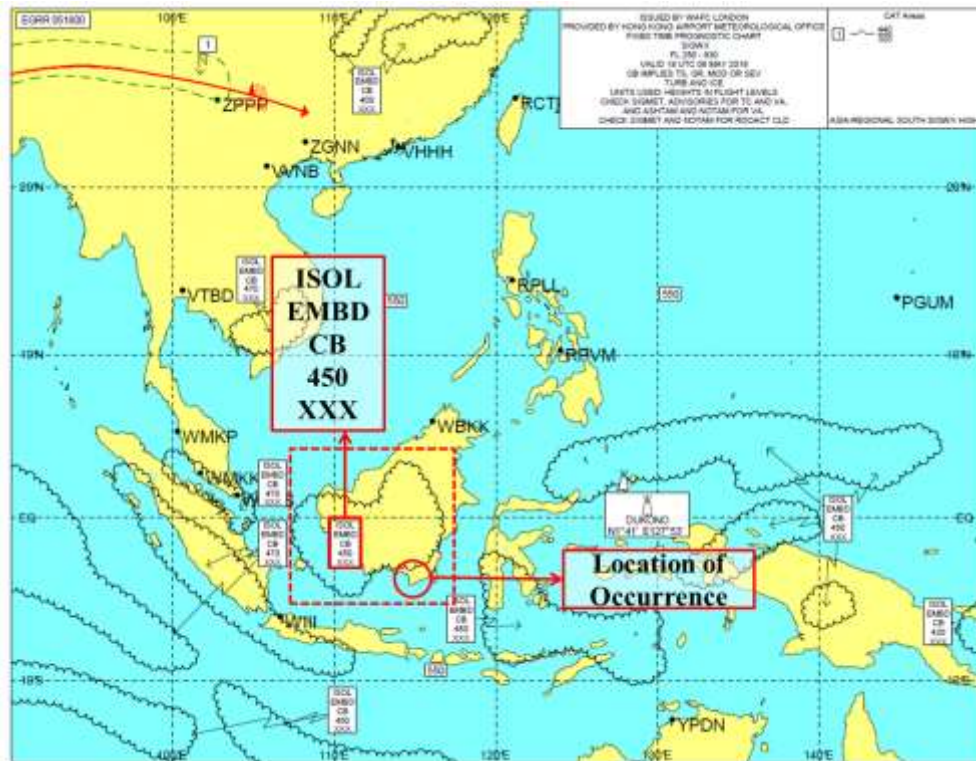
Figure 4: Prognosis chart FL250-630 valid for 6 May 2016 at 1800 UTC

The prognosis chart issued on 6 May 2016 at 1800 UTC showed the area of potentially develop isolated embedded cumulonimbus clouds was over most of Kalimantan including the occurrence area.

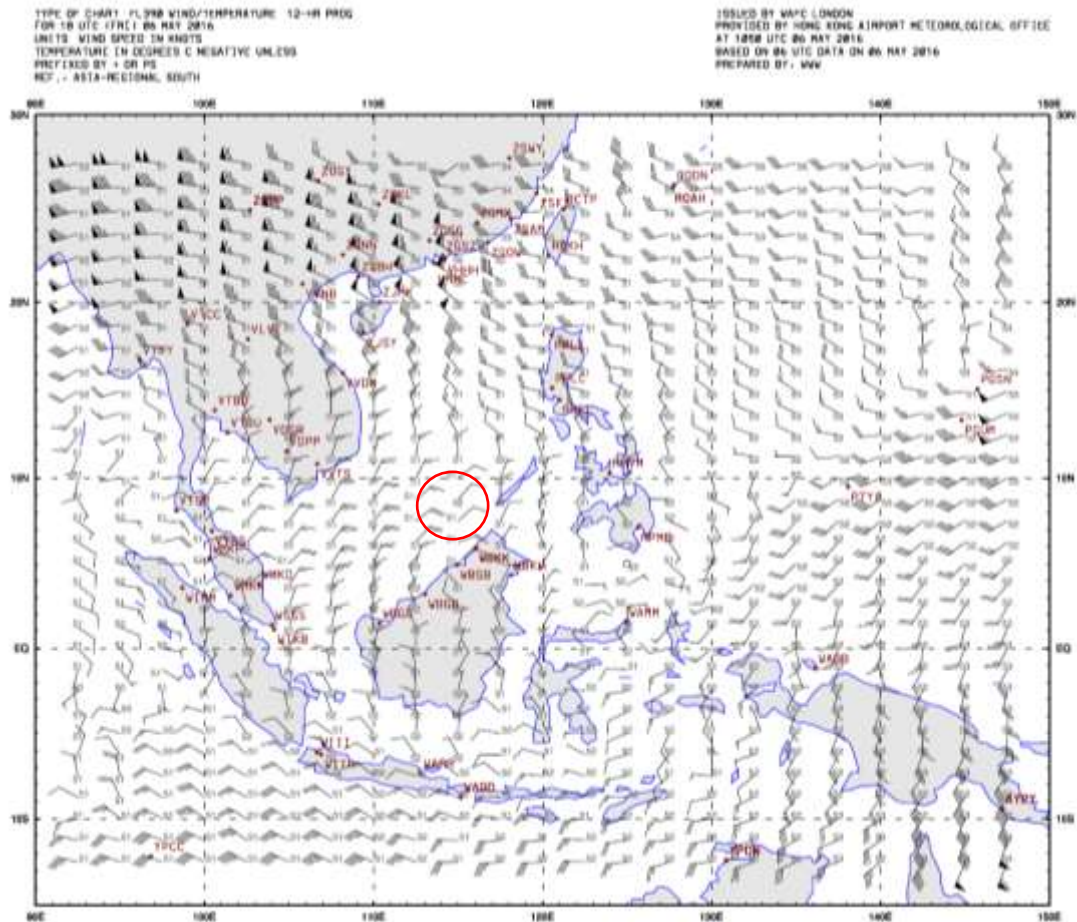
Figure 5: The wind/temperature chart at FL390 for 6 May 2016 at 1800 UTC over the occurrence area (circle in red)

The wind loft chart issued on 6 May 2016 at 1800 UTC showed 5 knots at FL 390 over the occurrence area with temperature of -52°C .

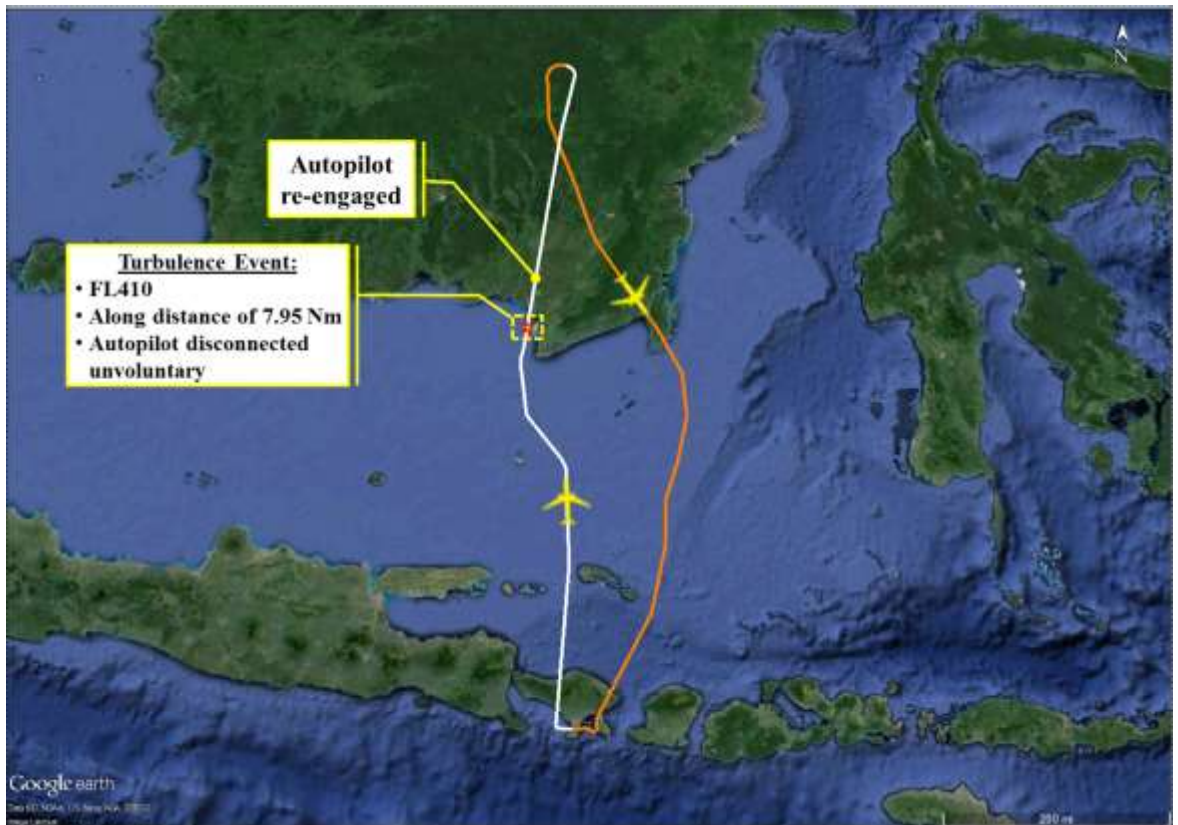
Figure 7: Aircraft flight track based on FDR data

The recorded parameters of latitude and longitude from the FDR were superimposed with the Google Earth (figure 7) and the satellite image to provide actual flight track during the occurrence (figure 8 and 9).
