**KOMITE NASIONAL KESELAMATAN TRANSPORTASI
REPUBLIC OF INDONESIA**

KNKT.16.10.35.04

Aircraft Accident Investigation Report

**Perkasa Flight School
Piper PA28-161 Warrior II; PK-PBH
Jeruk Legi Village, Cilacap, Central Java
Republic of Indonesia
19 October 2016**

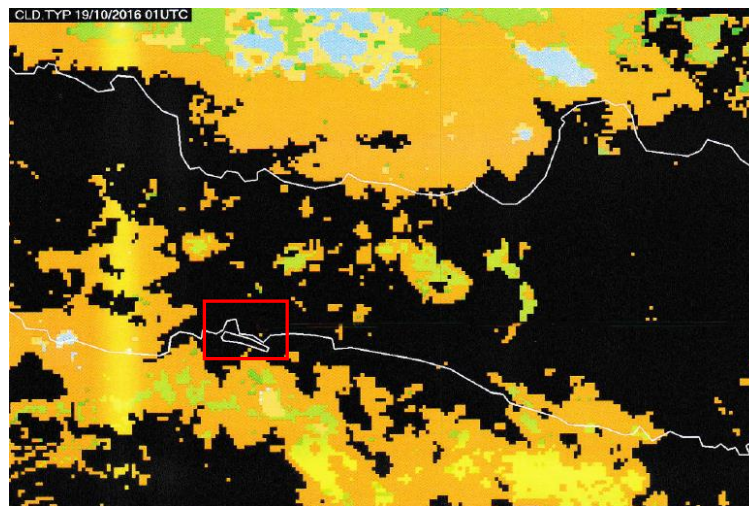
Figure 4: The weather satellite image at 0800 LT

Weather satellite image information issued by Meteorological, Climatological, and Geophysical Agency (*Badan Meteorologi Klimatologi dan Geofisika – BMKG*) showed that on 19 October 2016 at 0800 LT and 0900 LT the weather at Tunggul Wulung area was clear as shown in the figure below.

Note: The black colour represented clear weather and the area of occurrence showed in the red square in the figure below.

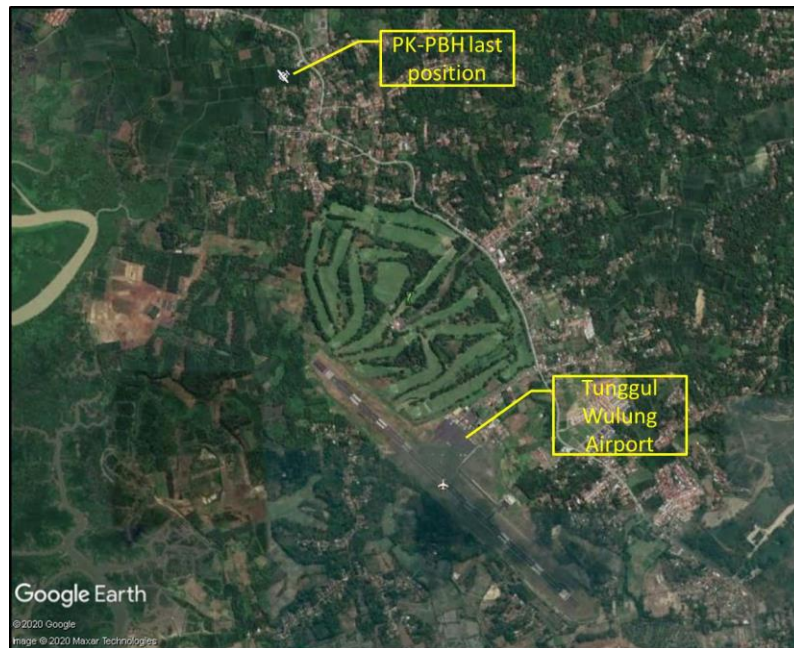
Figure 5: The aircraft position relative to the Tunggul Wulung Airport

The aircraft was found at Tunggul Wulung village RT01/RW02 Tritih Lor, Jeruk Legi of Cilacap resident, north west of the airport, approximately 1.3 Nm from the beginning of runway 31 at coordinate 7° 37' 46.58" S 109° 1' 40.12" E. The aircraft stopped on heading 250°.

The ground mark after the aircraft tumbling was approximately 10×2 meters from the embankment of paddy field. The observation of the landing path, after landed the aircraft nose wheel impacted the embankment of paddy field resulted in aircraft upside-down as indicated by the ground marks.

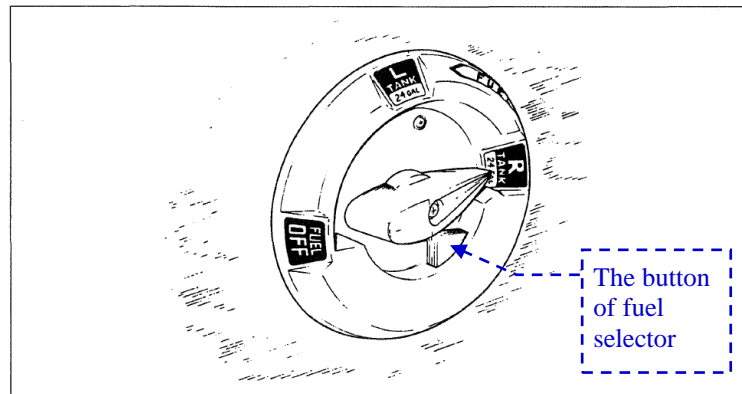
Figure 16: The fuel selector

The button on the fuel selector must be pressed and held while the selector is moved to the FUEL OFF position. The button releases automatically when the selector is in the detent of L TANK or R TANK position.

The investigation found the fuel selector position was at the L TANK position at the crash site. The instructor pilot stated that during the force landing, the engine restart was attempted and the fuel selector was moved from L to R TANK position and finally the instructor pilot placed the fuel selector to the L TANK position. However, the engine restart was unsuccessful.
