**KOMITE NASIONAL KESELAMATAN TRANSPORTASI
REPUBLIC OF INDONESIA**

Aircraft Accident Investigation Report

Perkumpulan Penerbangan Alfa Indonesia

DHC – 4 Caribou; PK-SWW

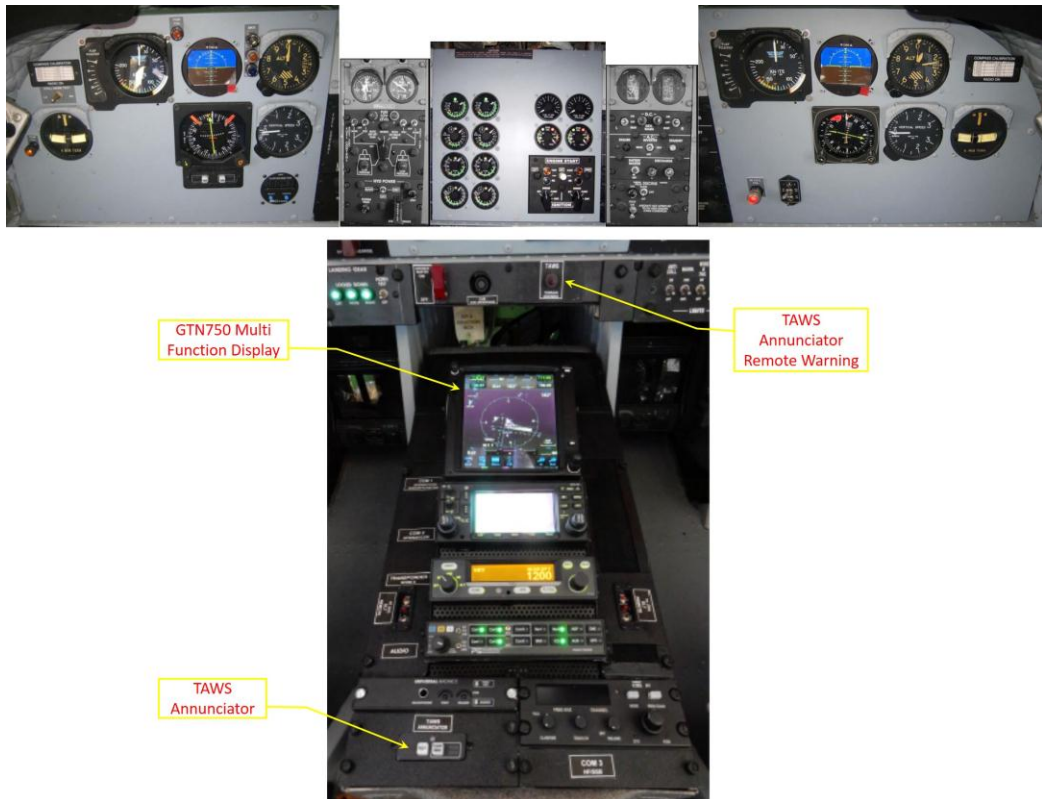
Figure 3: The cockpit layout after modification

As part of the TAWS installation, the MD41-1208 annunciator light and control of terrain was installed on the pedestal (see figure 3 for the location in the cockpit).

1. The cockpit area microphone wiring interconnection to the CVR CAM channel line was normally connected. The cockpit area microphone unit was located on the central lower panel in between avionics master switch and TAWS annunciator remote warning switch (see figure 3, the cockpit layout after modification).

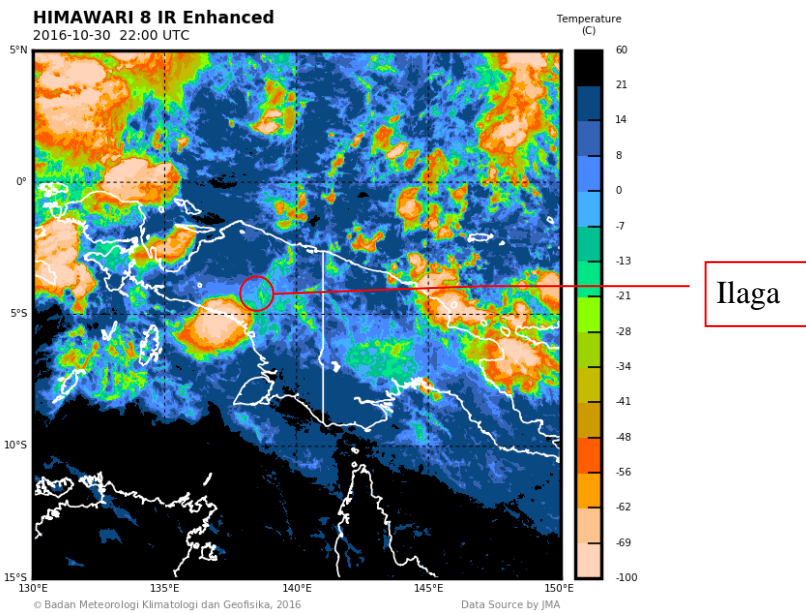
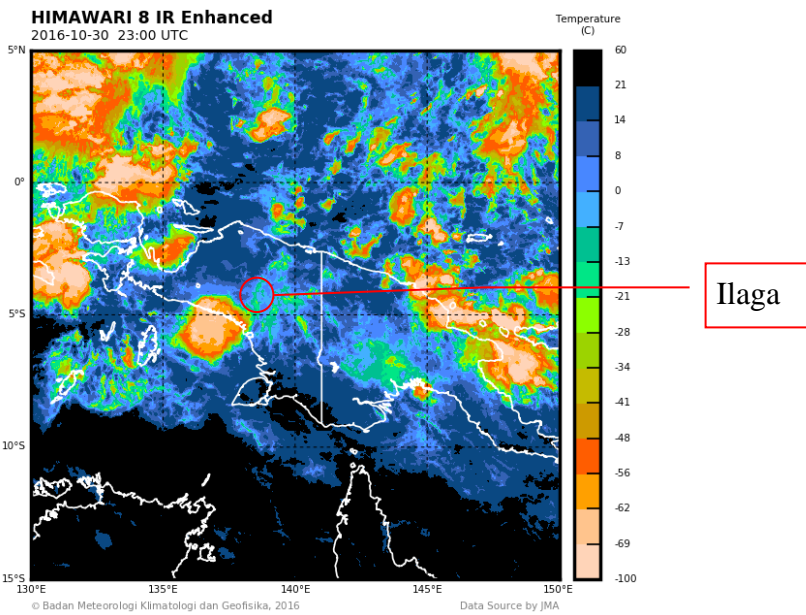
Figure 9: Satellite weather image 31 October 2016 at 2200 UTC

The satellite image showed the low clouds covered the Ilaga area during the accident flight, identified by blue and green color in the figure 9 and 10.

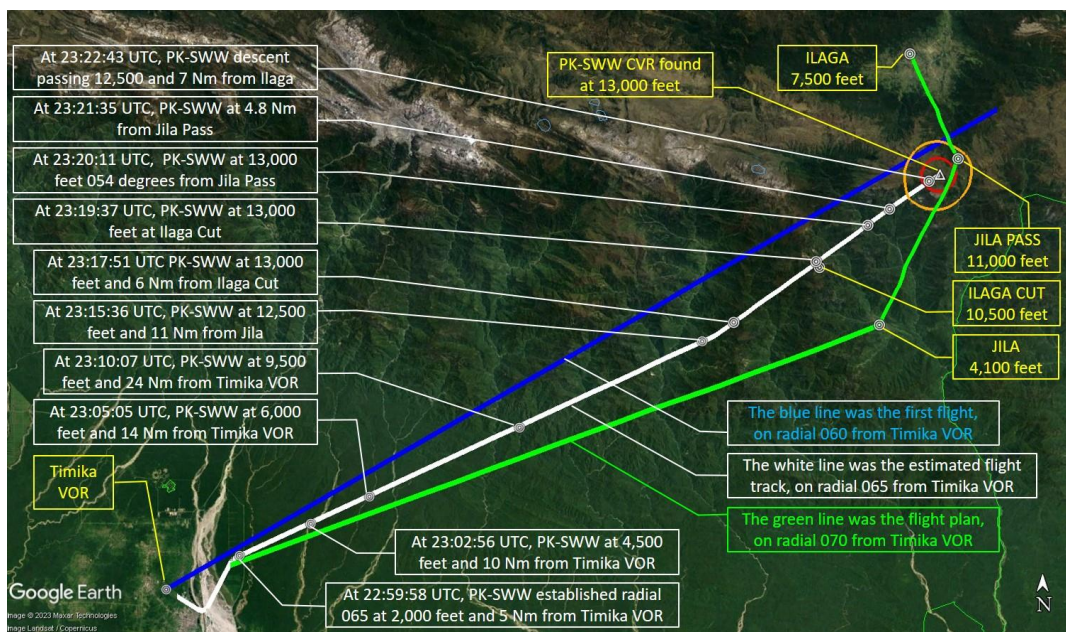
Figure 15: The estimated flight track of the aircraft

At 21:15:36 UTC, the aircraft maintained the altitude of 12,000 feet and flew toward Ilaga Cut in which the aircraft was slightly deviated to the right about 3° and 9 minutes later the SIC stated that the aircraft was about 4 Nm from Ilaga. The aircraft was landed safely at Ilaga. The estimated flight track of the first flight is shown in the blue line in the figure 15 below.

The estimated flight track of the flight plan (green line), the first flight (blue line) and the second flight (white line) are as follow.

At 23:06:16 UTC, after about 14 Nm from Timika VOR while the PIC maintained the radial 065, the PIC briefed the SIC the intention to follow the radial 070 (the radial 070 was the filed flight plan) direct to Jila (see figure 15). About 4 minutes later, the PIC responded the other station calling and stated that the aircraft was at 24 Nm with altitude of 9,500 feet at radial 065 from Timika VOR, which mean the PIC intention to fly the radial 070 probably was not executed at that time.

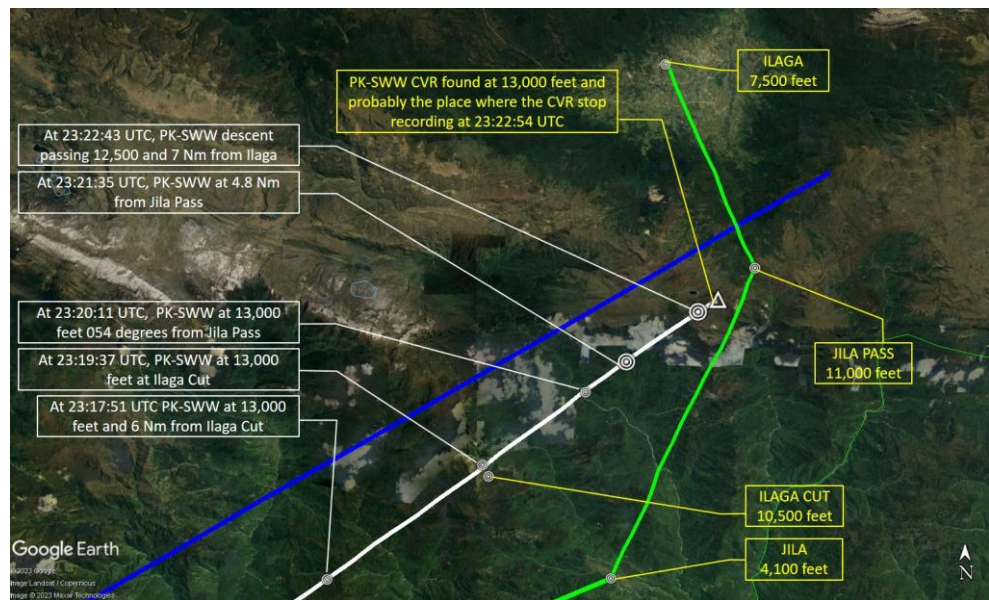
Figure 16: The plot of 4.8 Nm from Jila Pass

The statement of “48 miles” was a pilot statement about a distance. The probable interpretation of the “48 miles” was of 4.8 Nm distance from Jila Pass (see figure 16 below).

Plotting the 4.8 Nm to Jila Pass in direction of 054 in the Google Earth shows the distance about 3.2 Nm to the impact point. The time spent of the point “4.8 Nm from Jila Pass” (at 22:21:35 UTC) to the impact point (at 23:22:54 UTC), was 1 minute and 19 seconds. Assuming the aircraft speed of 120 knots, the aircraft would travel about 2.63 Nm which is close to the plotted distance about 3.2 Nm in the Google Earth.

Reviewing the track along the radial 065 from Timika toward Ilaga Cut, the highest elevation was below 12,000 feet (see figure 16 about the terrain before the distance of 45 Nm), while the flight maintained the cruise altitude of 13,000 feet.

At 23:20:11 UTC, after passing Ilaga Cut, the PIC stated ‘just leave it 054 for a while’. The track 054 was the bearing to Jila Pass from the aircraft current position. It means that the PIC probably intended to fly via Jila Pass, while the direct bearing to Ilaga from the aircraft current position was about 023 (see figure 16).
